PROJECT NOTIFICATION FORM

Dudley Office Building Project

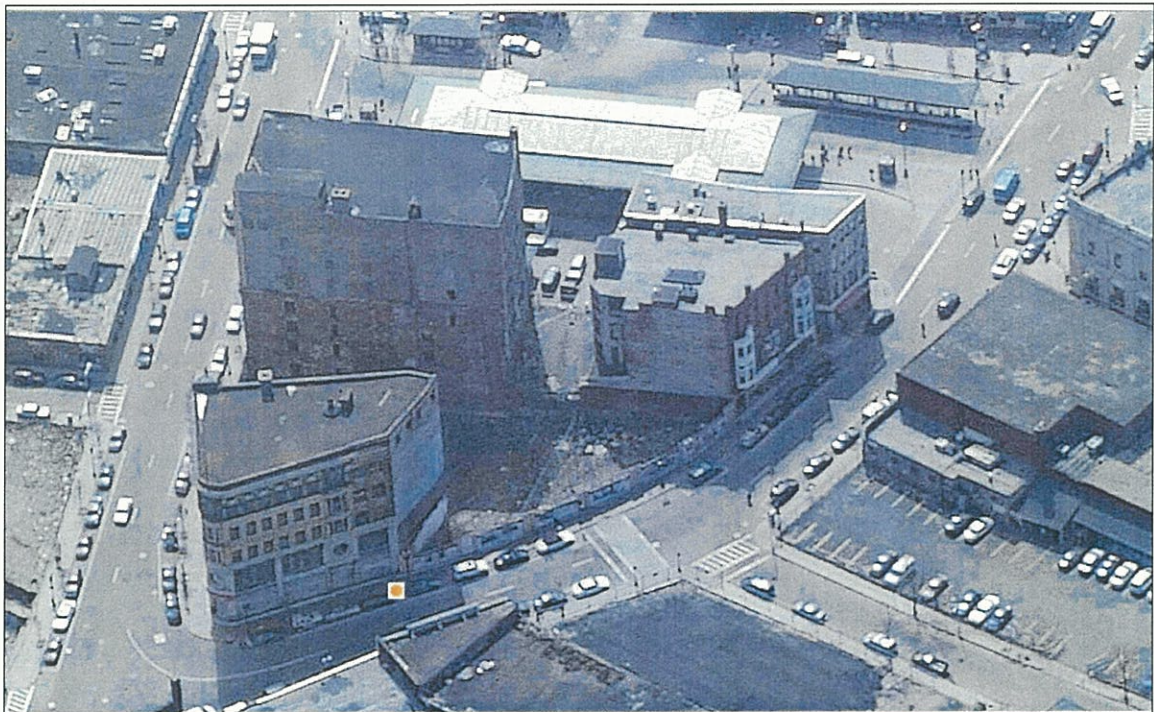
Submitted to: **Massachusetts Historical Commission**
220 Morrissey Boulevard
Boston, MA 02125

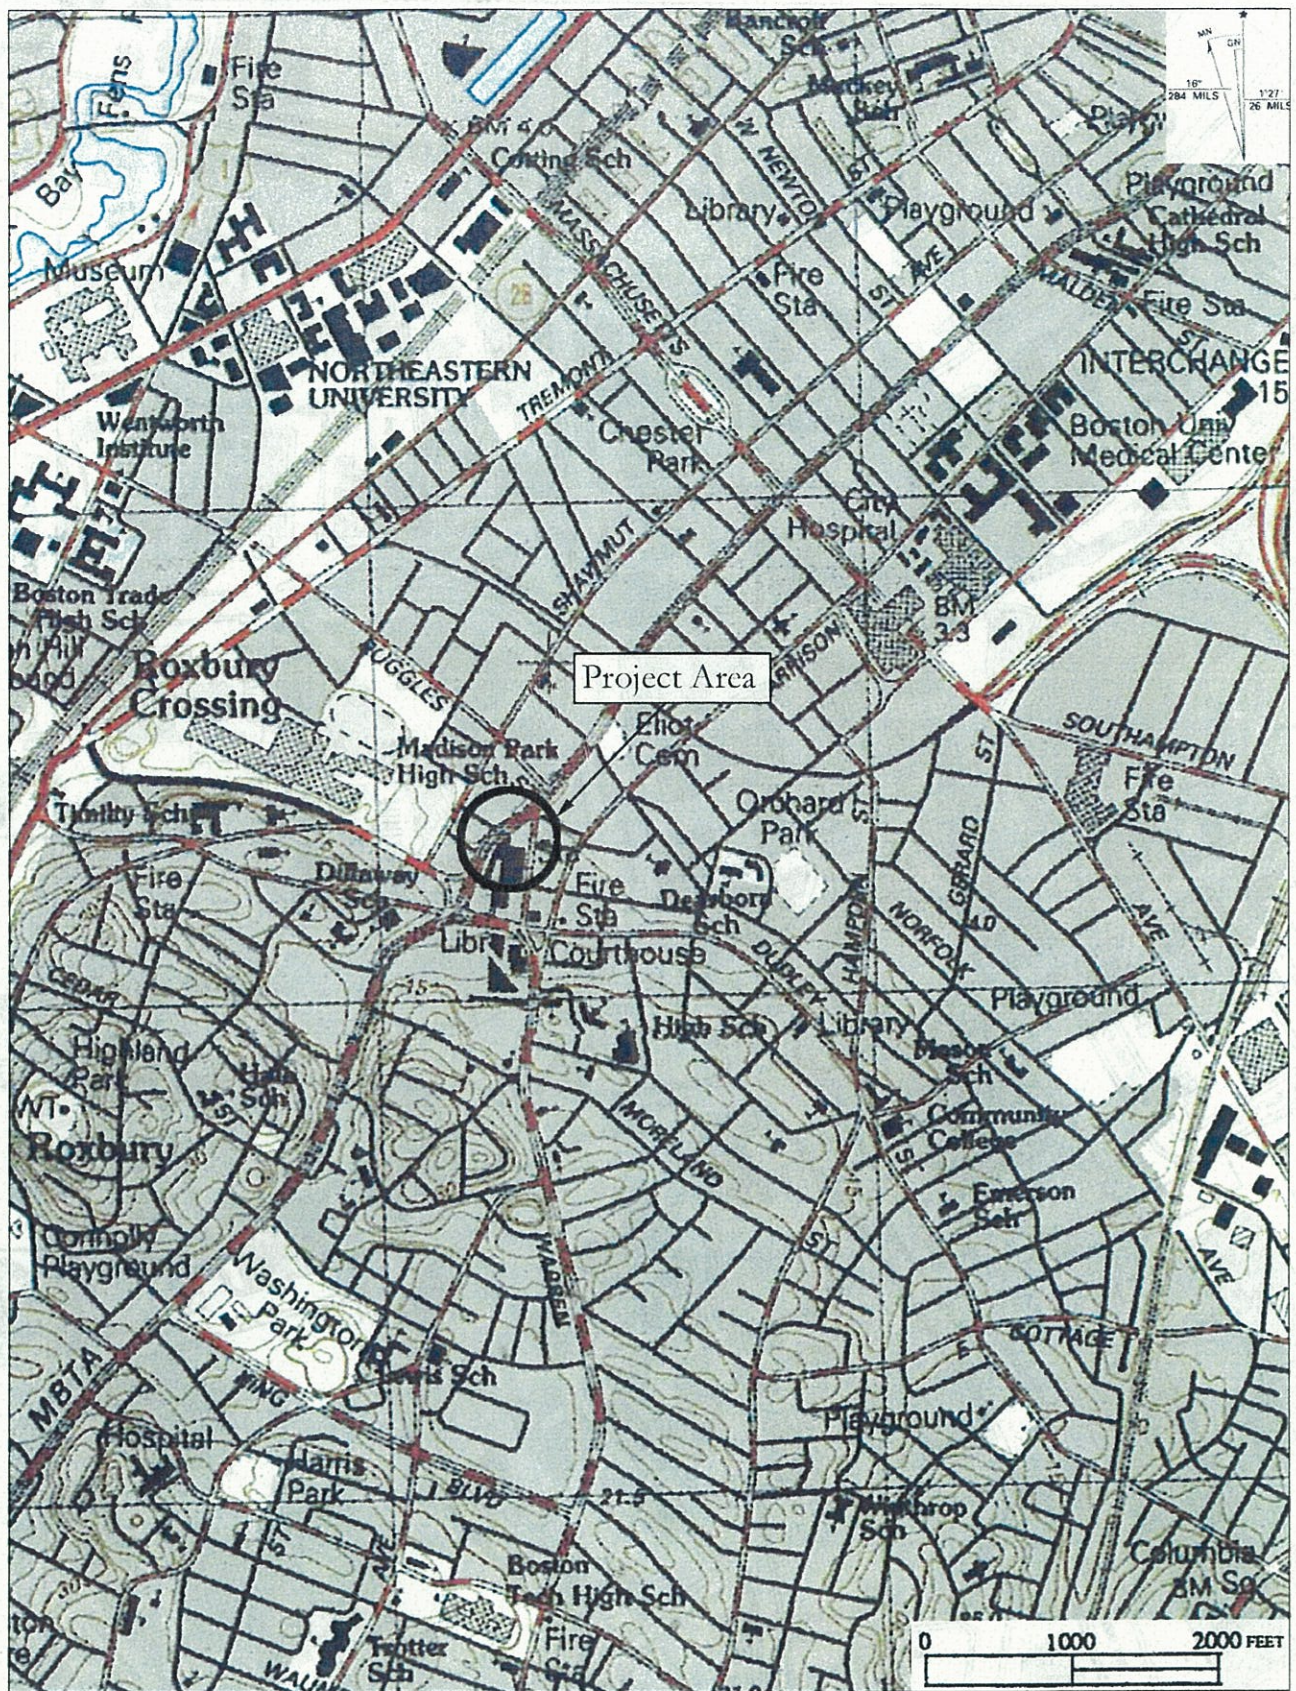
Figure 1. Location of the Dudley Square project area on the Boston South, MA, USGS topographic quadrangle, 7.5 minute series.

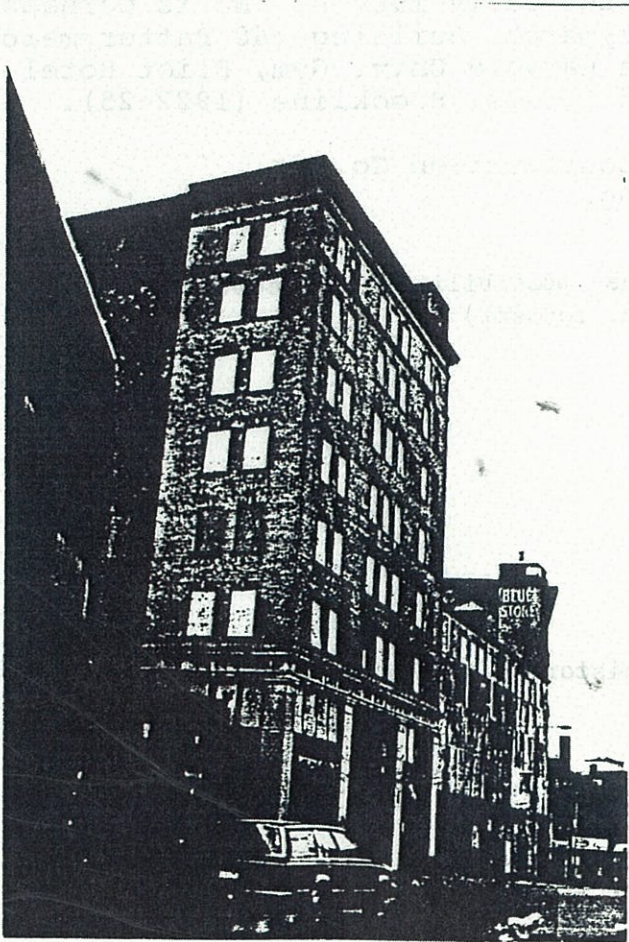
minor moderate drastic _____

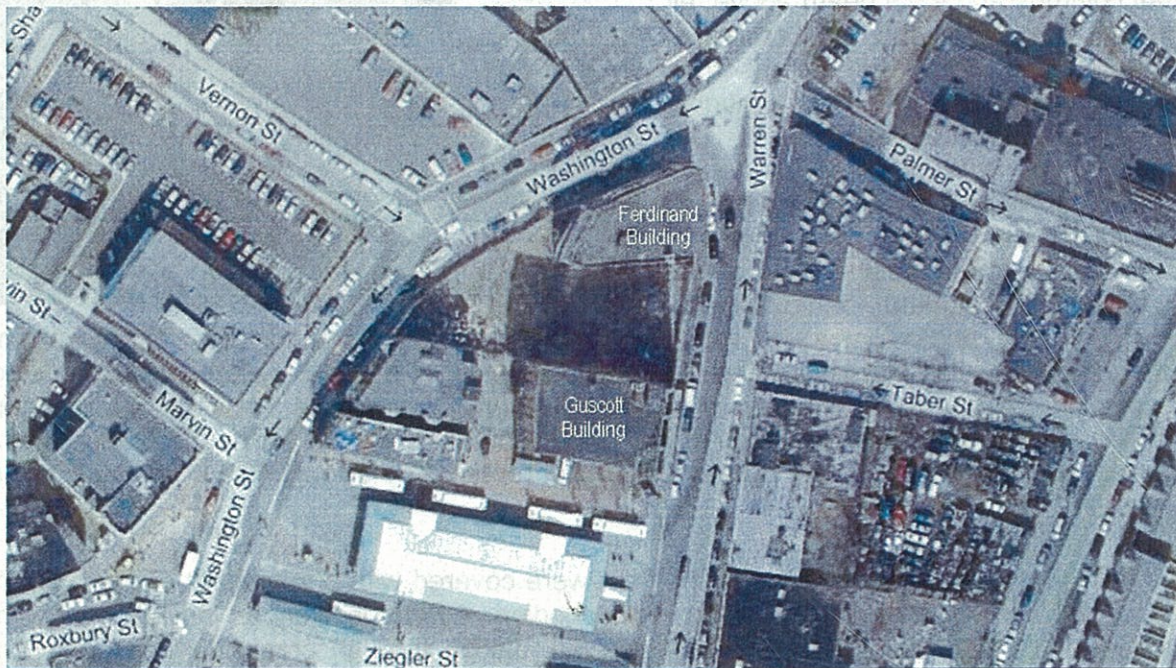
Other Activities: This document presents the findings from the Guscott Building inspection only. A separate inspection report will be issued at a future date for the Ferdinand Building, which is part of a later building preservation work phase of the Dudley Square Environmental Remediation, Site Clearance and Building Preservation Project.

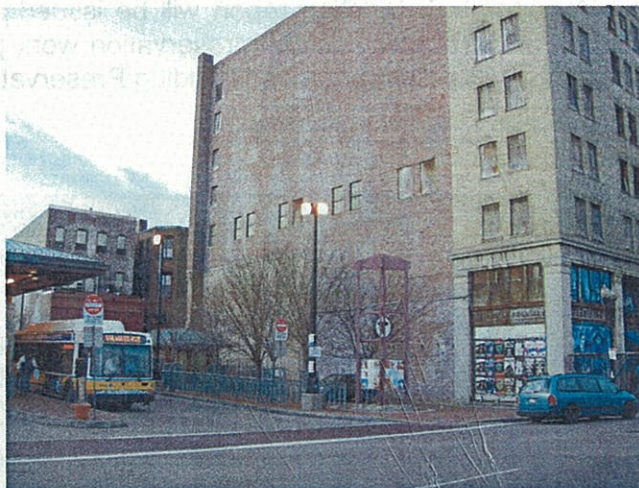
There were no structural members that were displaced, seriously deflected, or had experienced a major loss of cross section. Although no signs of imminent failure were evident at the time of inspection, significant structural deficiencies may arise as deterioration of the building's load-resisting elements continues to progress. Basement photographs G0.1 through G0.5 are included in Appendix A.

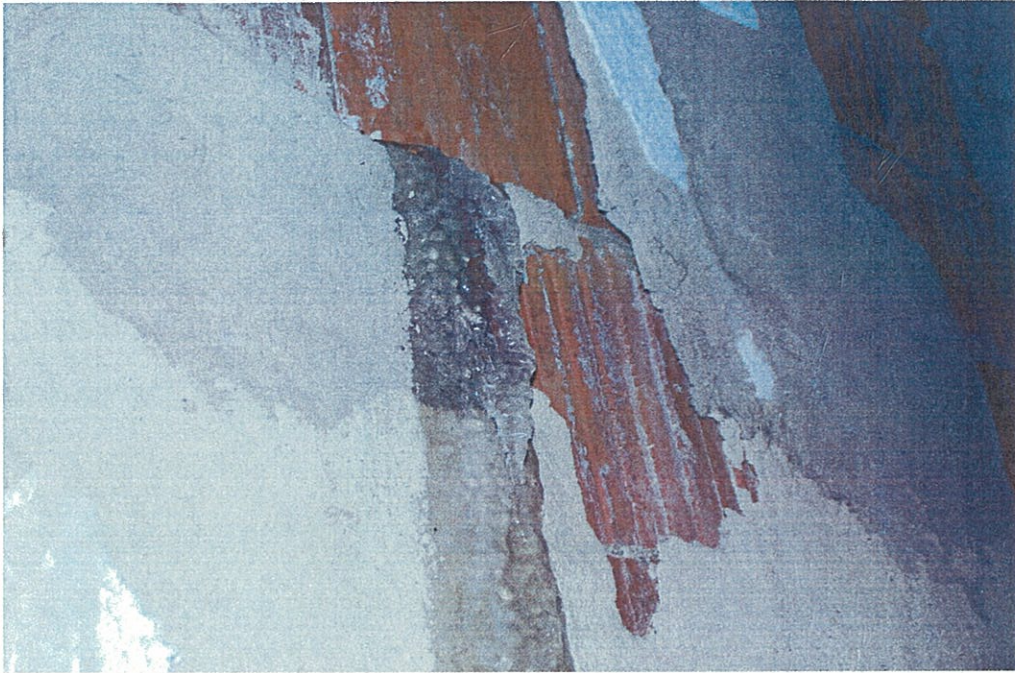
Photo G0.1 - Basement

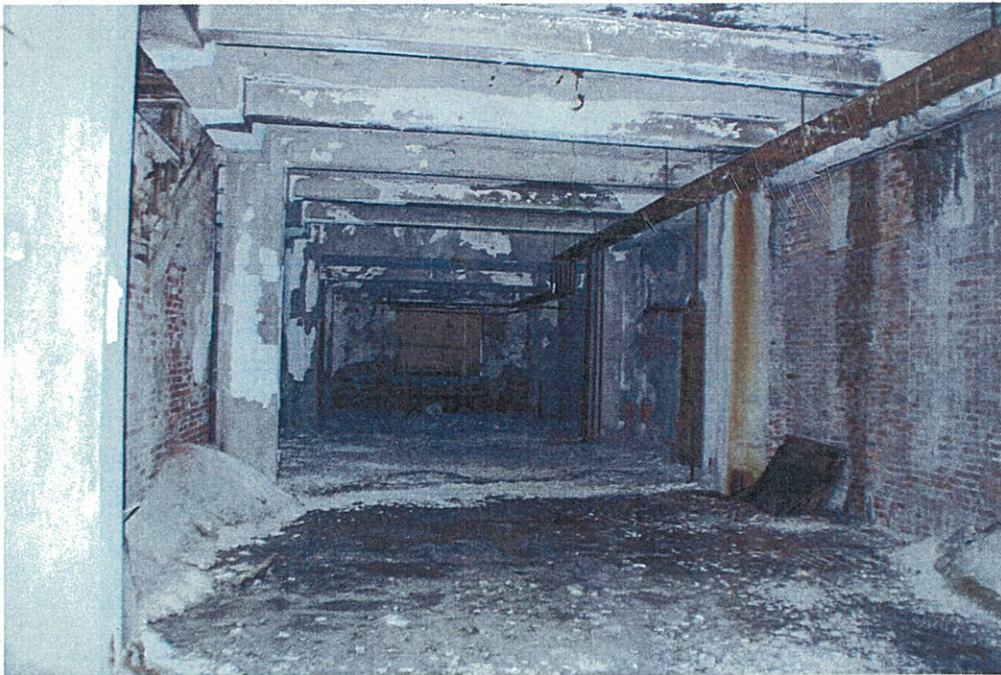
Photo G0.2 - Basement

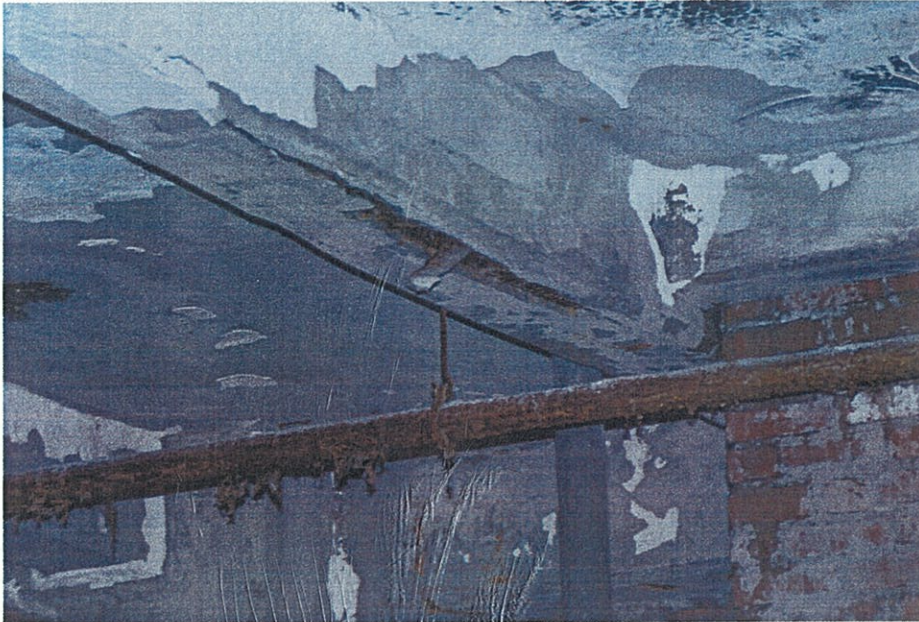
Photo G0.3 - Basement
Delamination of concrete encasement at underside of beam revealing corrosion of steel section. Ceiling-mounted piping system also shown.

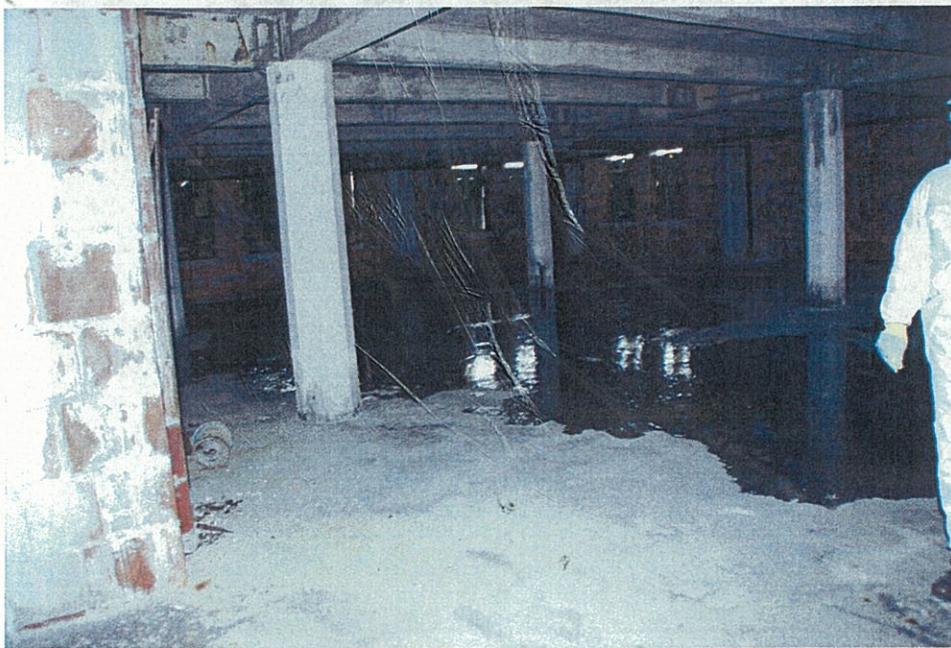
Photo G0.4 - Basement
Typical layout of concrete-encased steel columns shown. Large areas of floor covered with ice. Delaminated clay brick walls shown in foreground.

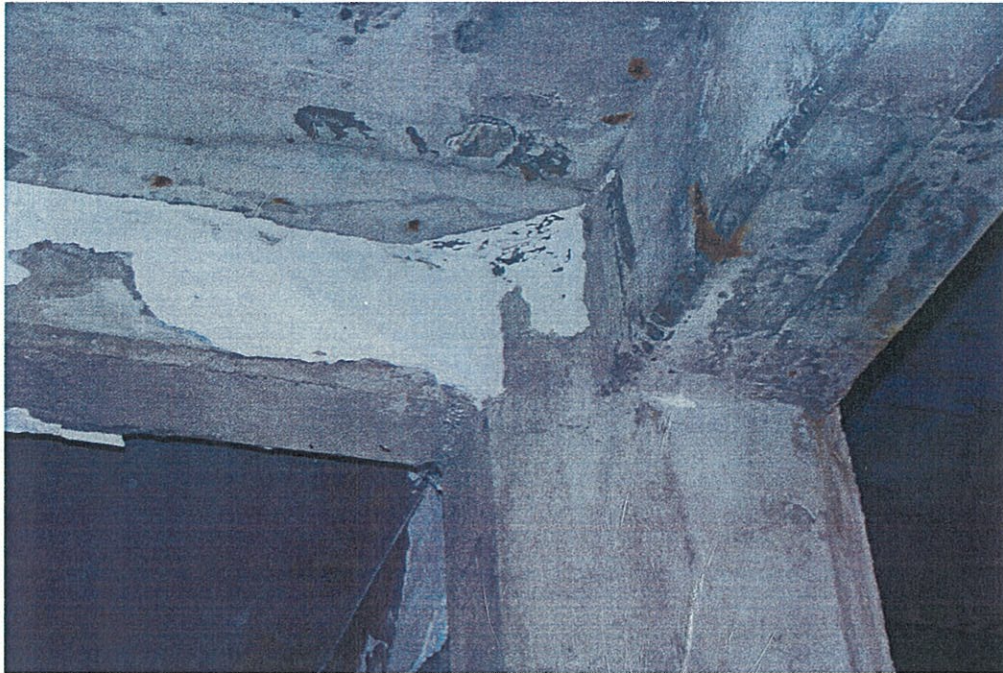
Photo G1.2 – 1st Floor

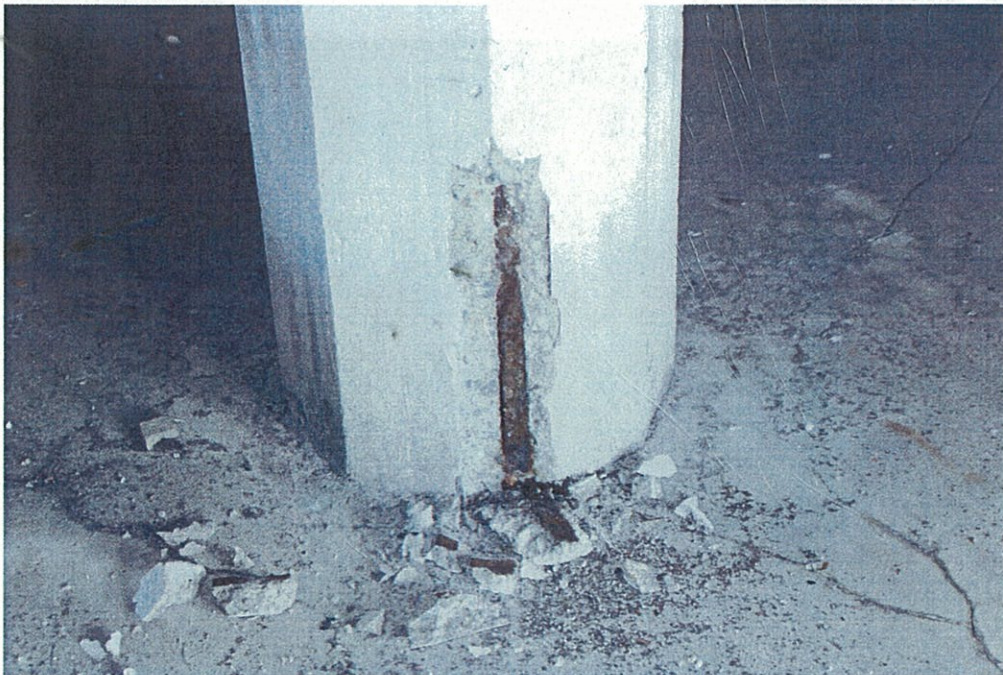
Photo G1.3 – 1st Floor

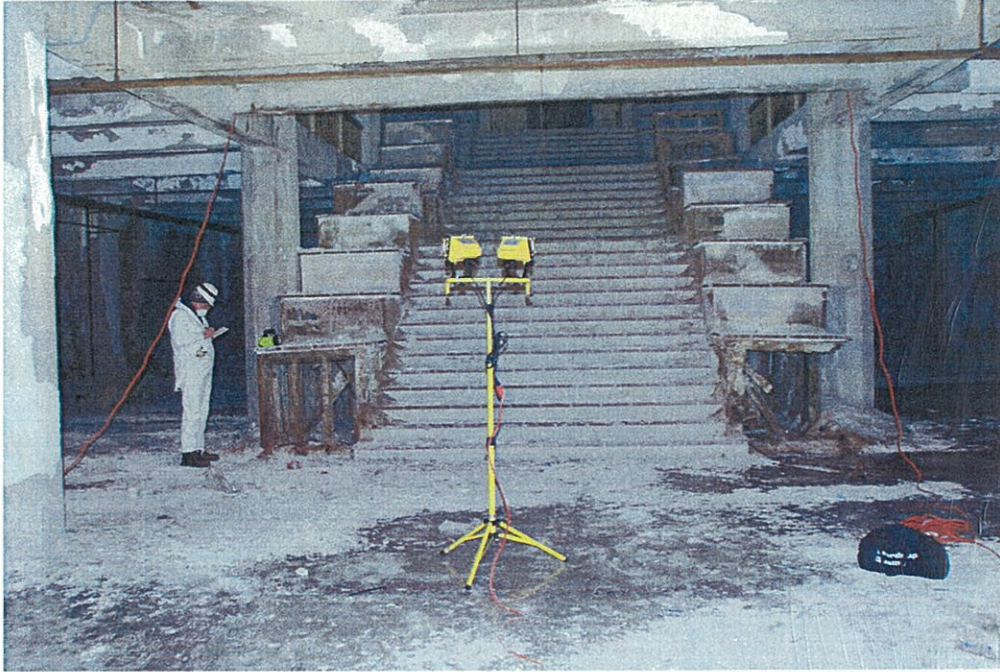
Photo G1.4 – 1st Floor

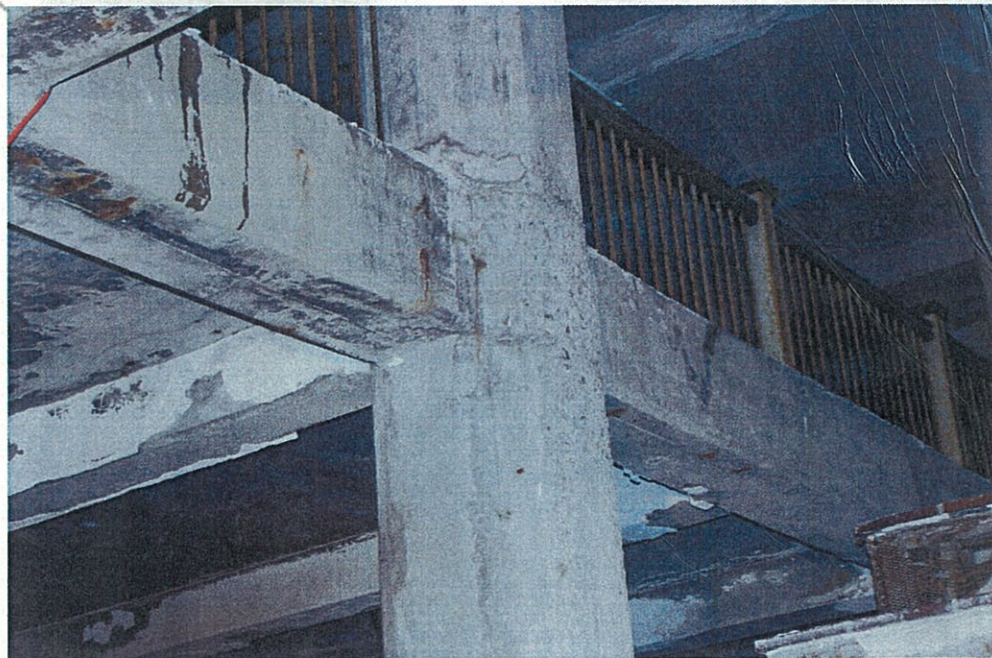
Photo G1.5 – 1st Floor

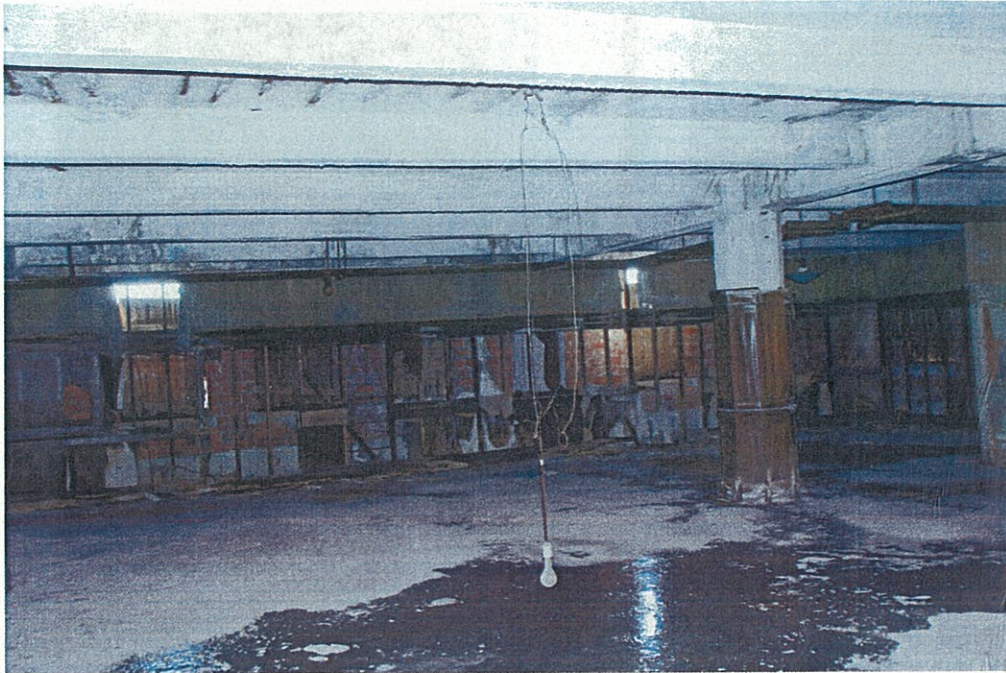
Photo G2.1 – 2nd (Mezzanine) Floor
Exposed abandoned utilities and showroom wood work on walls and columns shown. Floor covered with ice and fallen plaster.

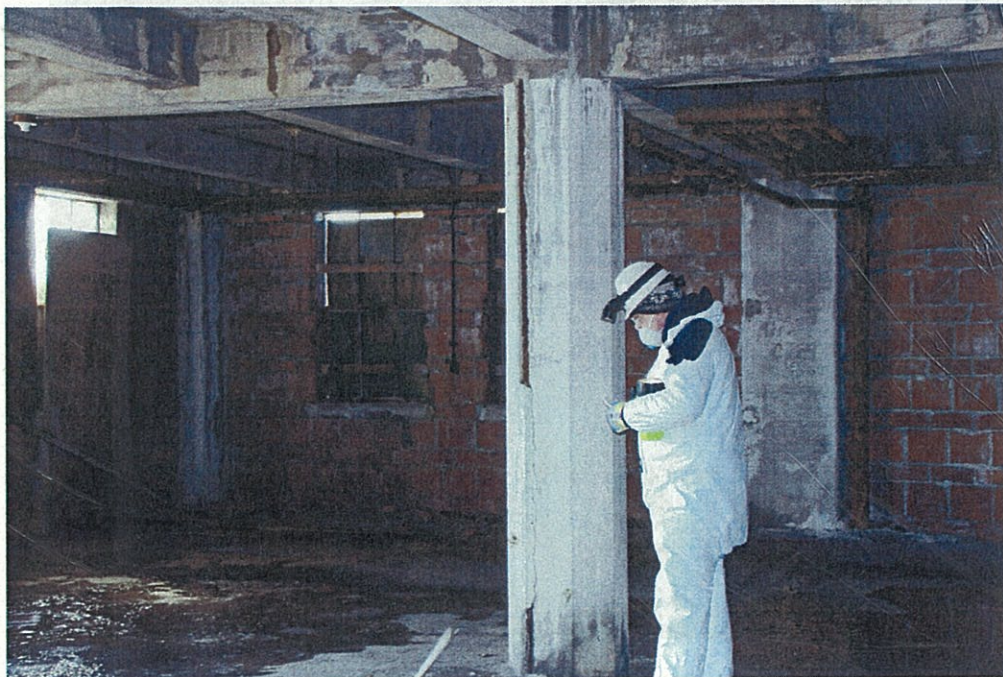
Photo G2.2 – 2nd (Mezzanine) Floor
Delamination and spalling of concrete encasement at column and beams revealing corrosion of steel sections.

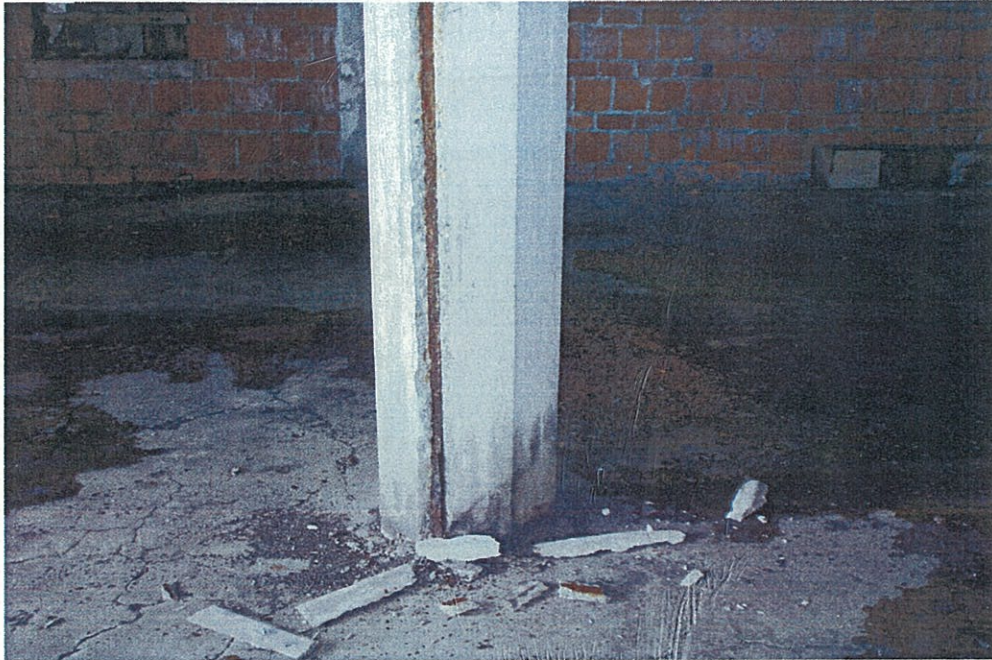
Photo G2.3 – 2nd (Mezzanine) Floor

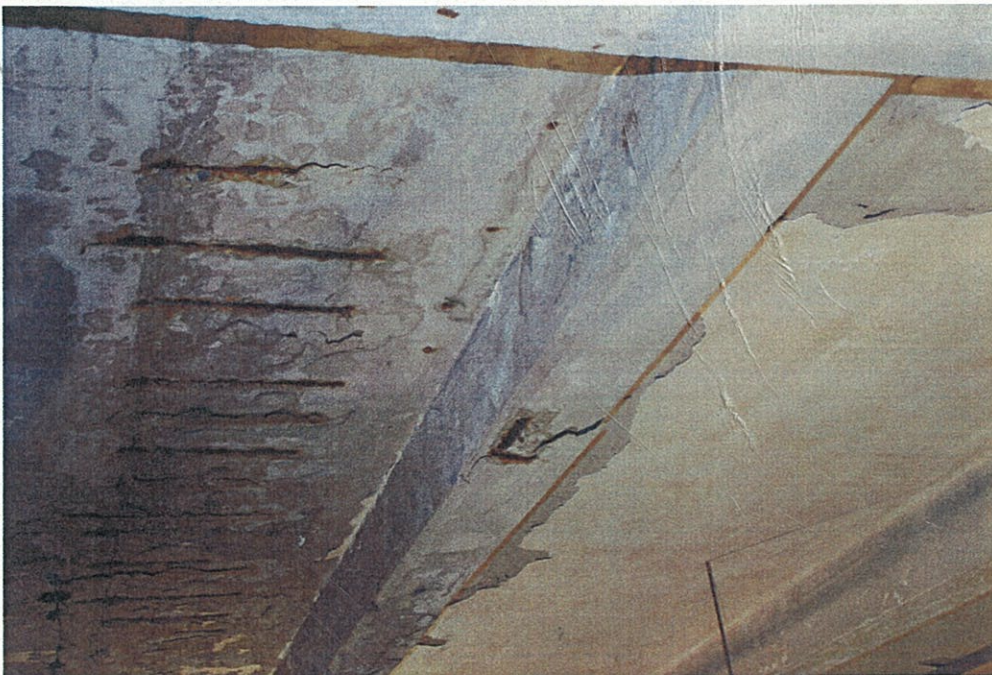
Photo G2.4 – 2nd (Mezzanine) Floor

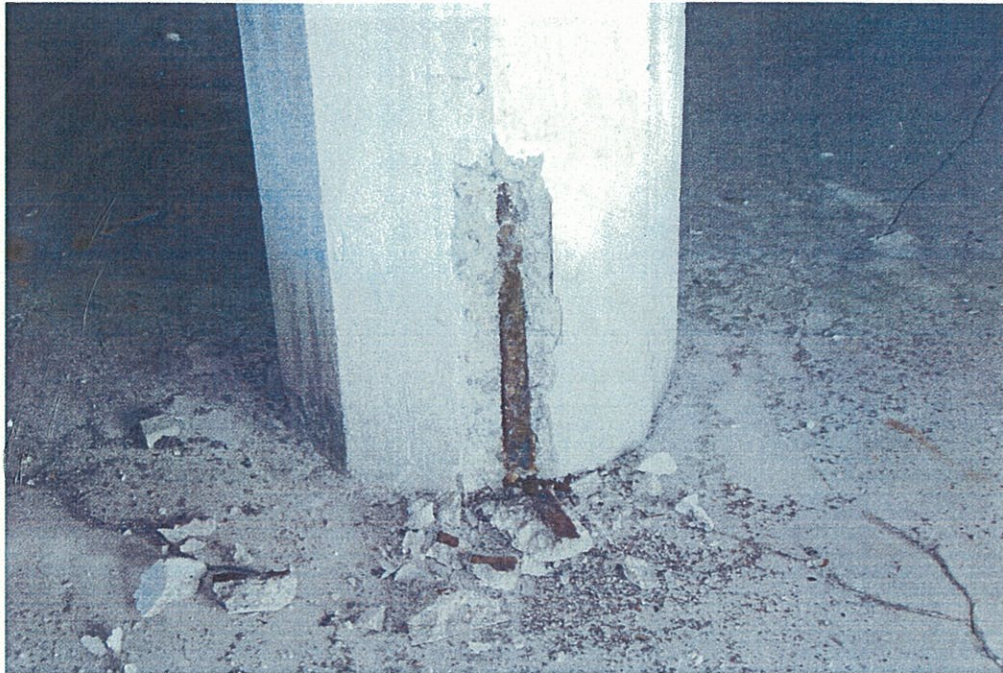
Photo G3.1 – 3rd Floor

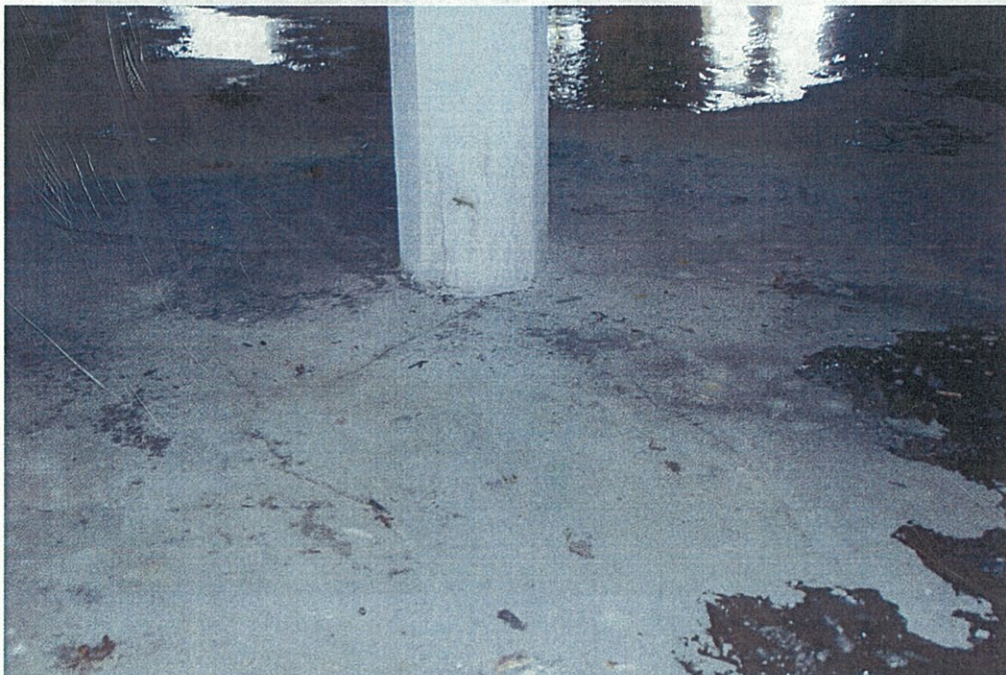
Photo G3.2 – 3rd Floor

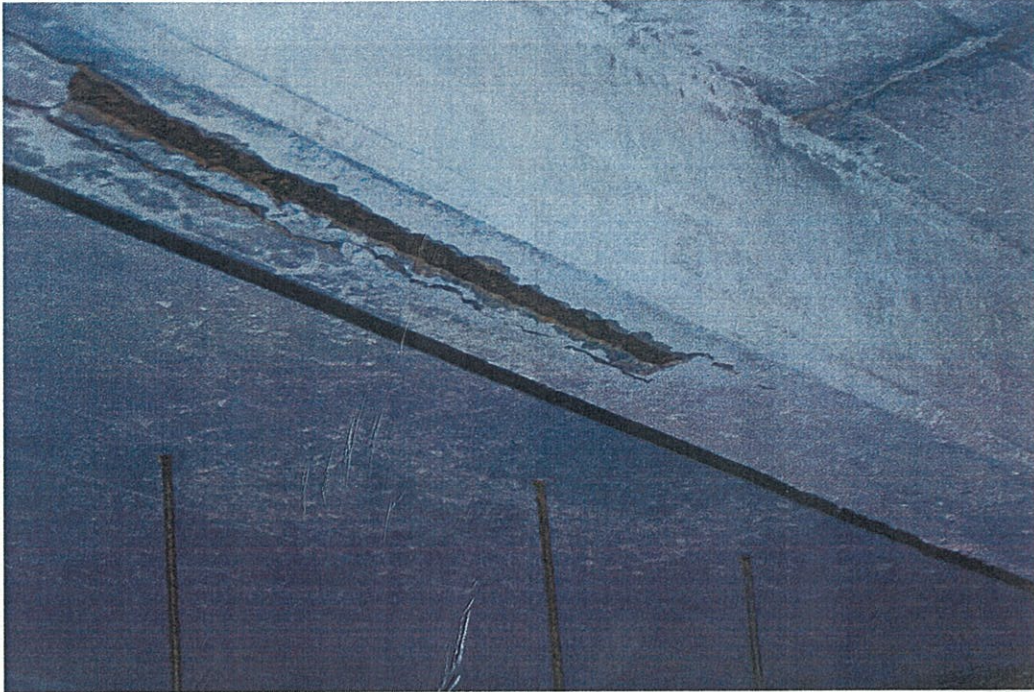
Photo G3.5 – 3rd Floor
Delamination of concrete encasement at underside of beam revealing corrosion of steel section.

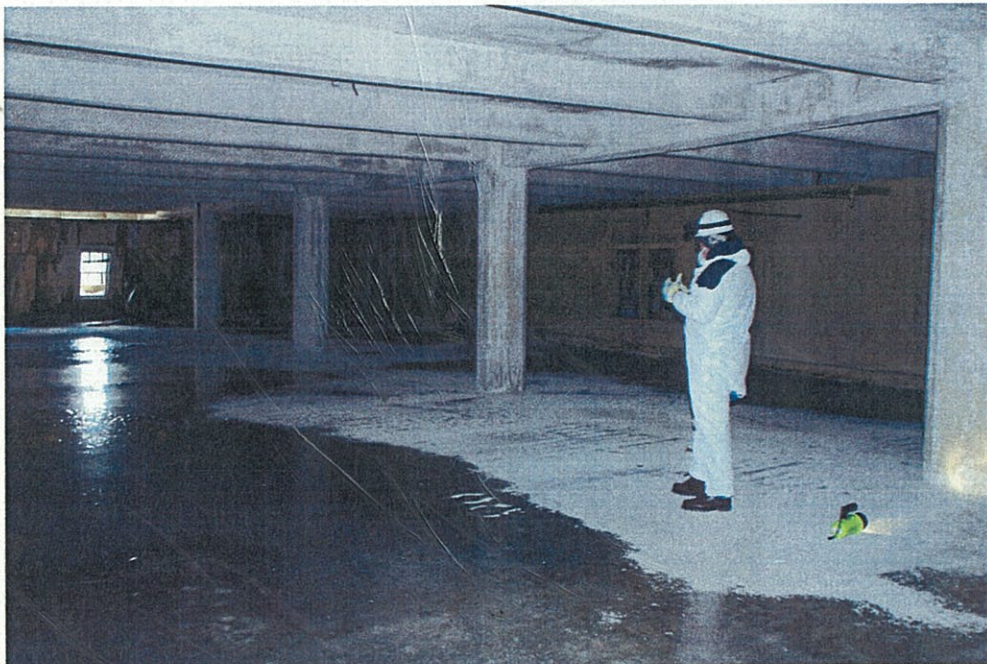
Photo G3.6 – 3rd Floor
Typical beam and column layout shown. Ice present over widespread area of floor.

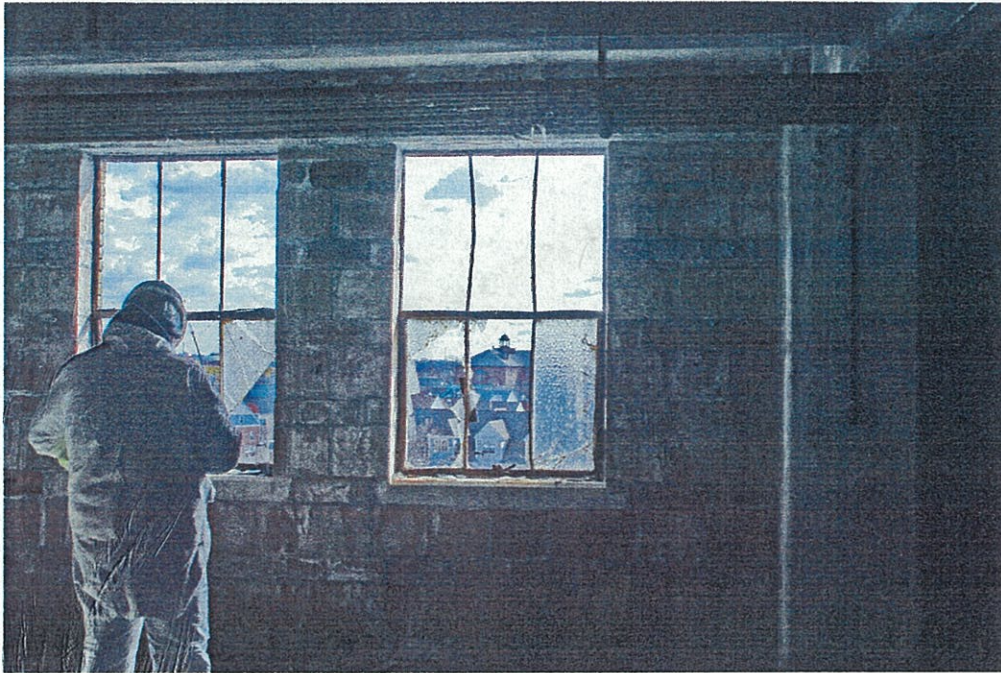
Photo G4.1 – Typical condition for 4th, 5th, & 6th Floors
Broken glass and deteriorated window frames.

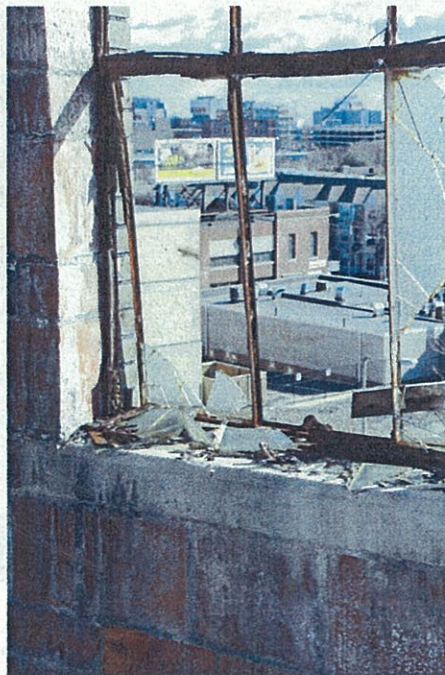
Photo G4.2 – Typical condition for 4th, 5th, & 6th Floors
Broken glass and deteriorated window frames.

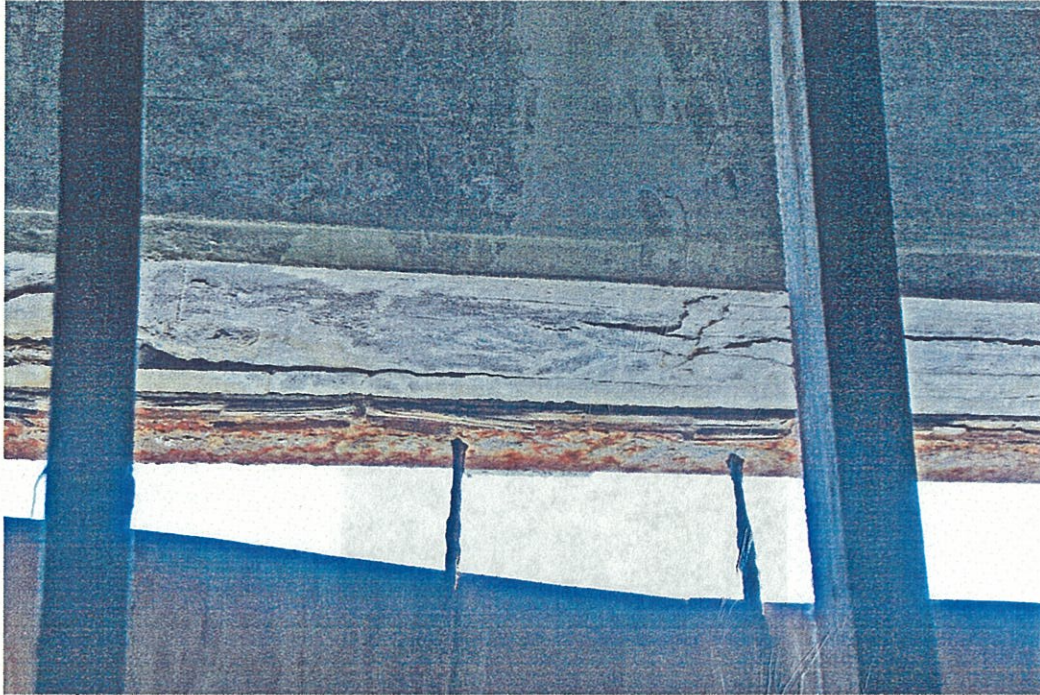
Photo G4.3 – 4th Floor
Deteriorated concrete around window lintels.

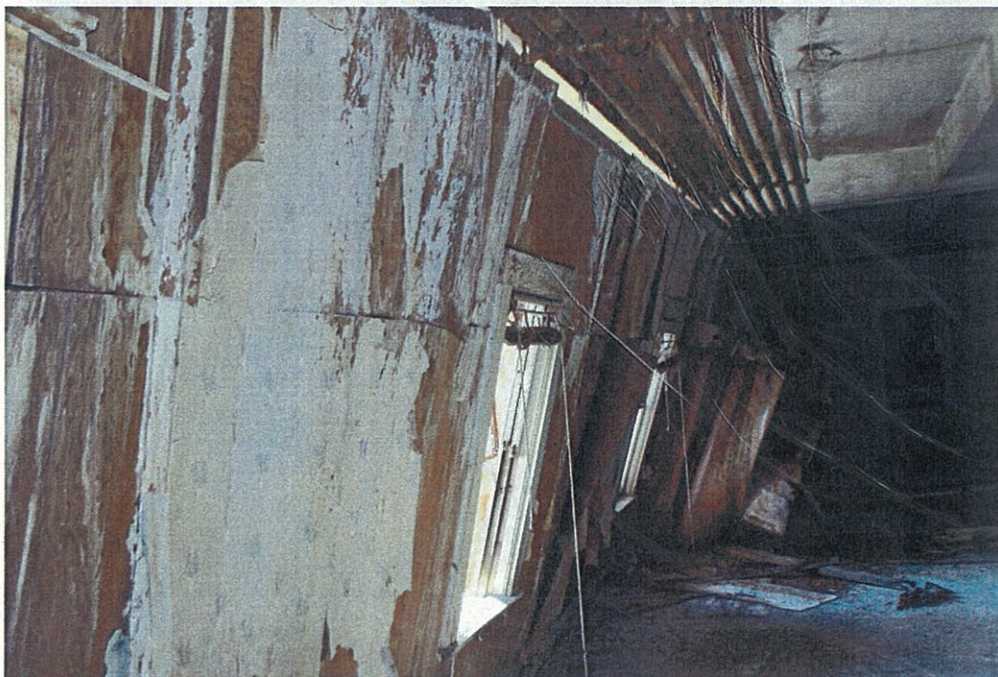
Photo G4.4 – 4th Floor
Unstable wall partitions ready to fall.

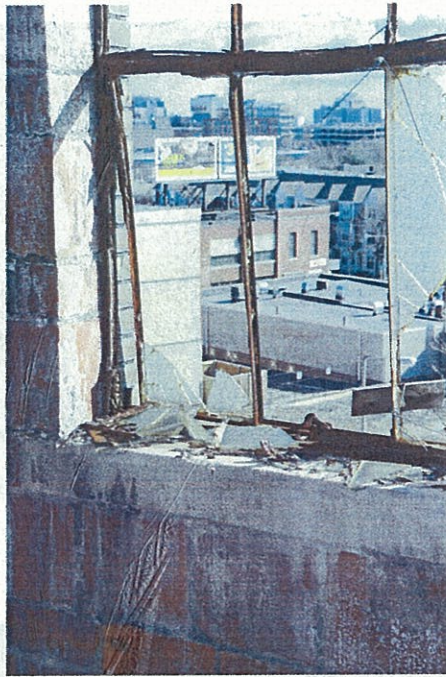
Photo G5.1 - Typical condition for 4th, 5th, & 6th Floors
Broken glass and deteriorated window frames, some located over Warren and Dudley Streets.

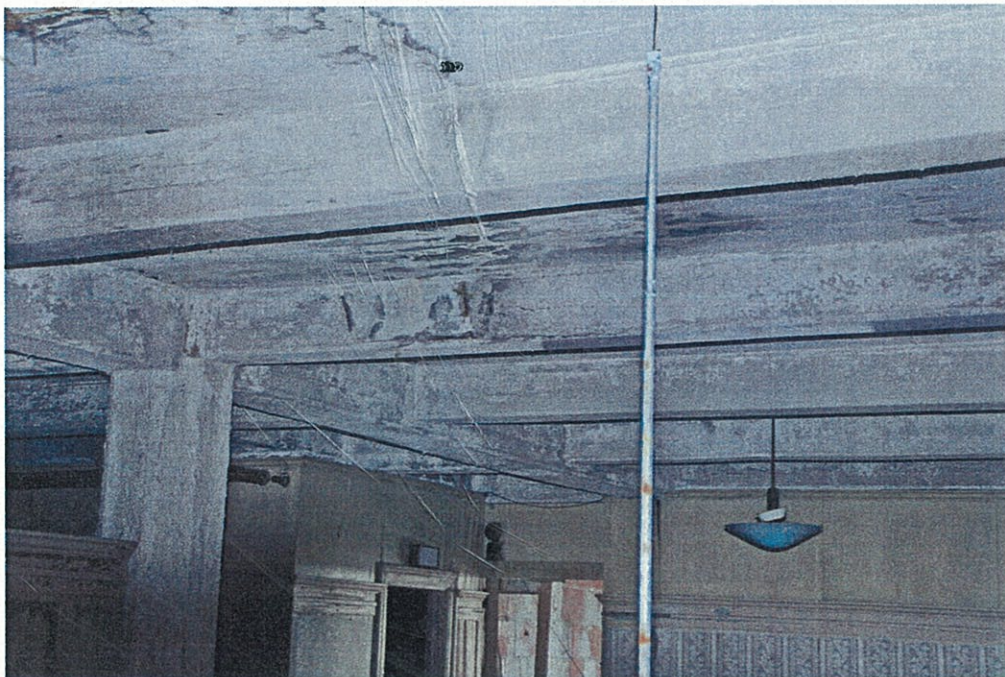
Photo G5.2 - 5th Floor
Spalling at underside of 6th floor slab and concrete-encased steel beams. Water stains follow apparent conduit to fixtures and junction boxes.

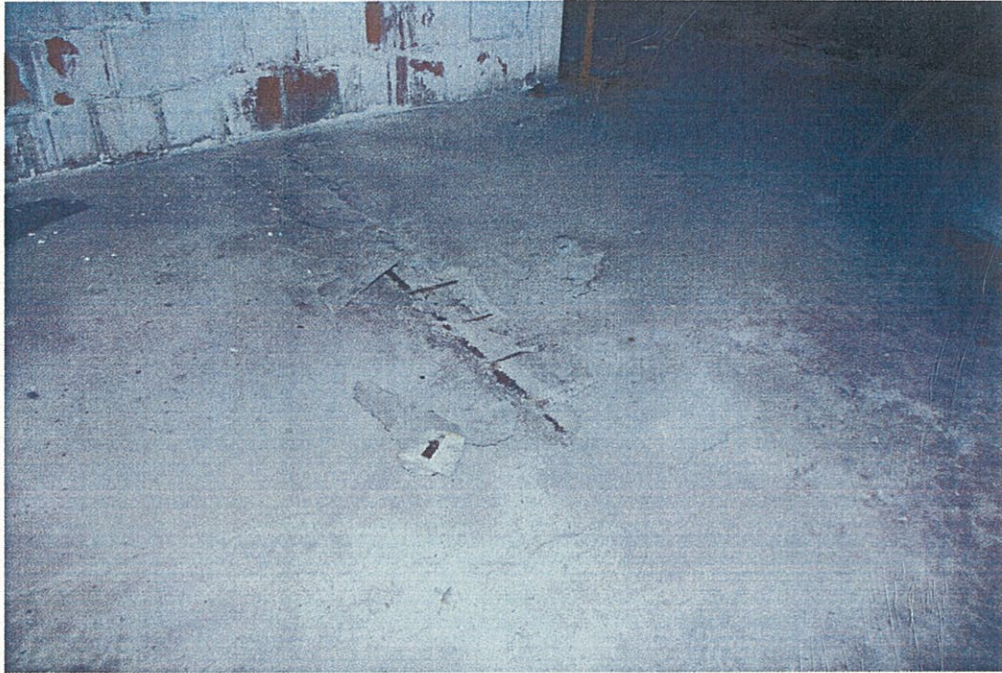
Photo G6.1 – 6th Floor
Exposed, corroded reinforcement in concrete floor.

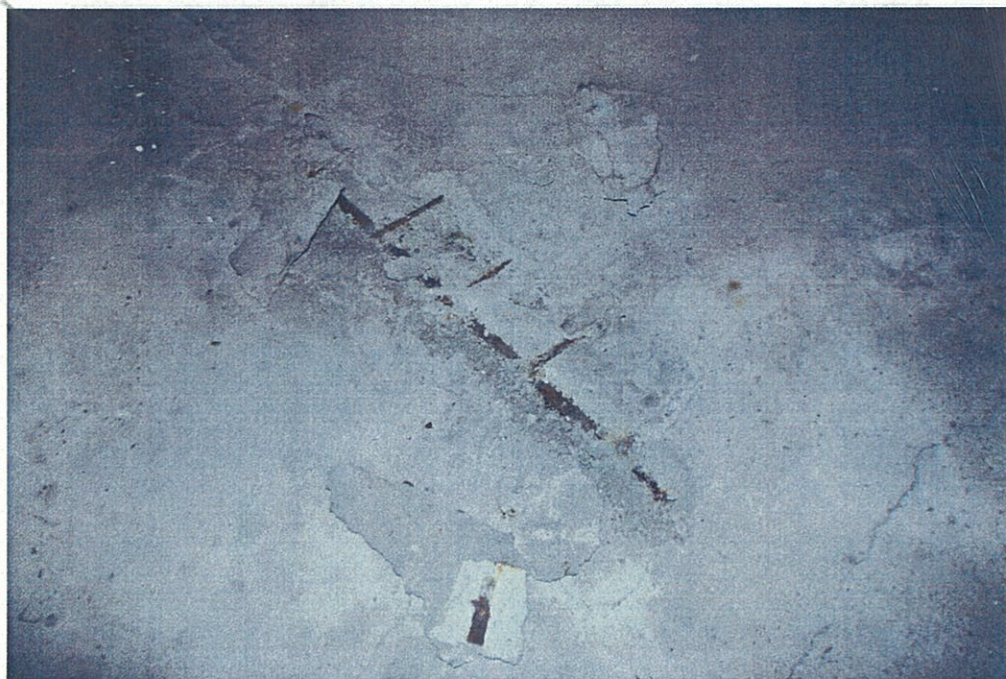
Photo G6.2 – 6th Floor
Exposed corroded reinforcement in concrete floor.

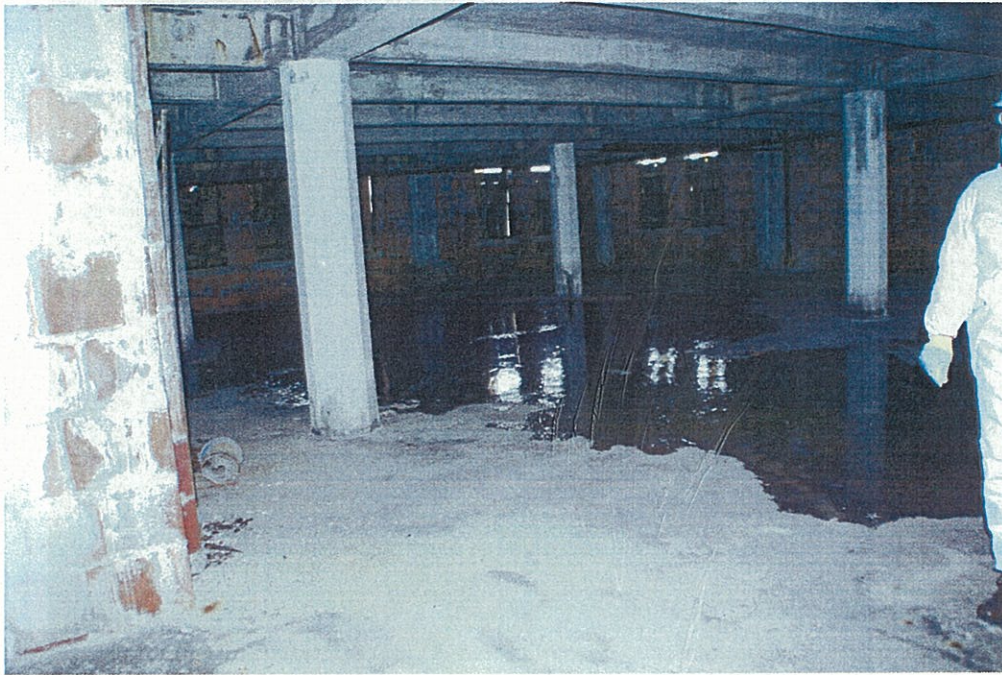
Photo G6.3 – 6th Floor

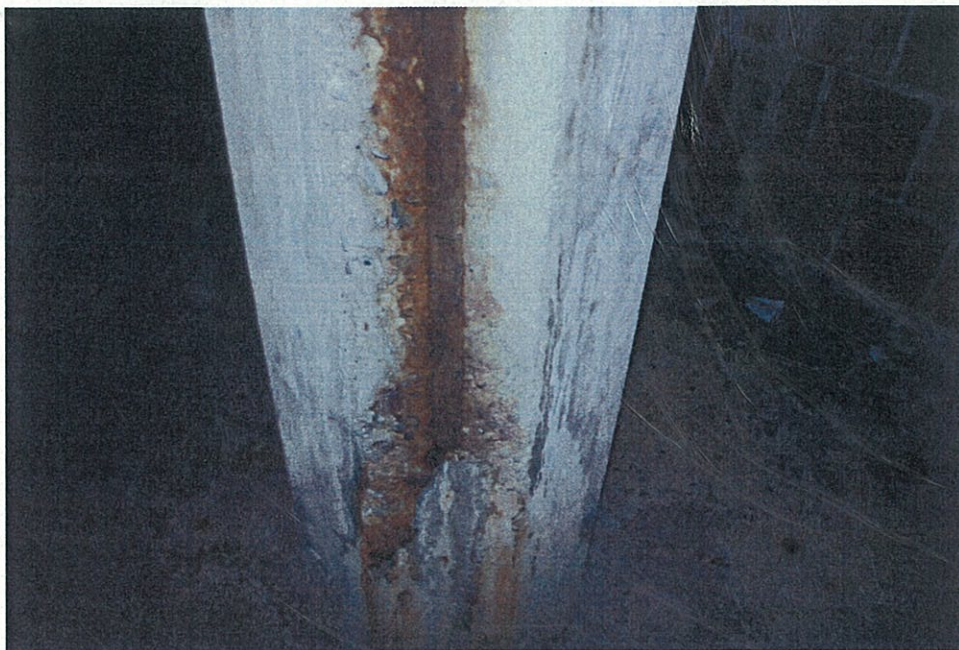
Photo G6.4 – 6th Floor

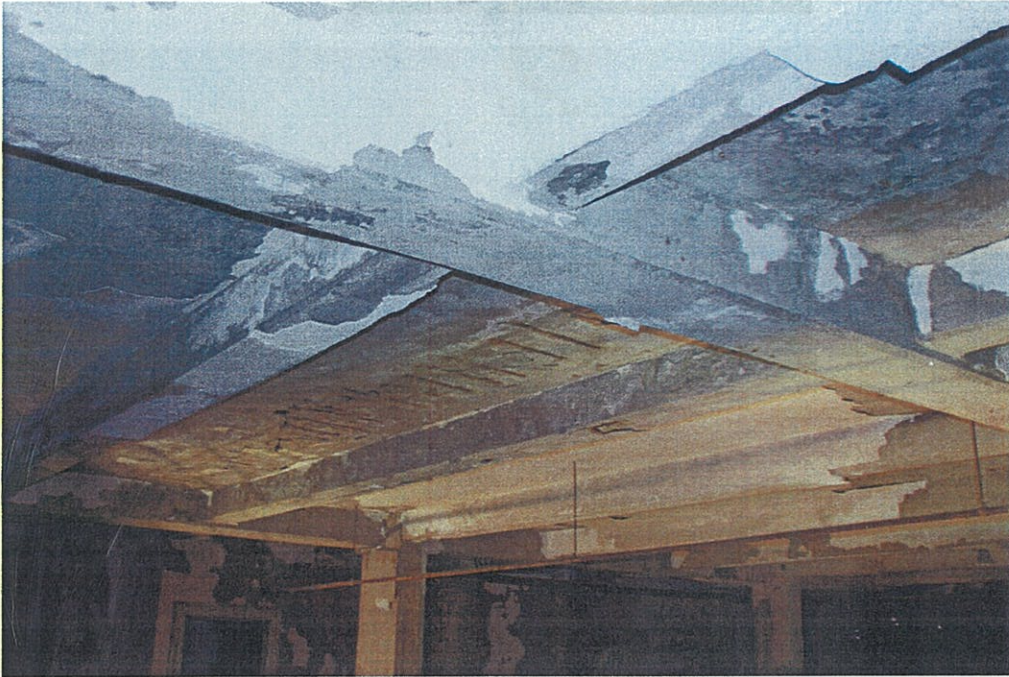
Photo G7.1 – 7th Floor
