PROJECT NOTIFICATION FORM

Dudley Office Building Project

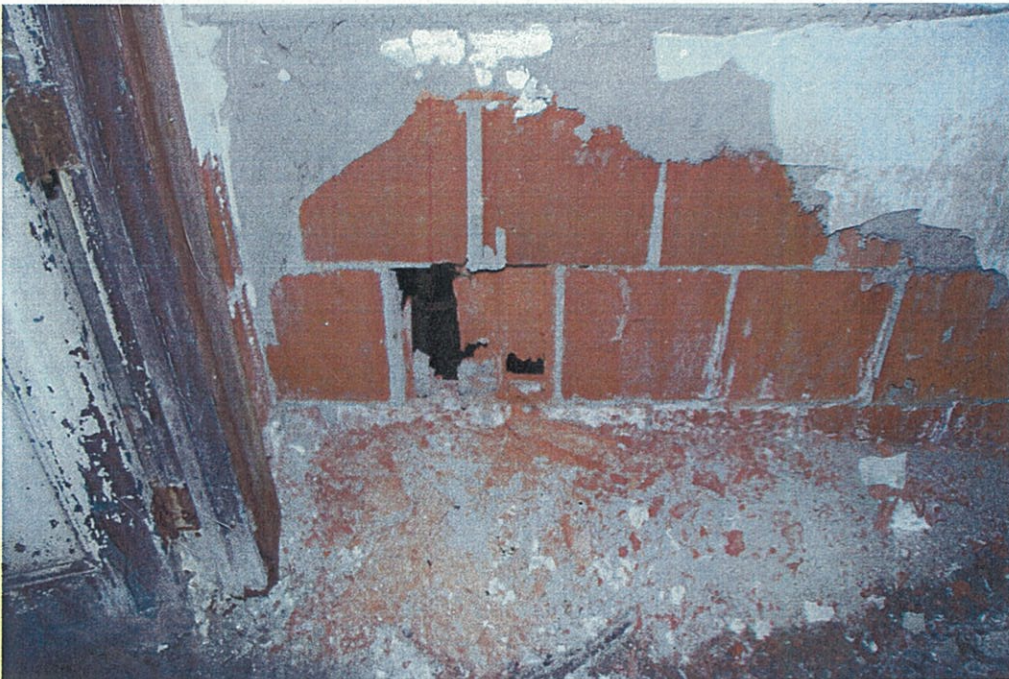
Photo G7.2 – 7th Floor

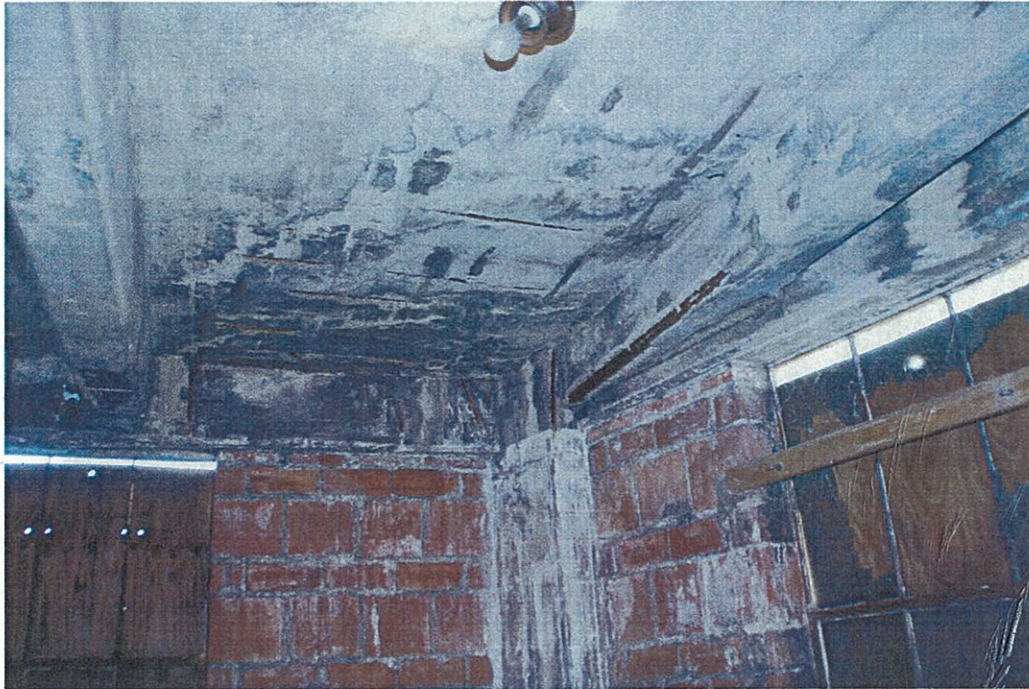
Photo G8.1 – 8th Floor

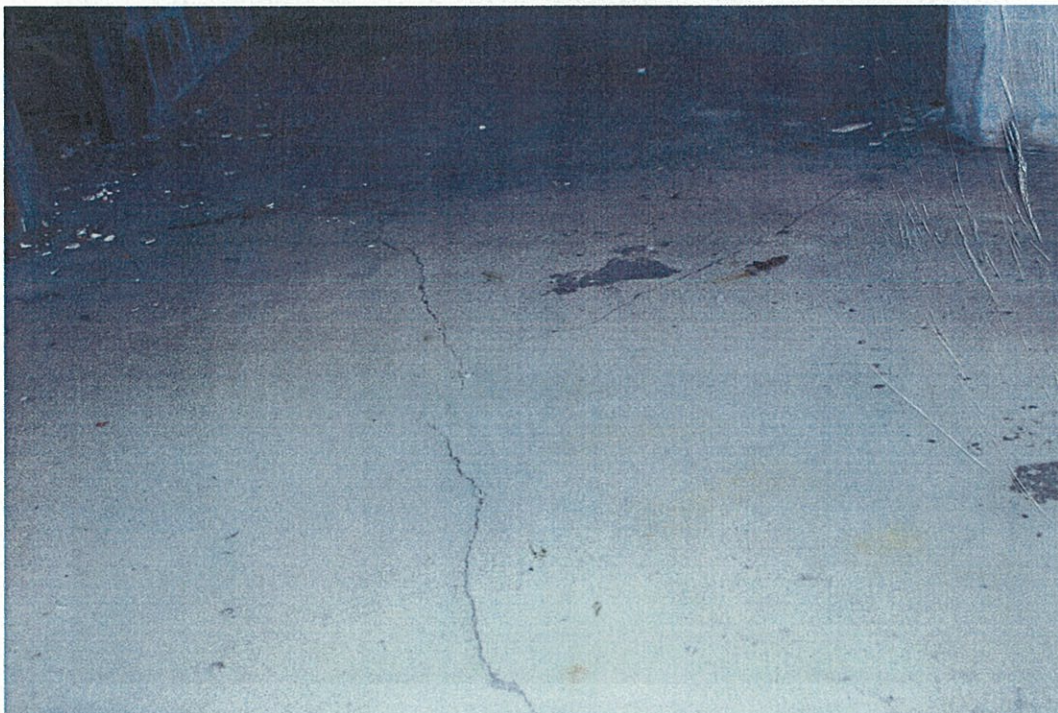
Photo G8.2 – 8th Floor

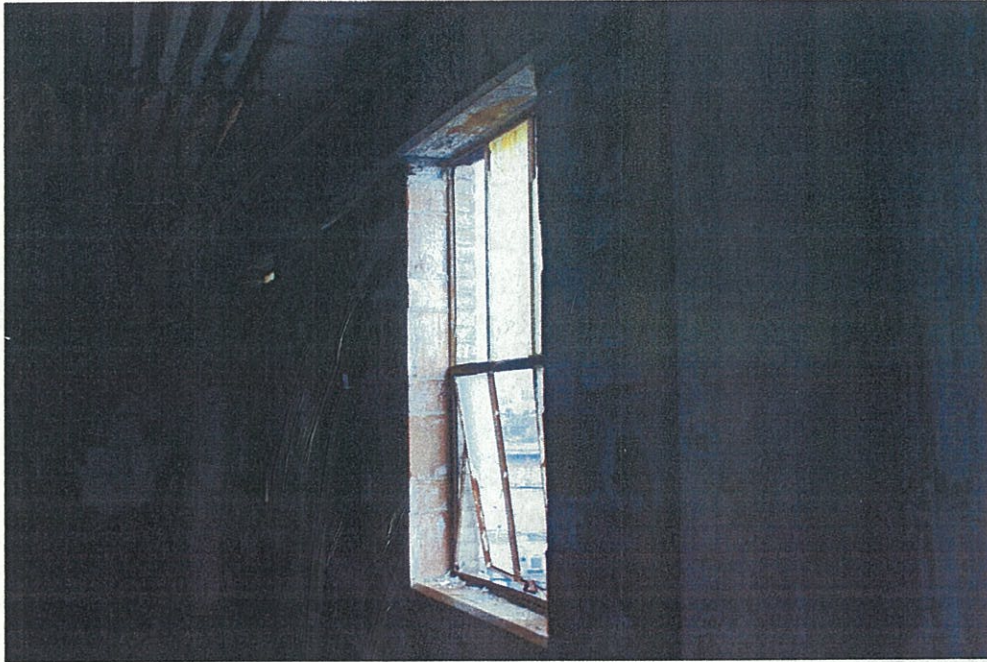
Photo G8.3 – 8th Floor
Broken glass and deteriorated window frame.

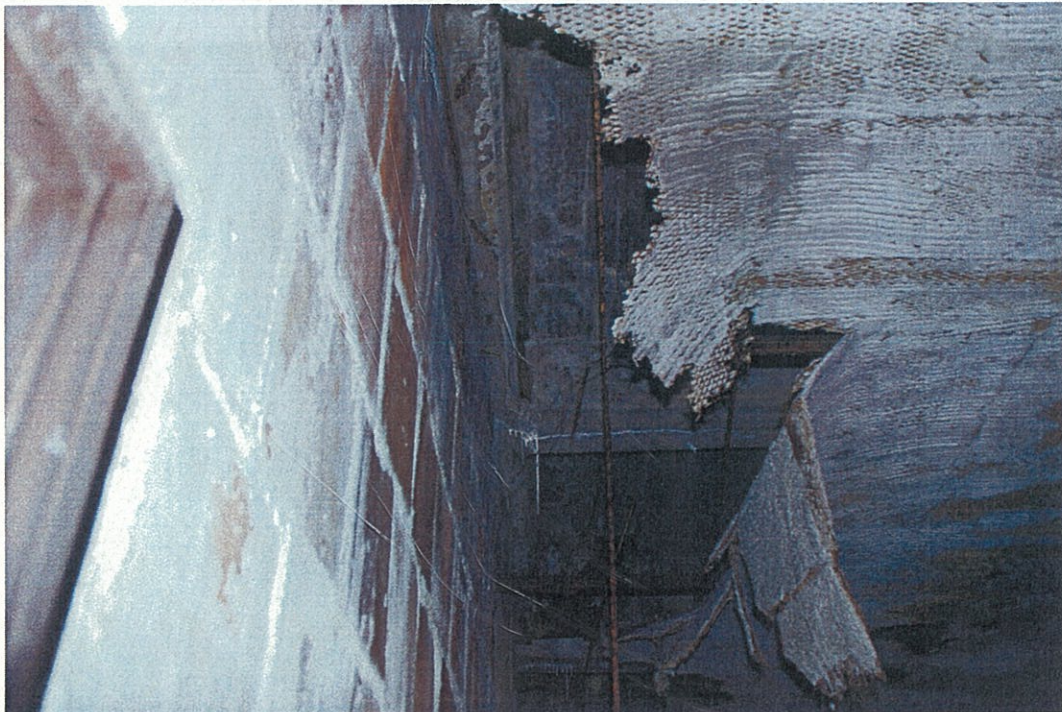
Photo G8.4 – 8th Floor
Ceiling deterioration at exterior walls.

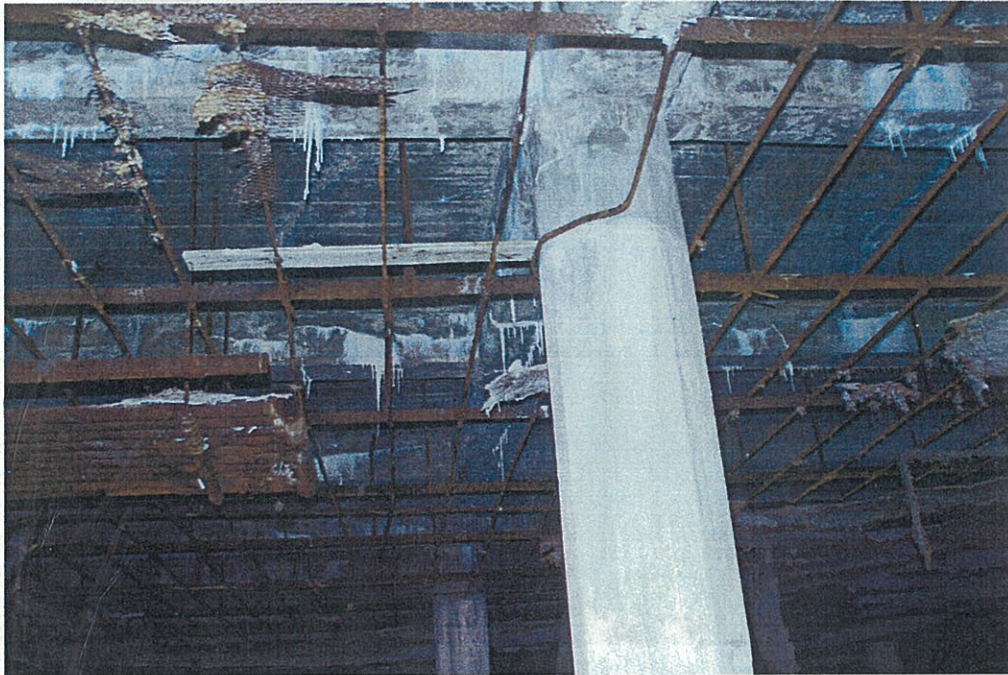
Photo G8.5 – 8th Floor
Ceiling framing suspended from structure above.

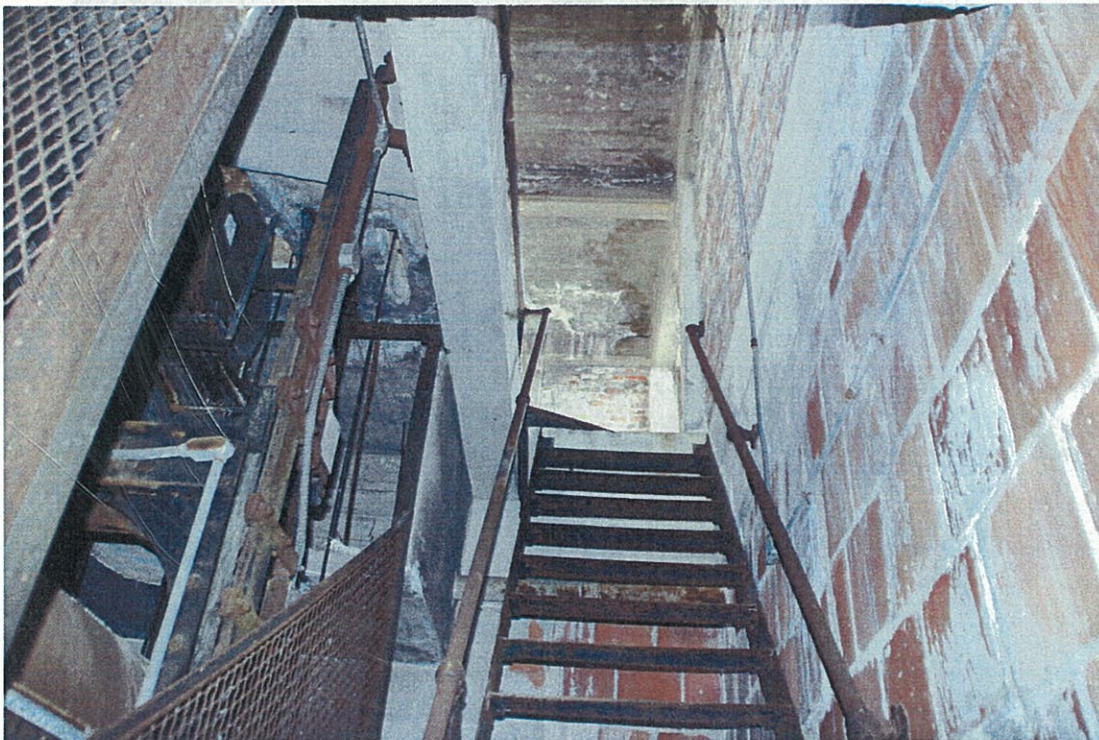
Photo G8.6 – 8th Floor
Highly deteriorated connections along stair leading to building roof.

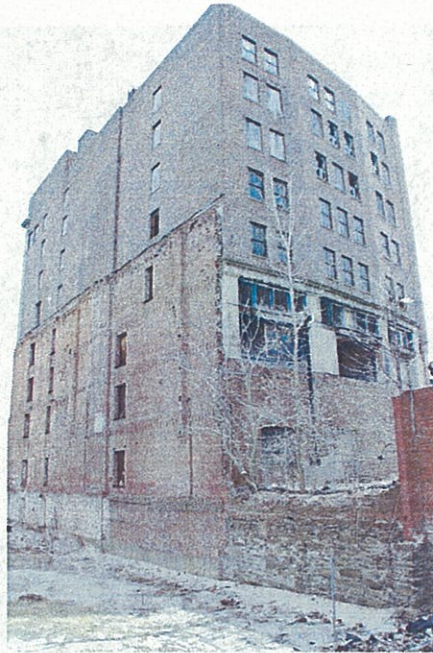
Photo GEX.1 - Elevation

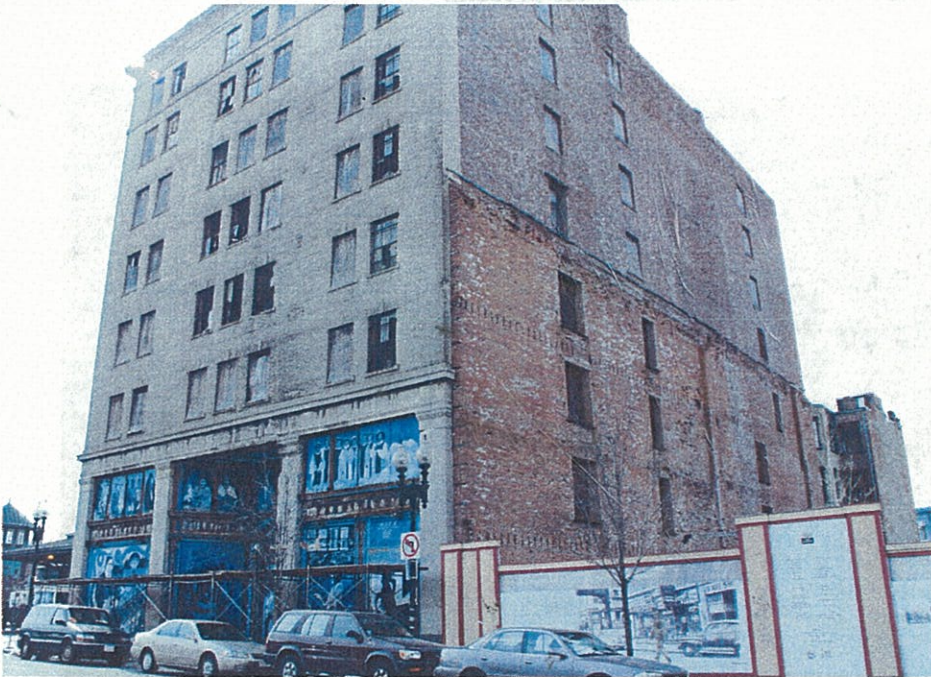
Photo GEX.2 - Elevation

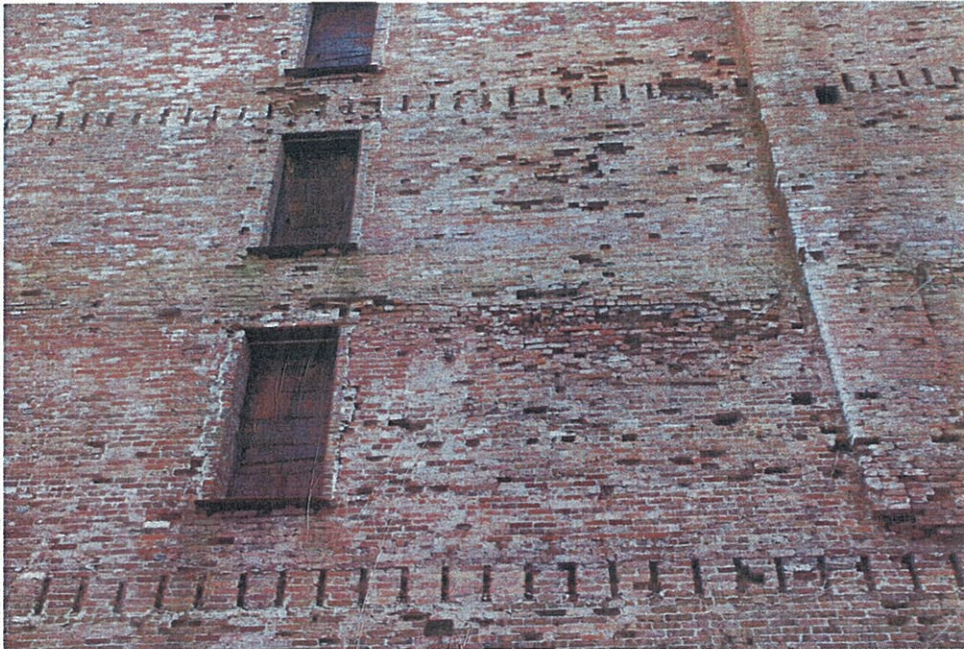
Photo GEX.3 – Exterior Wall

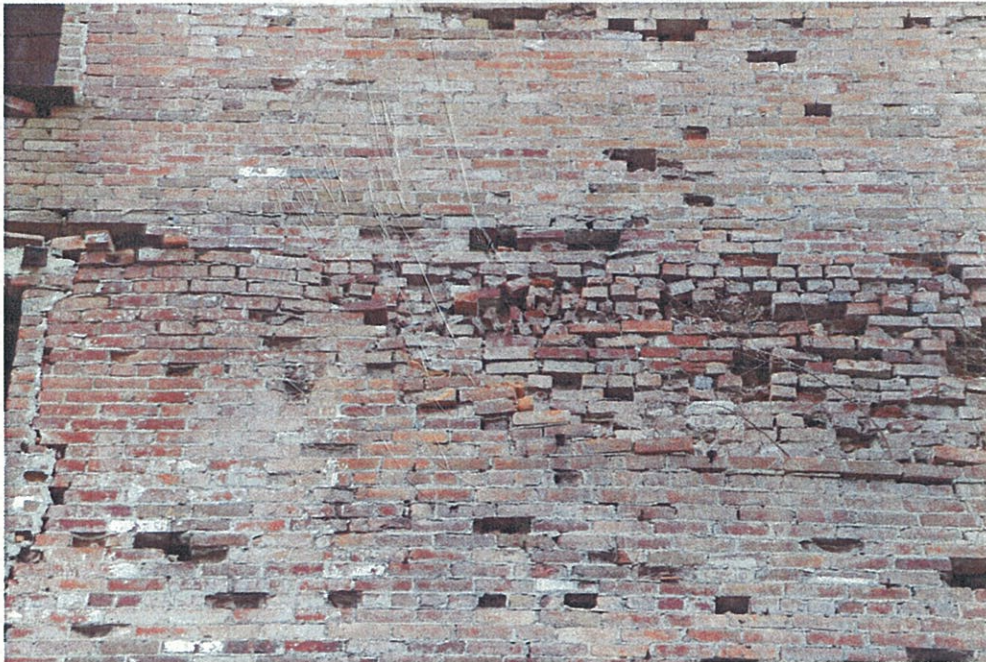
Photo GEX.4 – Exterior Wall

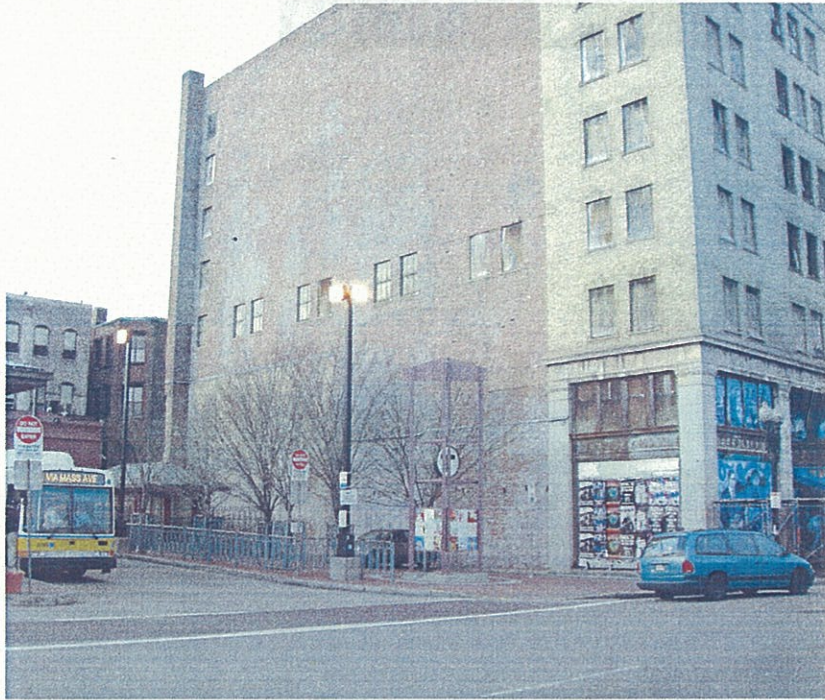
Photo GEX.5 - Elevation
Picture taken from Warren Street opposite MBTA Dudley Square Bus Station.

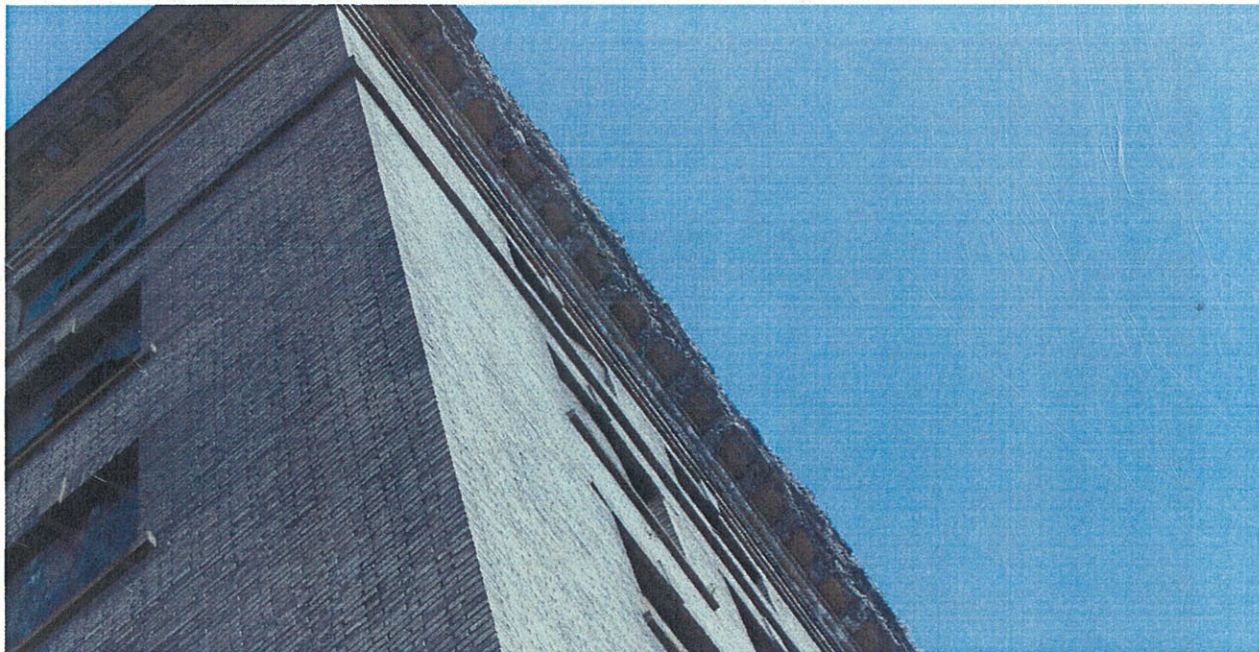
Photo GEX.6 – Elevation
Significant deterioration of cornice over Warren Street.

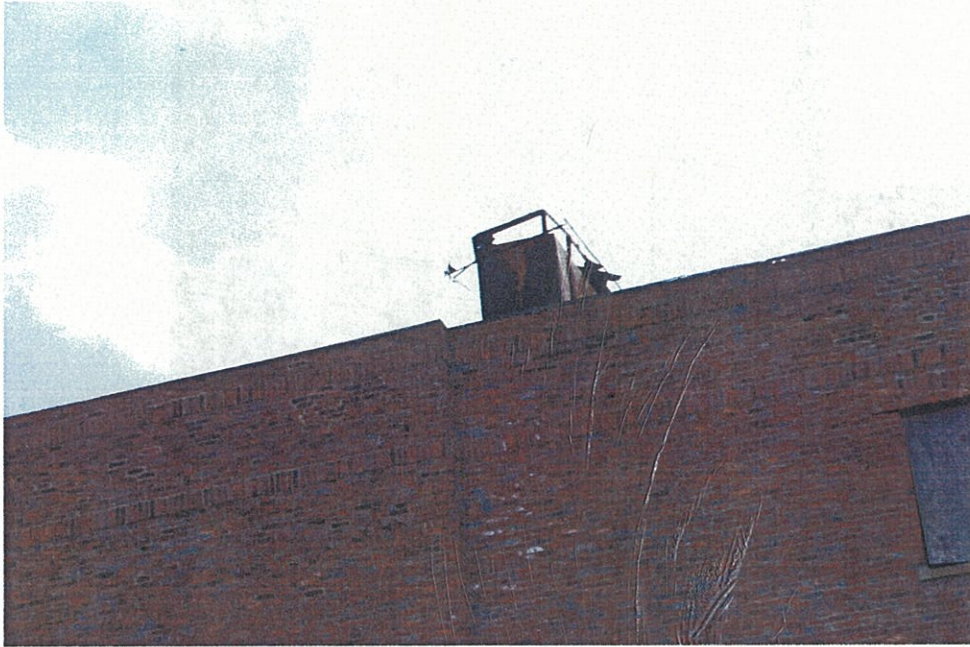
Photo GEX.7 – Partial Elevation
Some rooftop equipment seen, not inspected.

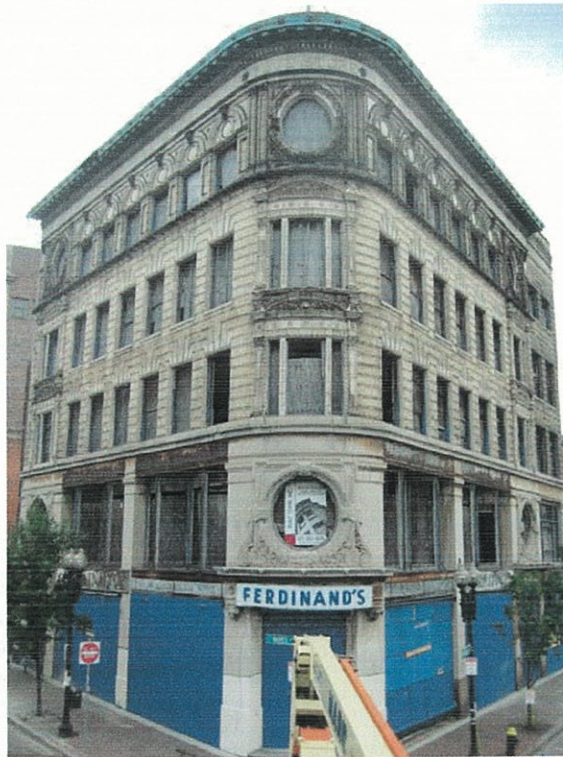
EXISTING CONDITIONS SUMMARY

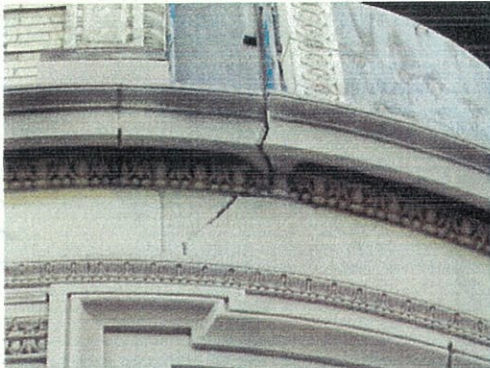
Photo 2: Wide limestone crack at building corner.

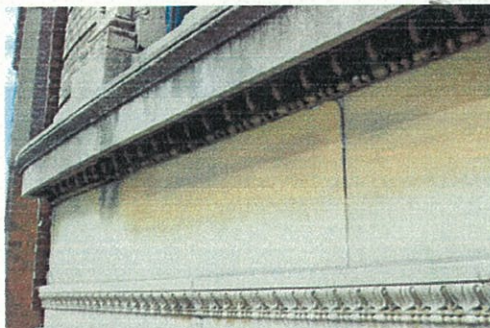
Photo 3: Rust stains on limestone.

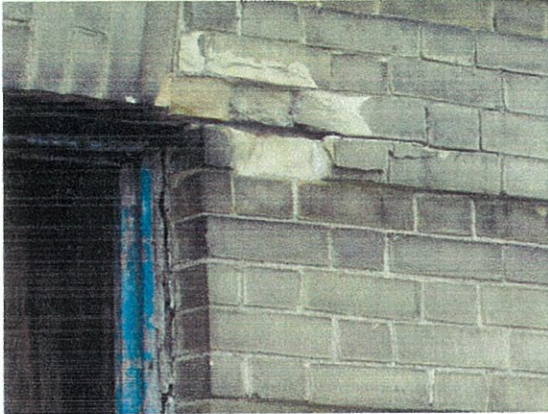
Photo 4: Iron lintel corrosion causing brick spall.

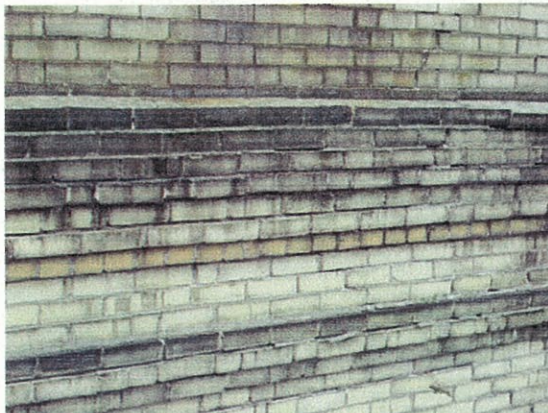
Photo 5: Rust stains, step cracks and open joints at brick.

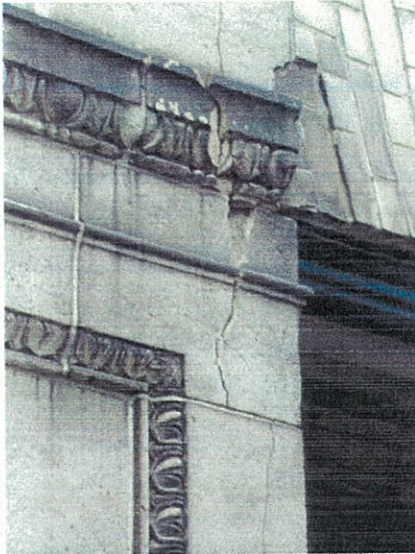
Photo 6: Cracked, spalled and soiled terra cotta.

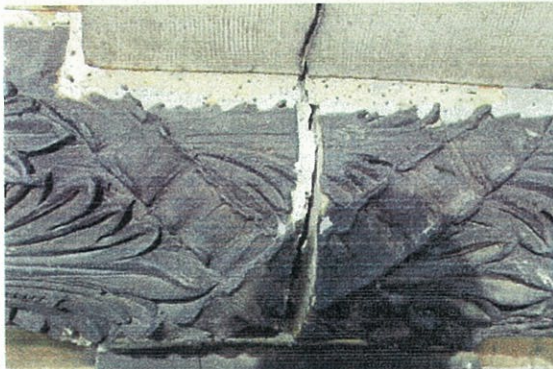
Photo 7: Extremely soiled cream colored terra cotta. Note cracked joint.

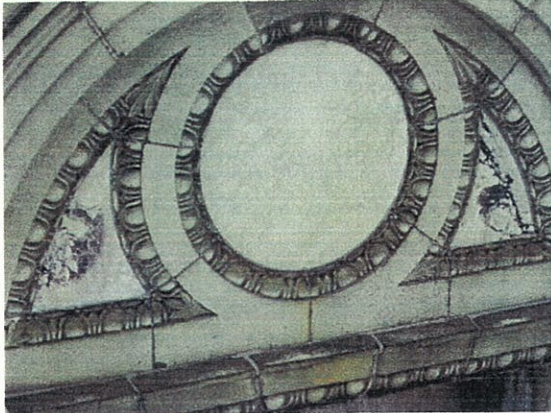
Photo 8: Marble medallions.

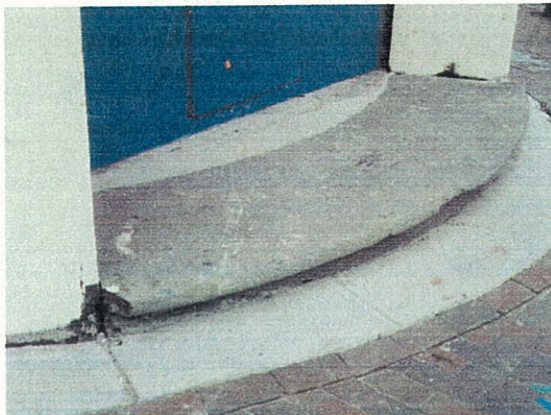
Photo 1: Painted, spalled granite column bases at entry.

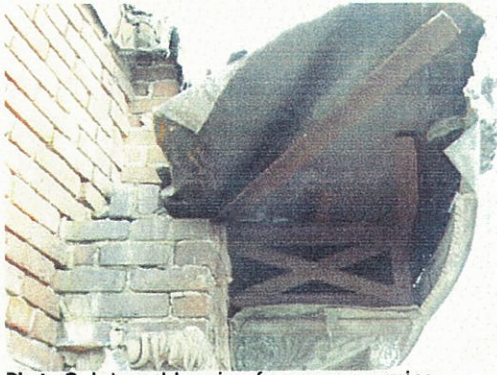
Photo 9: Internal bracing for copper cornice.

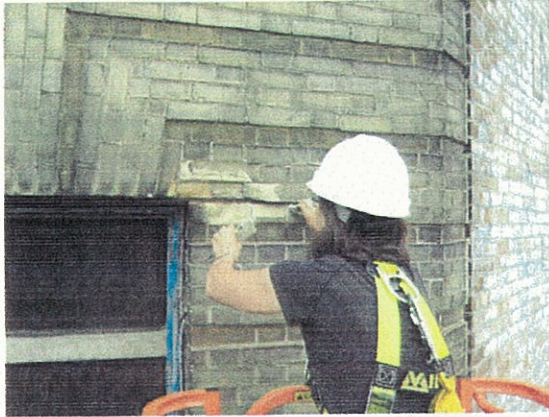
Photo 11: Removal of loose brick at point of iron lintel corrosion.

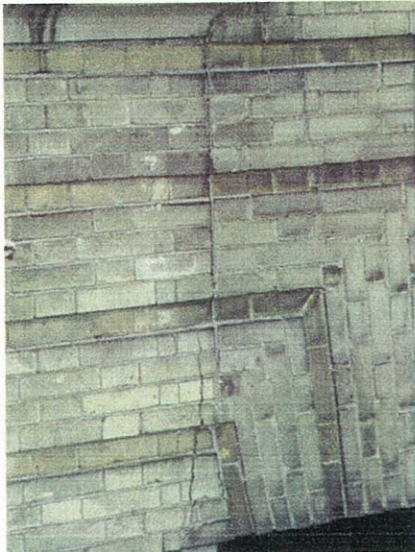
Photo 12: Joint between original building and addition at north elevation.

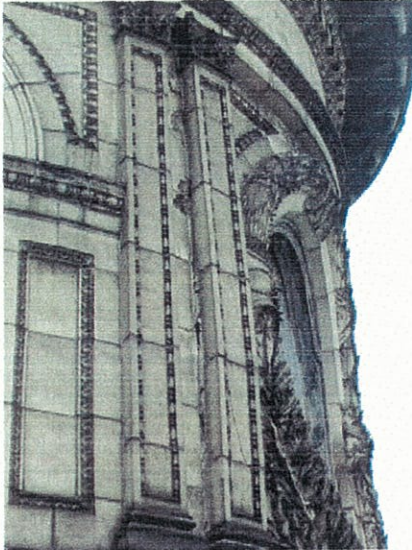
Photo 13: Note bowing of terra cotta units in right pilaster.

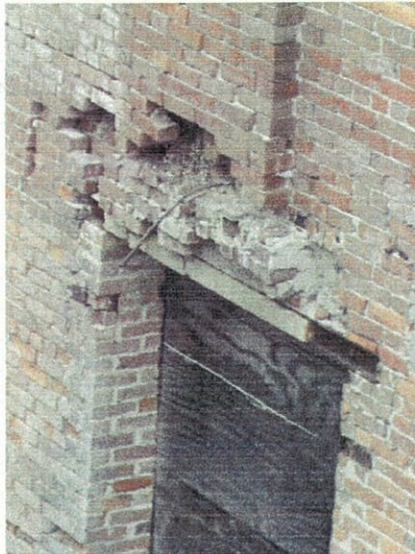
Photo 14: Note loose mortar and brick, brick loss.

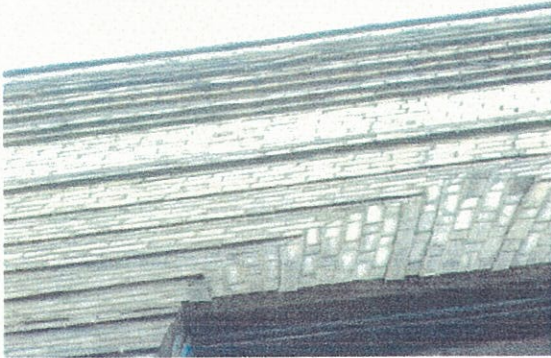
Photo 15: Note bulging courses of brick.
