Presented to:

**Boston Redevelopment
Authority**

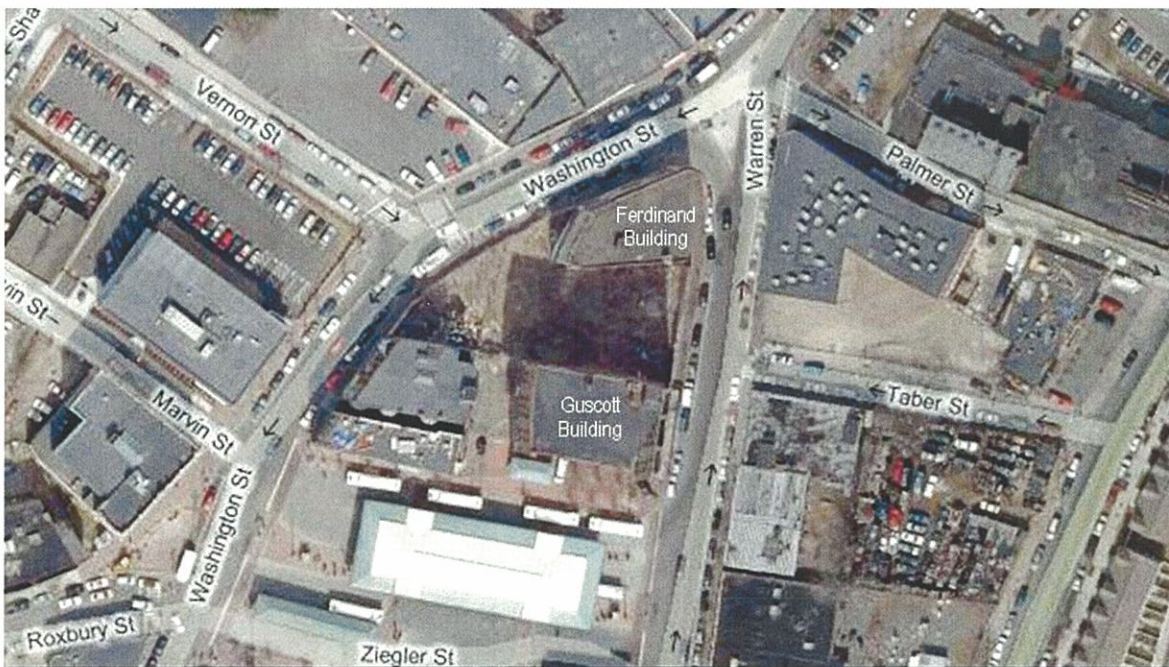
The inspections involved visual assessment of the building's structural elements and of the exterior of the façade, photographic recordings for later examination, and hammer tapping of concrete for indications of soundness. The purpose of the inspections was to 1) evaluate the integrity of the Ferdinand Building's structural system in preparation for restoration, and 2) document the condition of the façade in preparation for restoration, as well as identify any areas of the façade that could pose a threat to public safety.

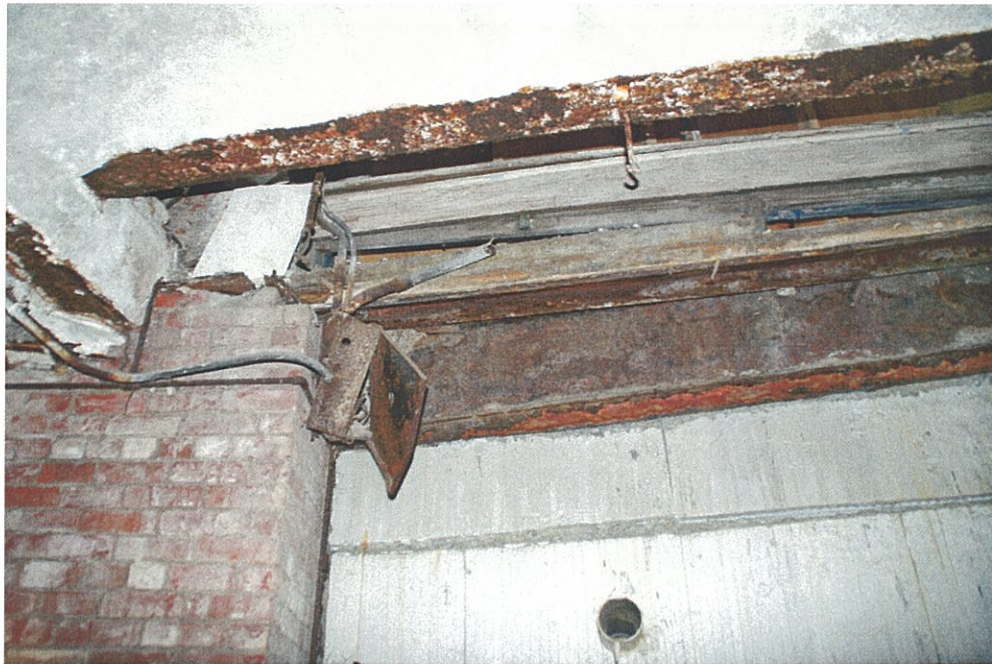
Photo F0.3 - Basement
Exposed, deteriorated steel framing at the opening in the 1st Floor concrete slab.

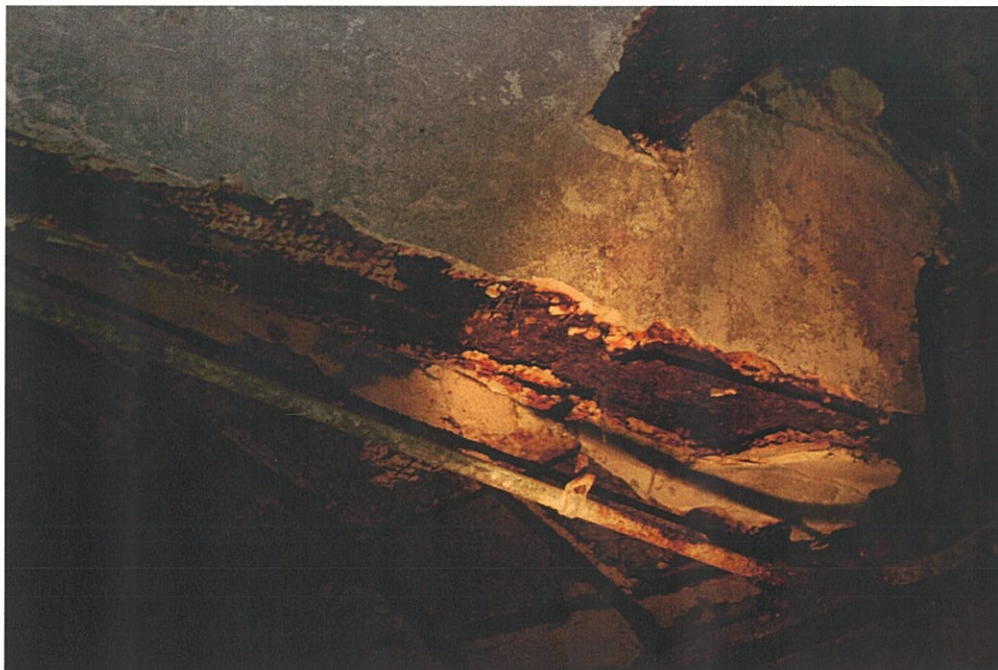
Photo F0.4 - Basement
Delamination and spalling of concrete at underside of floor beam revealing corrosion of steel section.

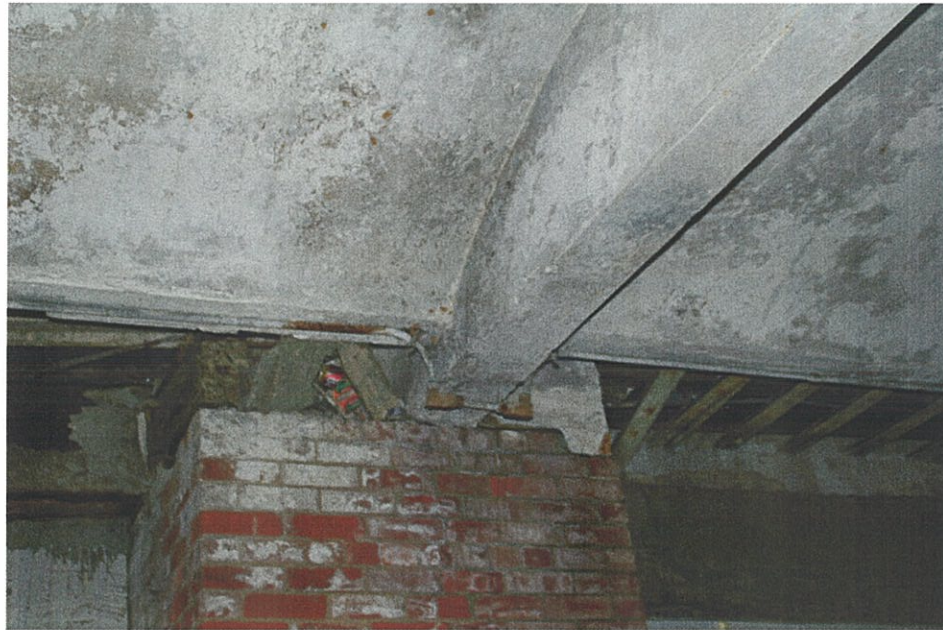
Photo F0.5 - Basement
Connection of 1st Floor framing to brick pilaster.

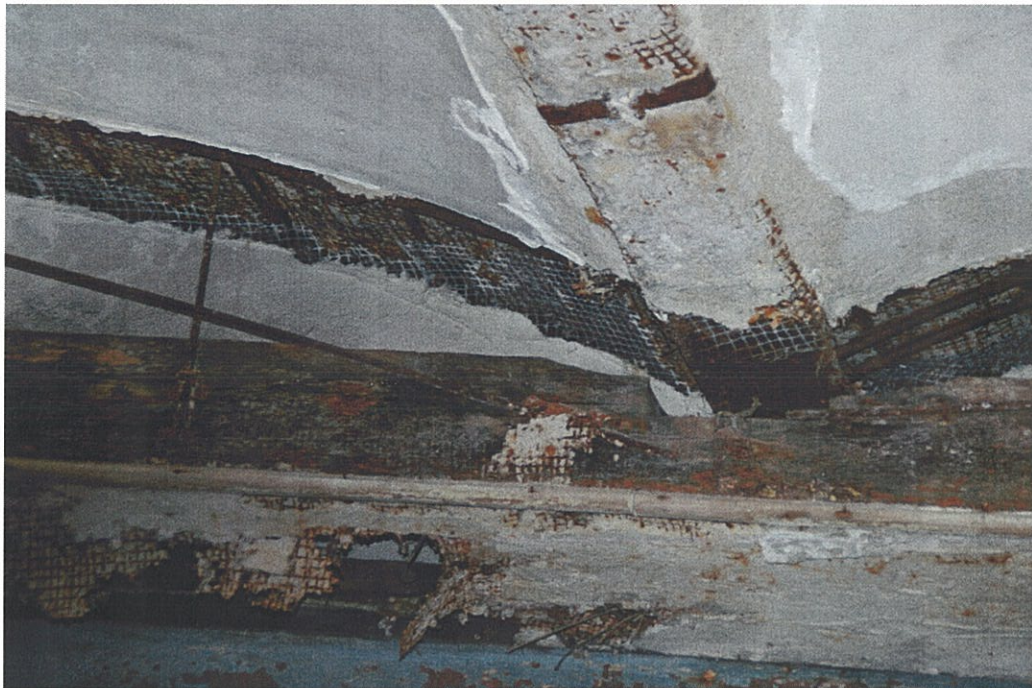
Photo F1.9 – 1st Floor
General deterioration at interface of floor structure underside and exterior wall.

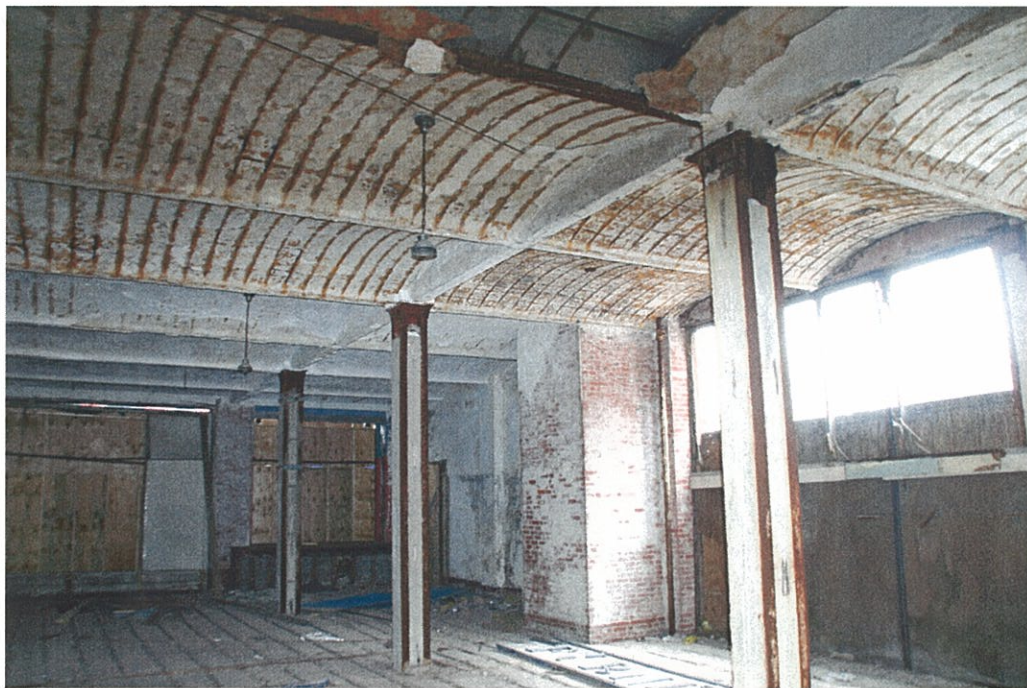
Photo F1.10 – 1st Floor
General interior elevation and typical structural framing system.

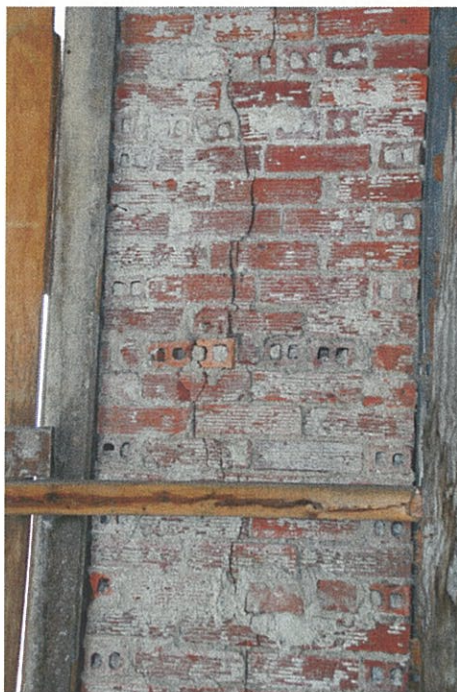
Photo F3.1 – 3rd Floor
Cracking in brick pilaster located between Warren Street windows.

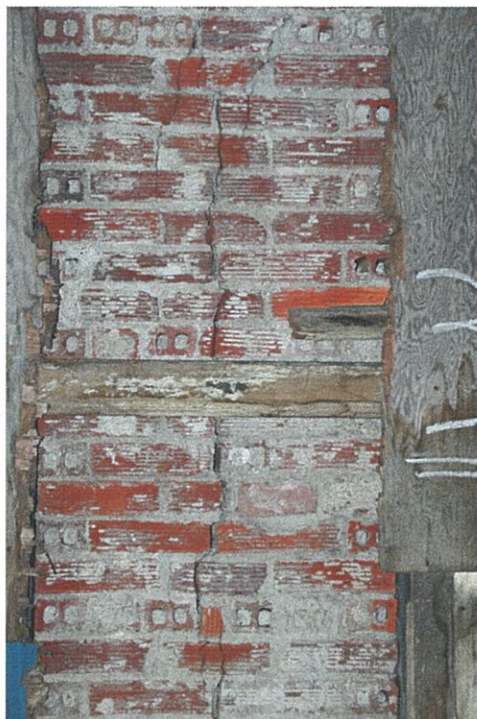
Photo F3.2 – 3rd Floor
Cracking in brick pilaster located between Warren Street windows.

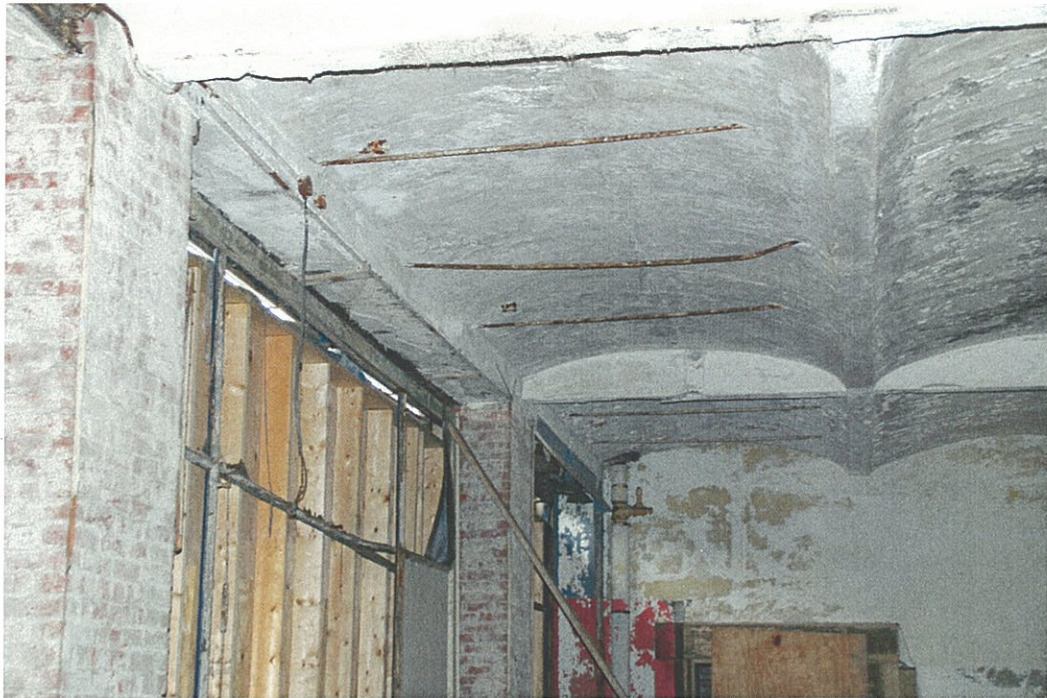
Photo F3.3 – 3rd Floor
Deterioration in arched plaster ceiling.

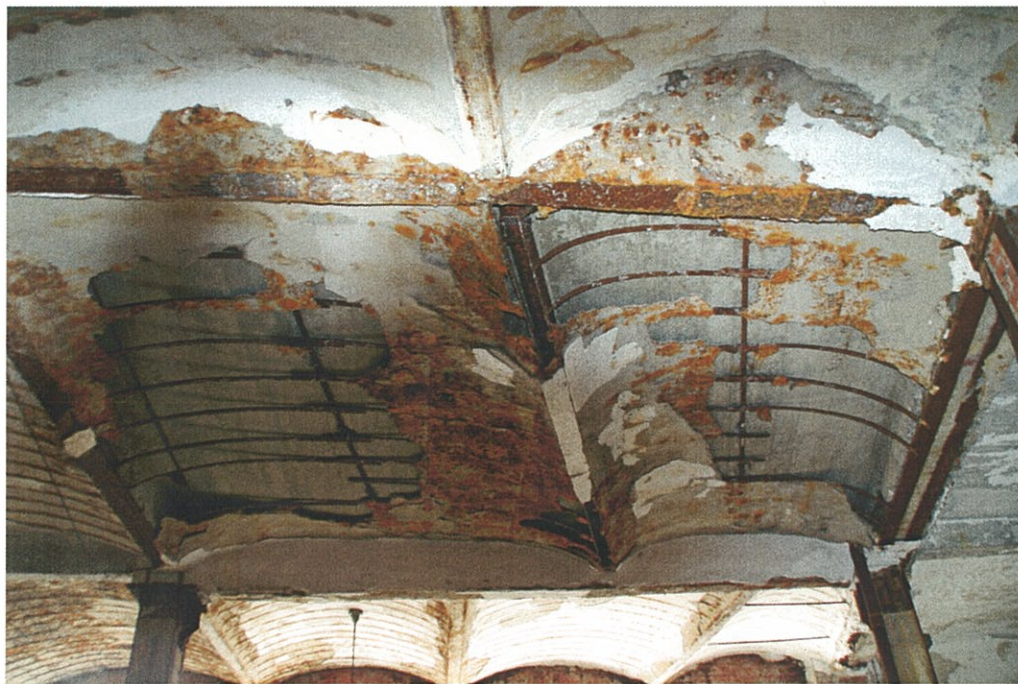
Photo F3.4 – 3rd Floor
Fallen plaster from arched ceiling reveals curved reinforcing bars.

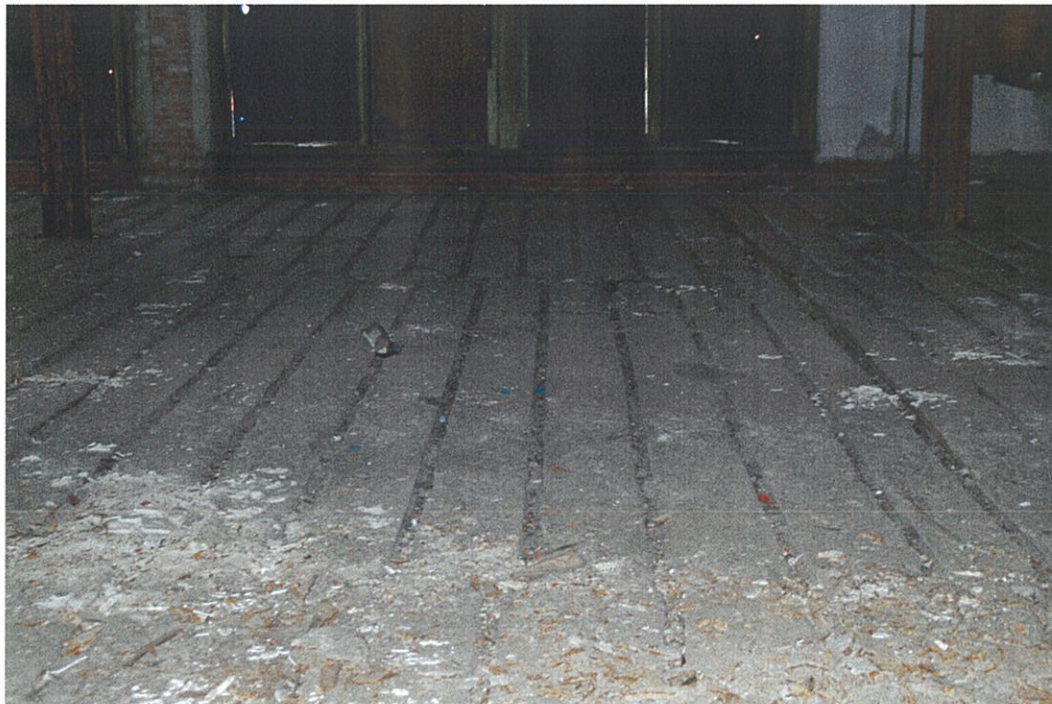
Photo F5.2 - 5th Floor

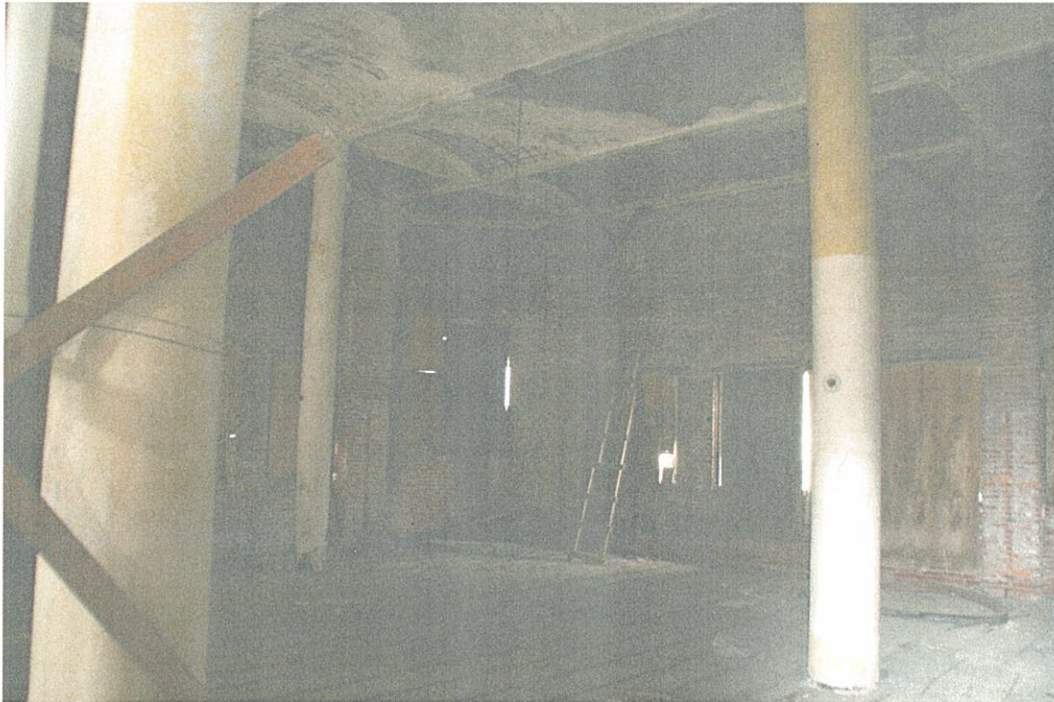
Photo F5.3 – 5th Floor

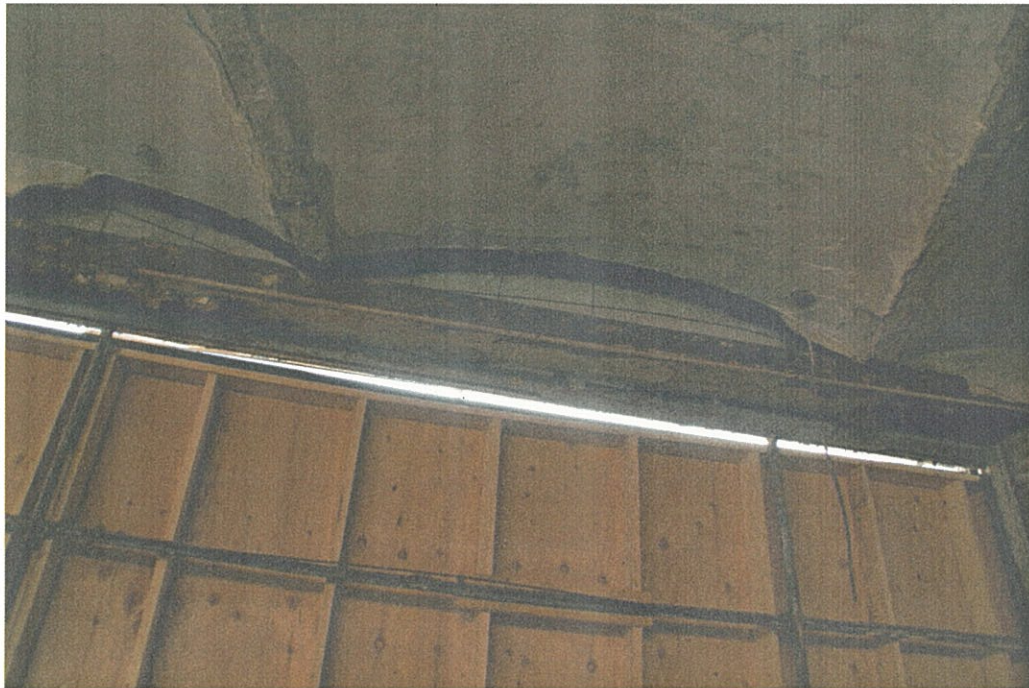
Photo F5.4 – 5th Floor

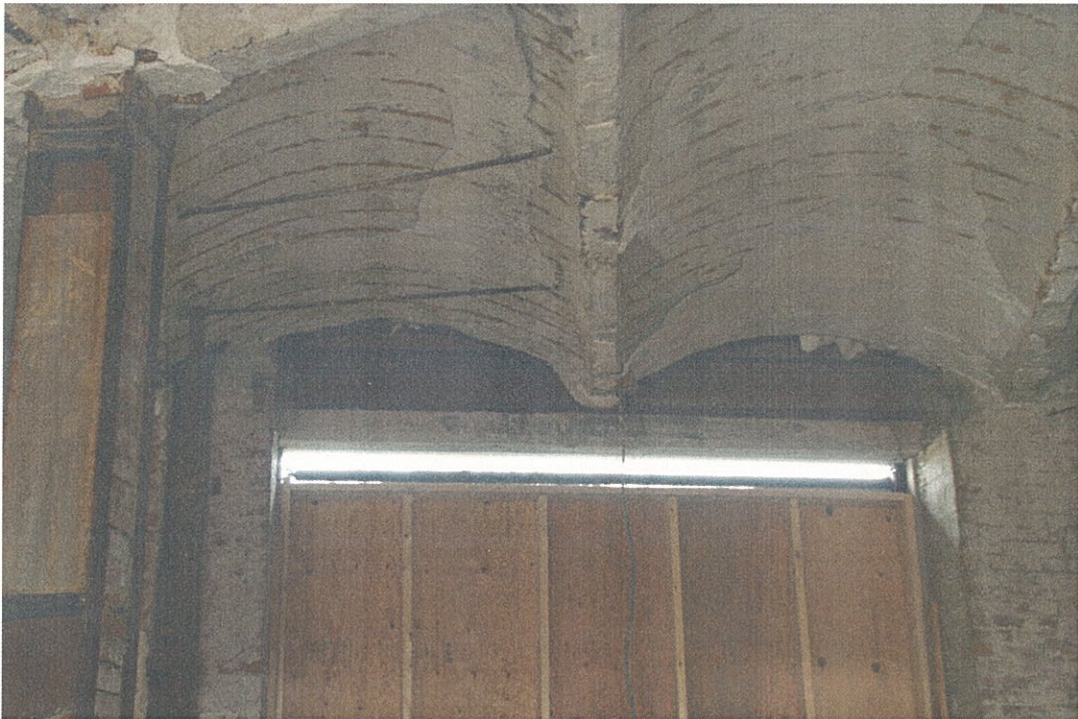
Photo F5.5 – 5th Floor
Deterioration at arched plaster ceiling and roof framing.

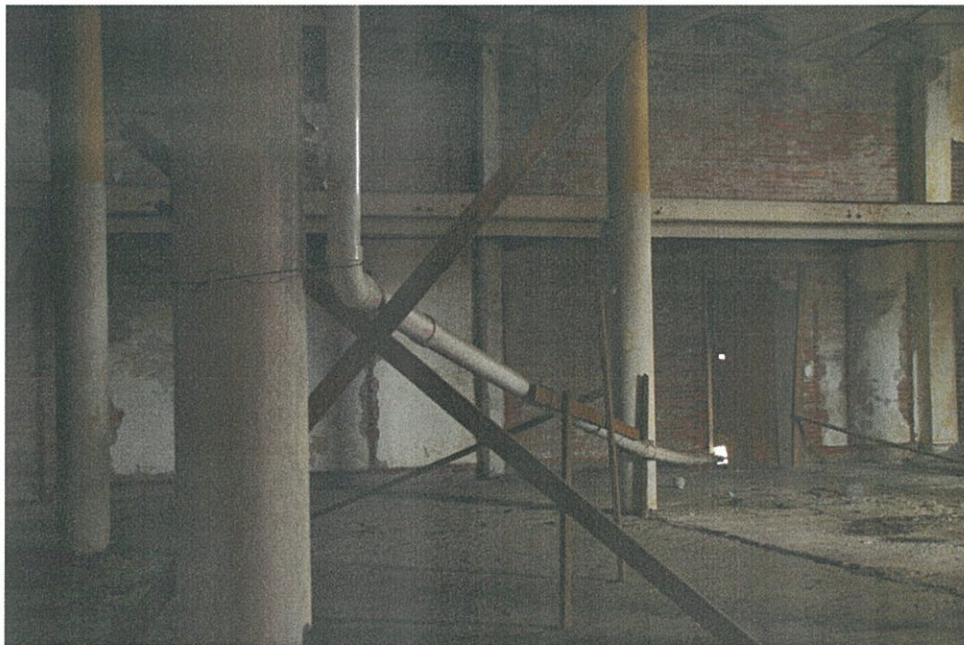
Photo F5.6 – 5th Floor
Elevation showing roof scupper drainage system and mezzanine level beyond.

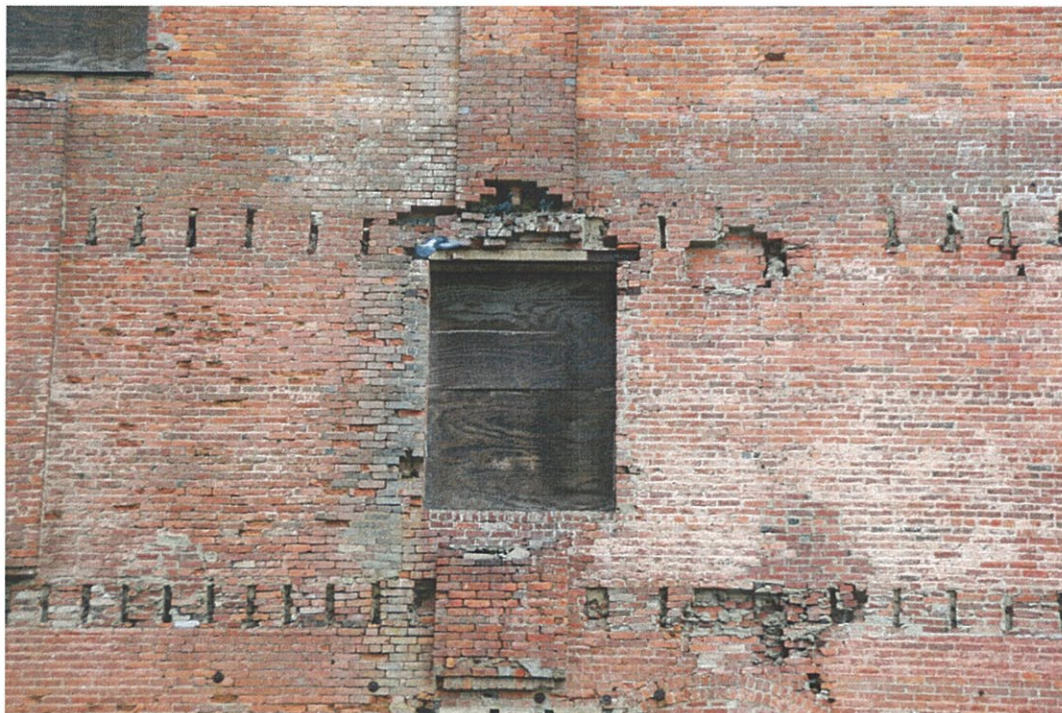
Photo FEX.5 – Building Exterior
Brick chimney on south façade – significant brick deterioration.

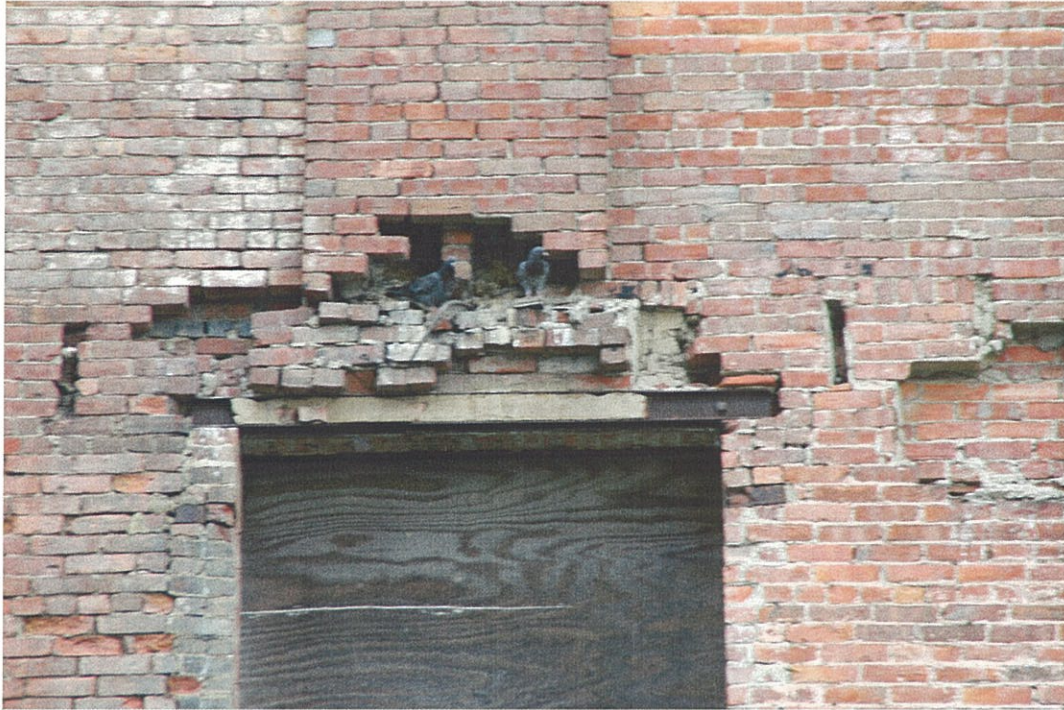
Photo FEX.6 – Building Exterior
Brick chimney on south façade – significant brick deterioration.

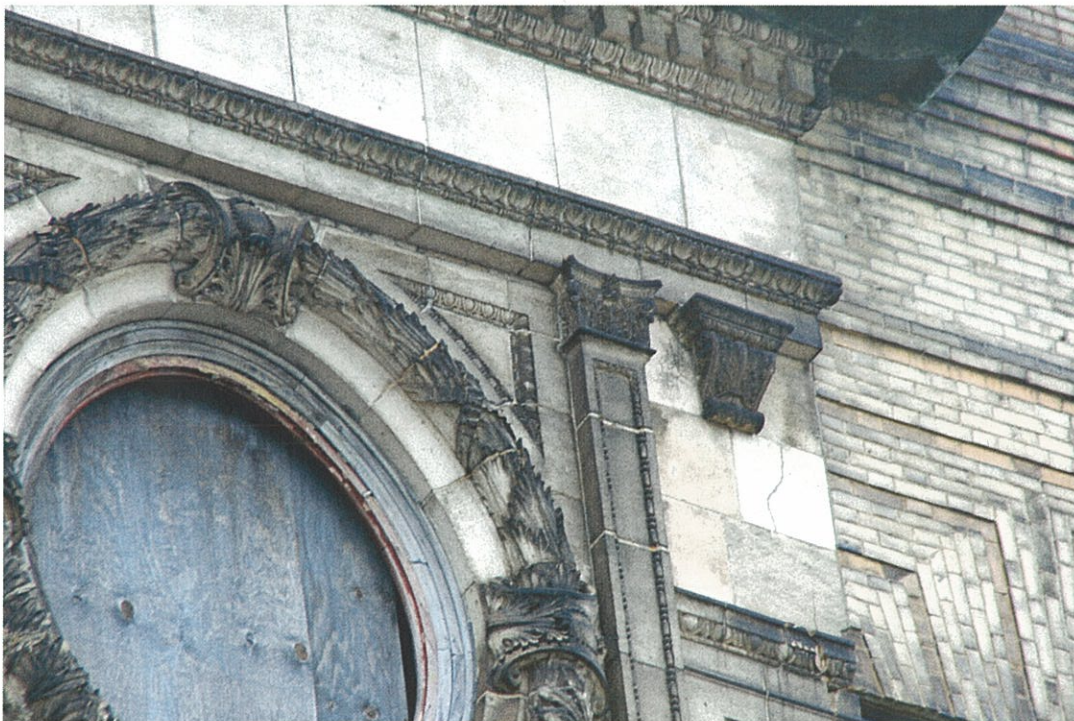
Photo FEX.7 – Building Exterior
Crack in façade near window.

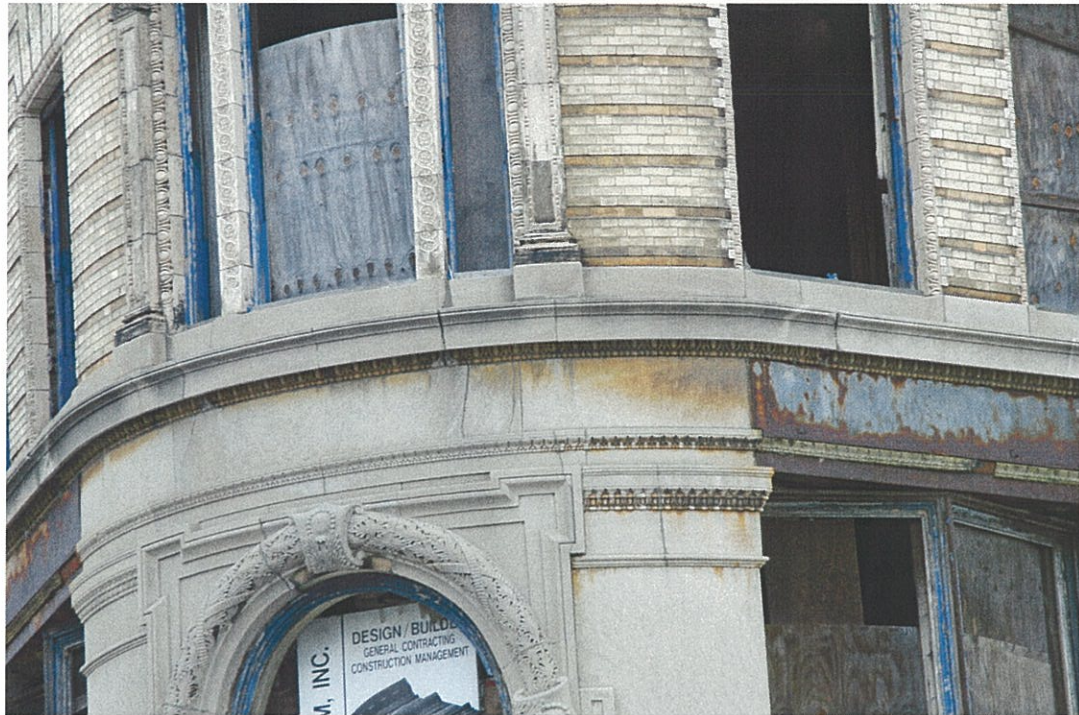
Photo FEX.8 – Building Exterior
Partial opening in masonry joints.

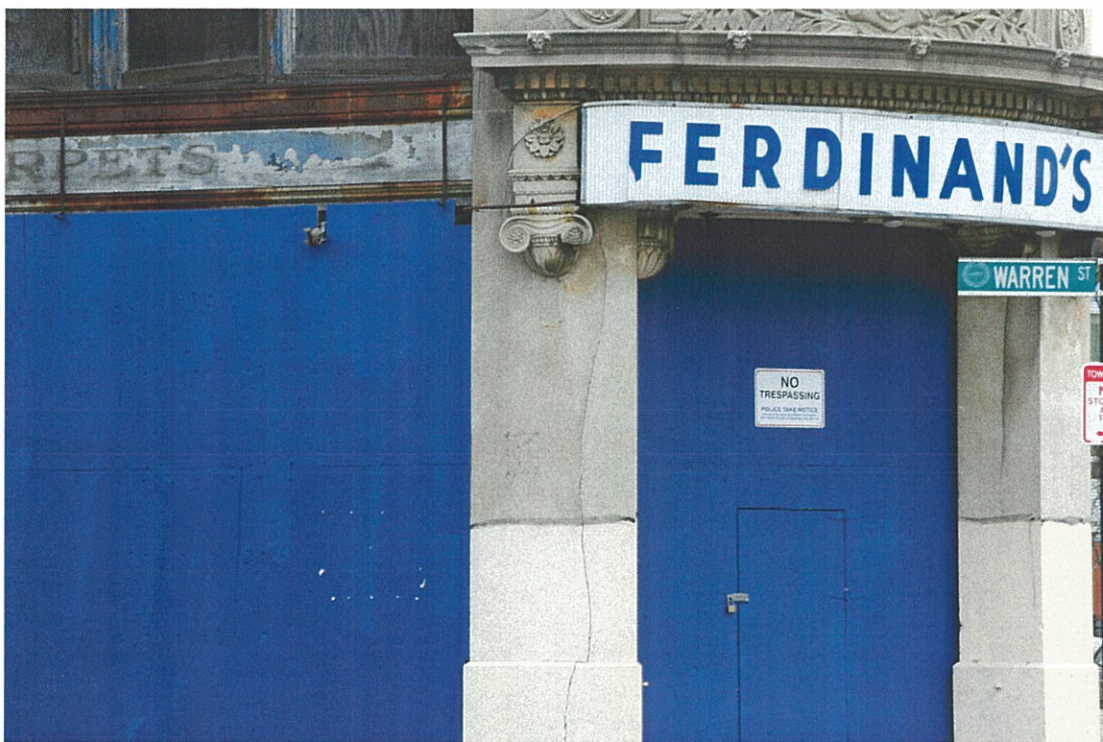
Photo FEX.9 – Building Exterior
Crack in masonry columns at building entrance.

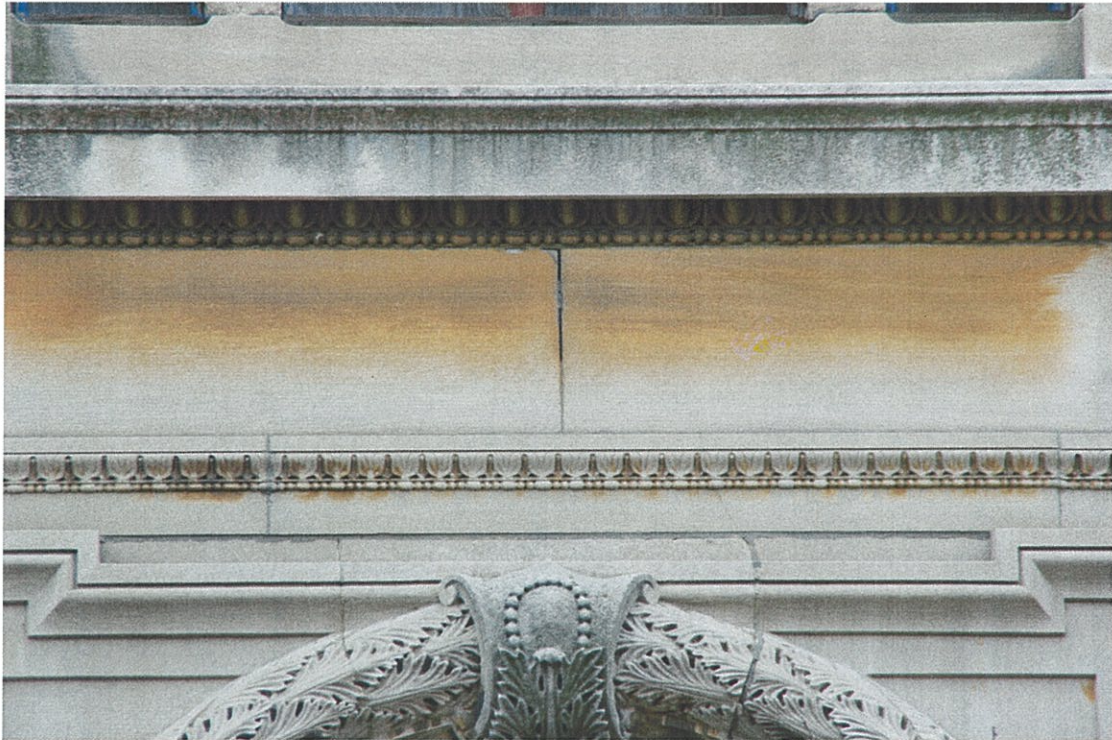
Photo FEX.10 – Building Exterior
Cracking observed in stone.

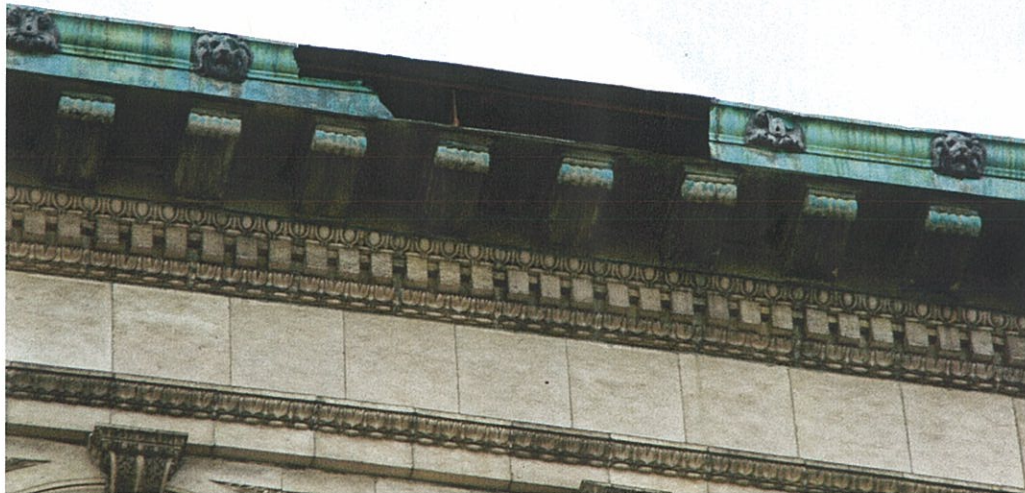
Photo FEX.11 – Building Exterior
Portion of cornice missing.

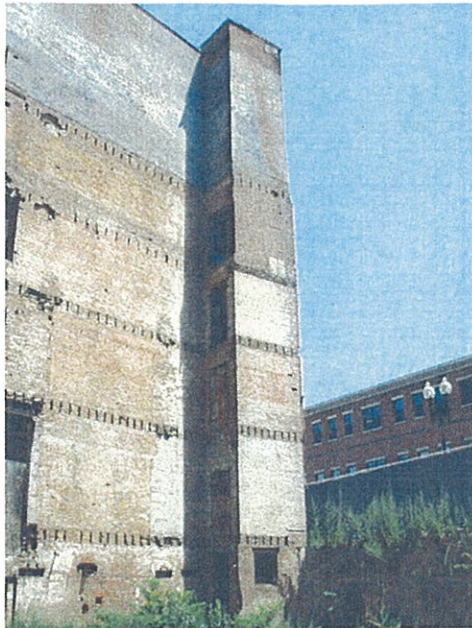
Figure 1: Ferdinand Building - Warren Street Elevator Shaft
Elevation view as seen from vacant lot
