Ferdinand Building

Existing Exterior Conditions

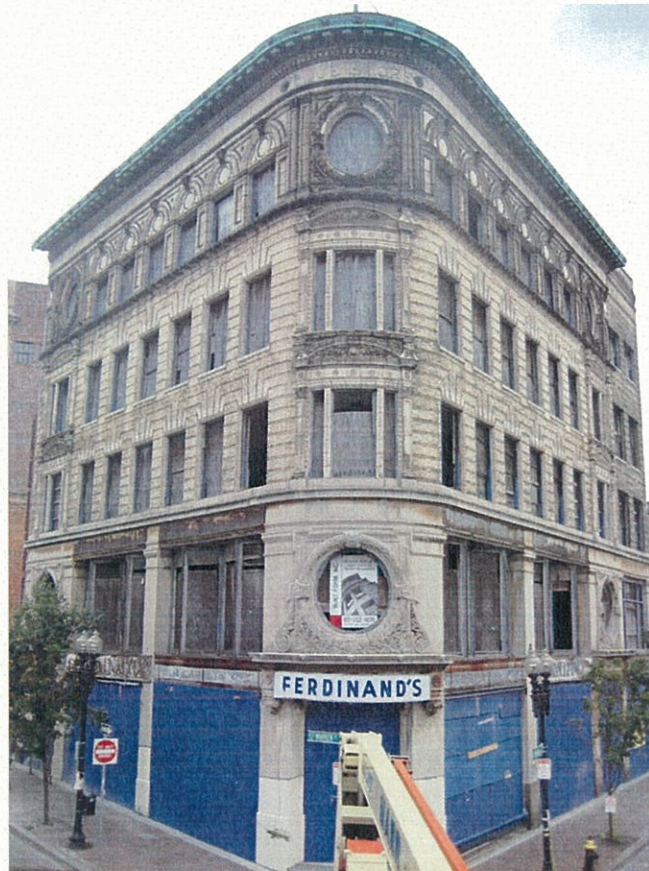
Dudley Square, Roxbury, Massachusetts

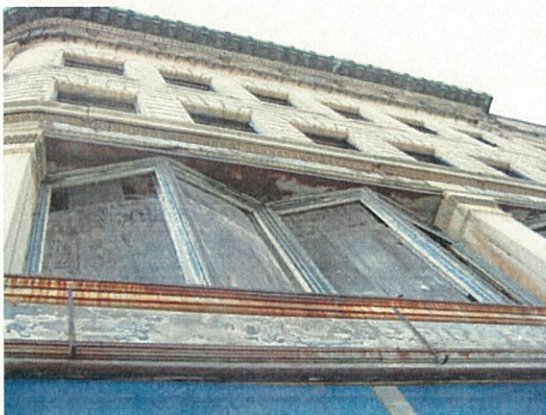
Figure 1. Accordion-paneled windows.

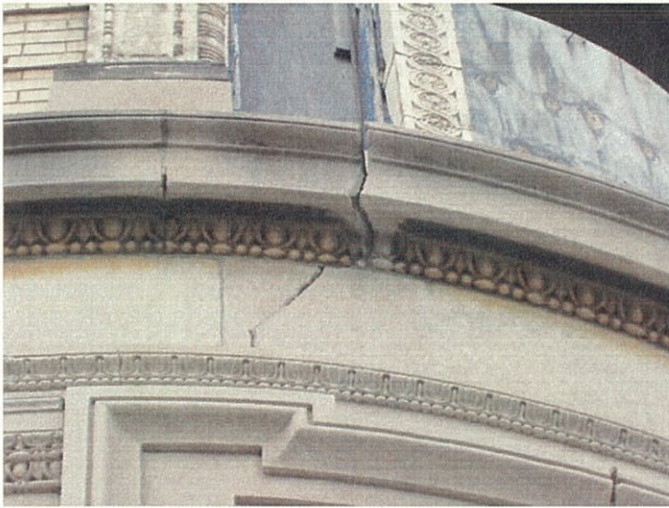
Figure 3. Wide crack in limestone at building corner.

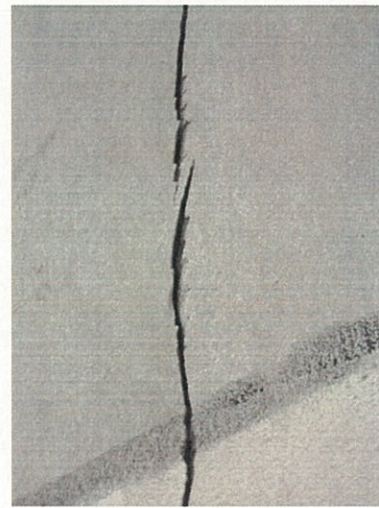
Figure 4. Shear crack in limestone.

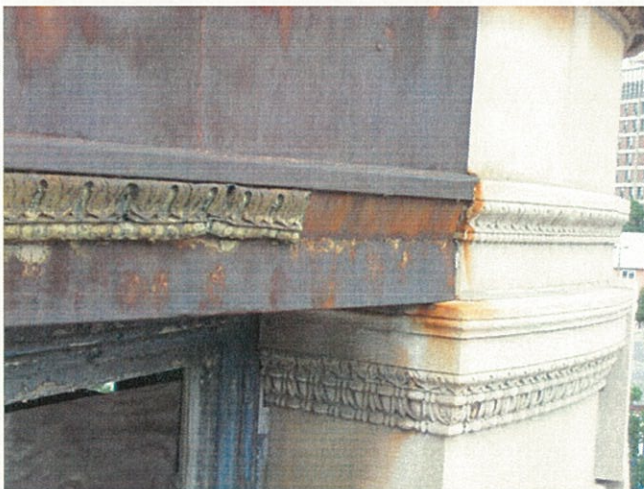
Figure 5. Rust staining at limestone column.

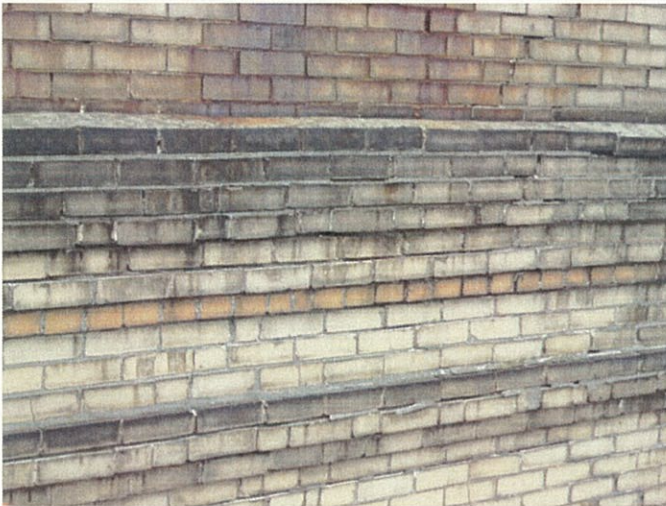
Figure 6. Soiling, open joints, cracked joints and staining at brick.

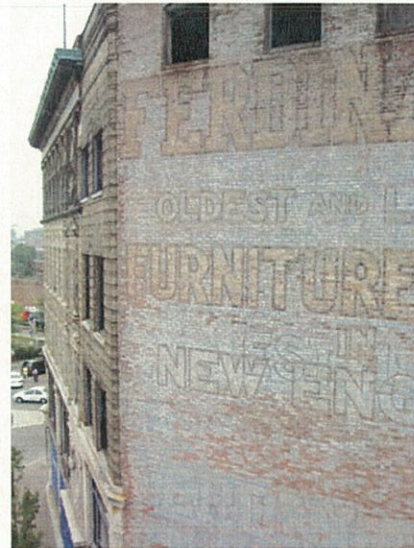
Figure 7. Full height painted wall sign.

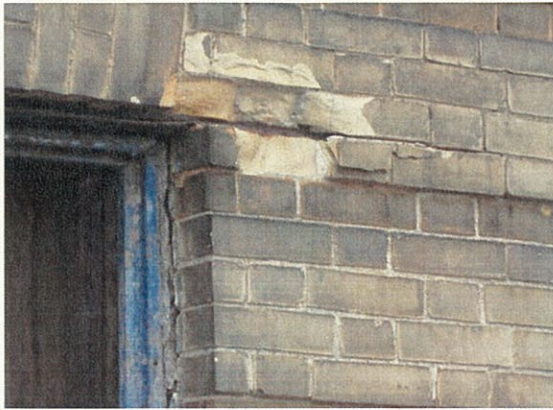
Figure 8. Spalled brick at site of iron corrosion/expansion.

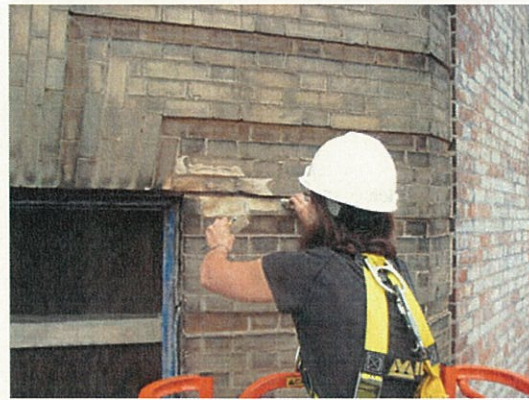
Figure 9. Removal of loose brick during survey.

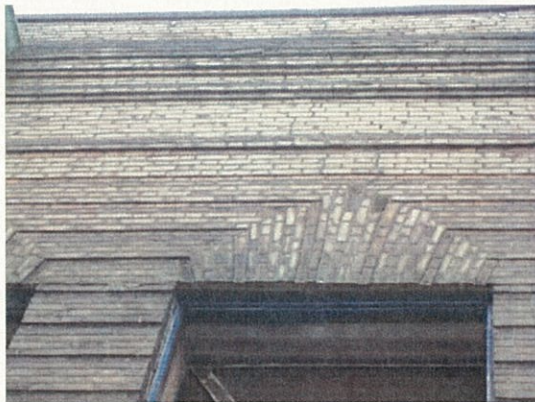
Figure 10. Bowing brick courses at addition.

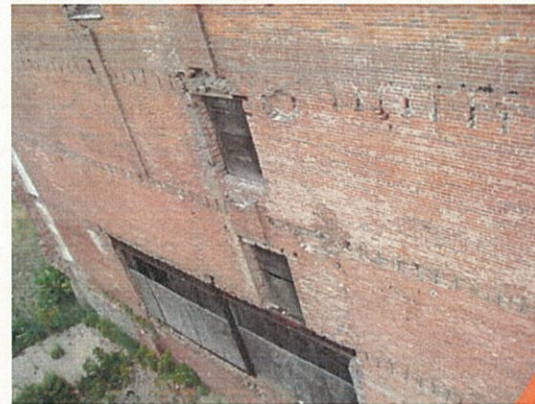
Figure 11. South elevation brick deterioration.

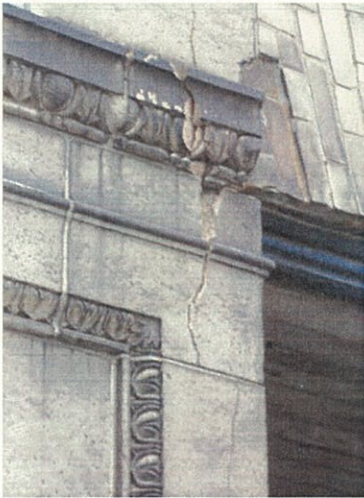
Figure 13. Cracking and spalling.

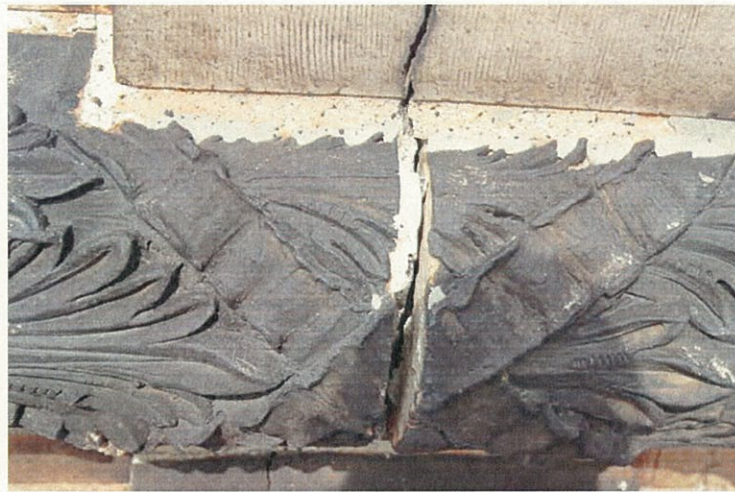
Figure 14. Extreme soiling and soot deposition on cream-colored terra cotta.

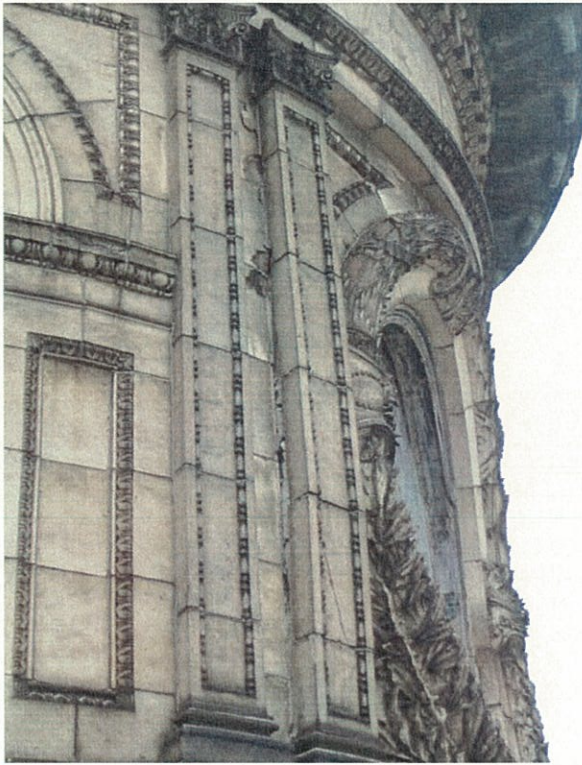
Figure 15. Bowing terra cotta units in right pilaster.

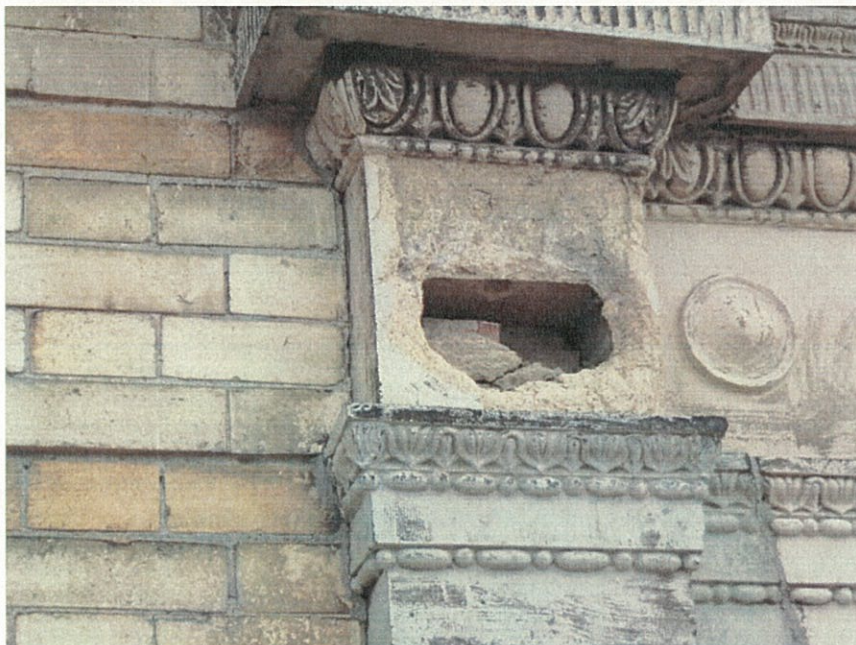
Figure 16. Large spall in terra cotta.

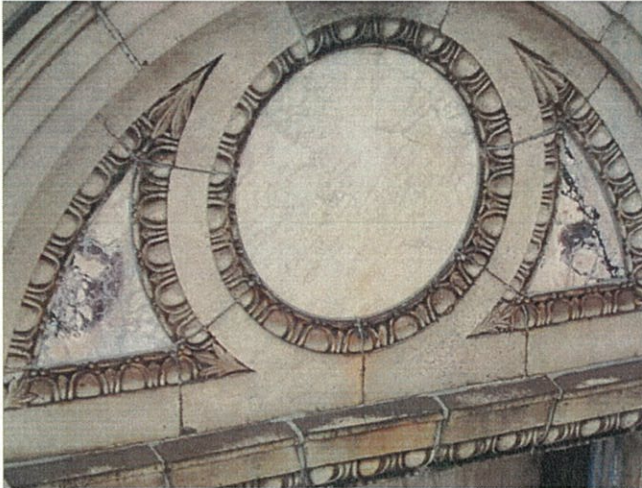
Figure 17. Marble medallion.

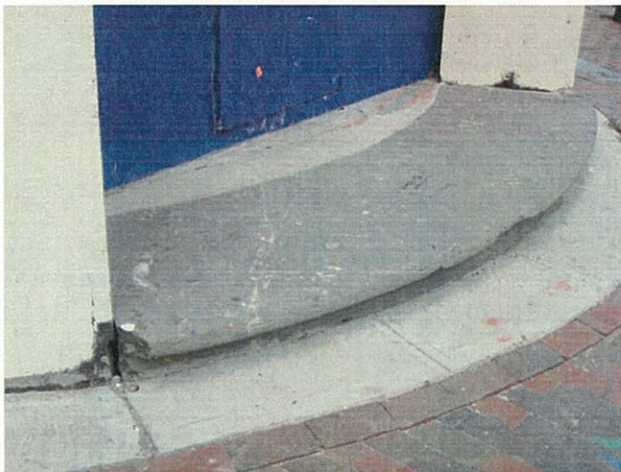
Figure 18. Granite spalls at main entry, building corner.

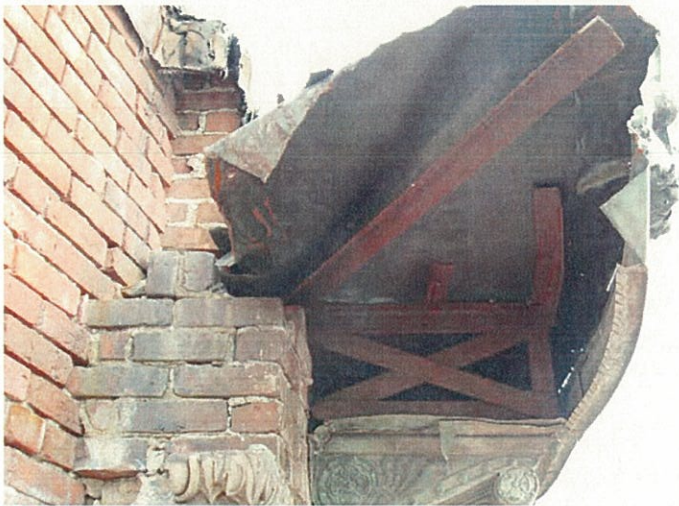
Figure 19. Interior bracing at cornice end (area of removal).

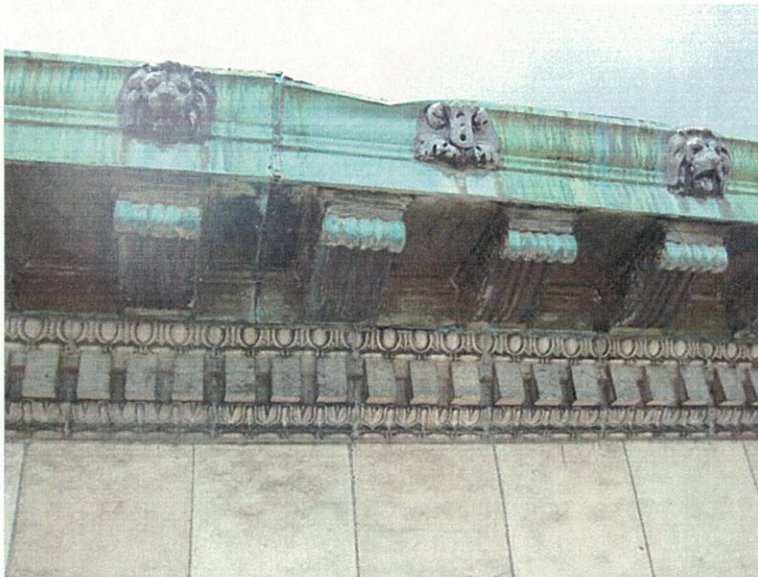
Figure 20. Copper cornice. Note missing element between the lions.

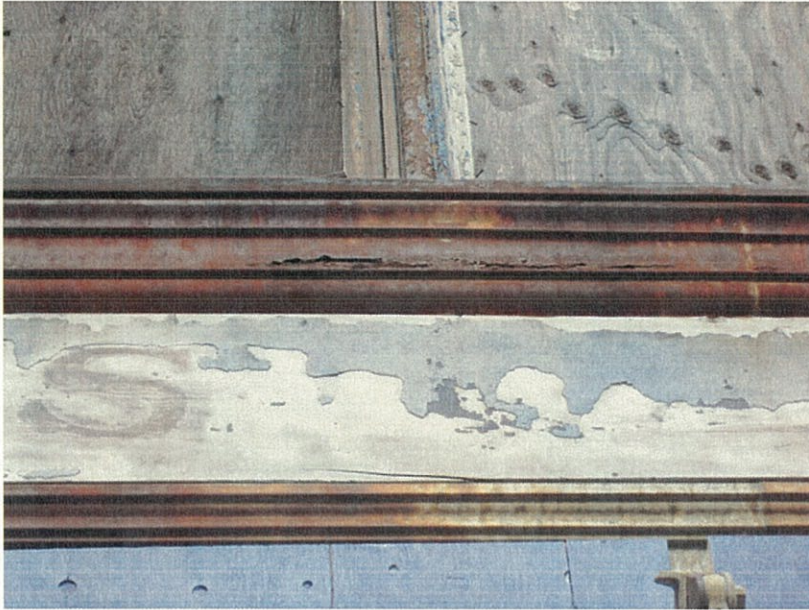
Figure 21. Deteriorated ferrous metal trim.

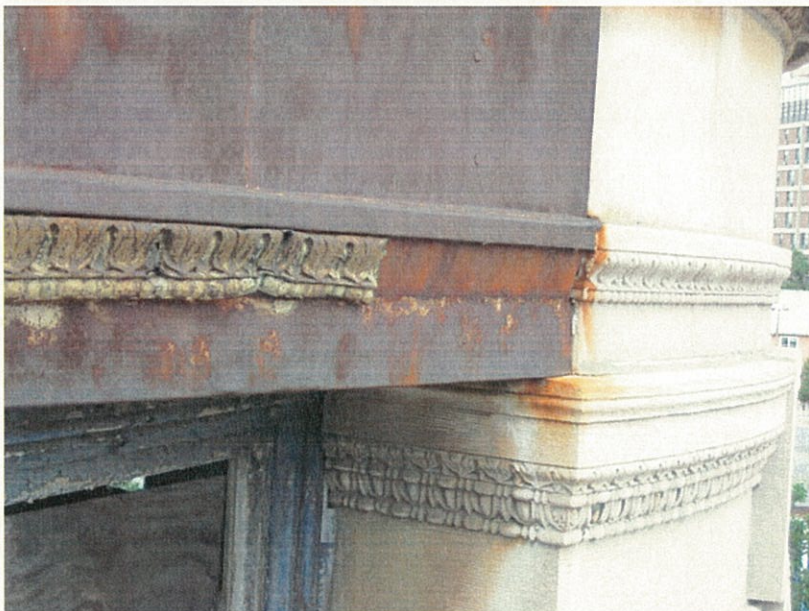
Figure 22. Corroding metal trim has stained limestone at first floor.

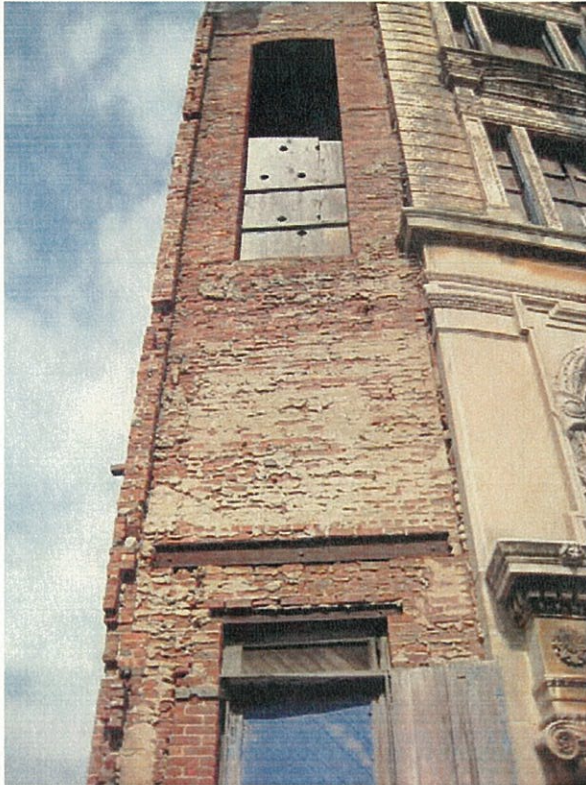
Figure 23. Elevator shaft.

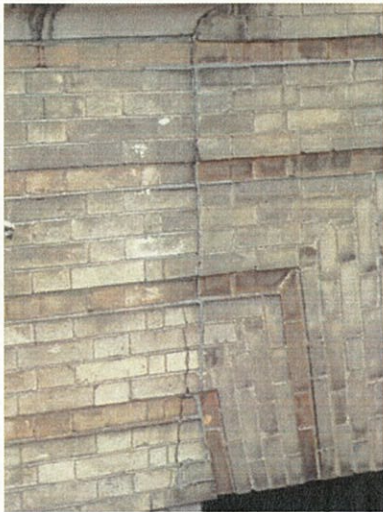
Figure 25. Joint between buildings.

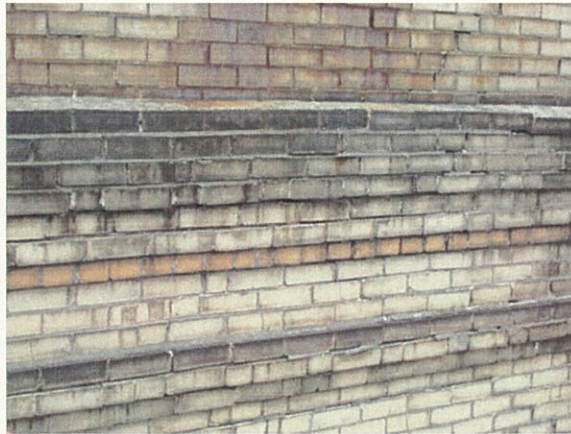
Figure 26. Cracked and open brick joints.

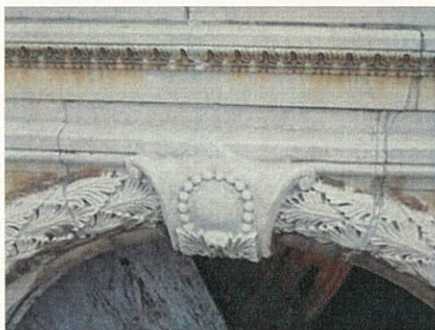
Figure 27. Portland cement repointing mortar in limestone joints.

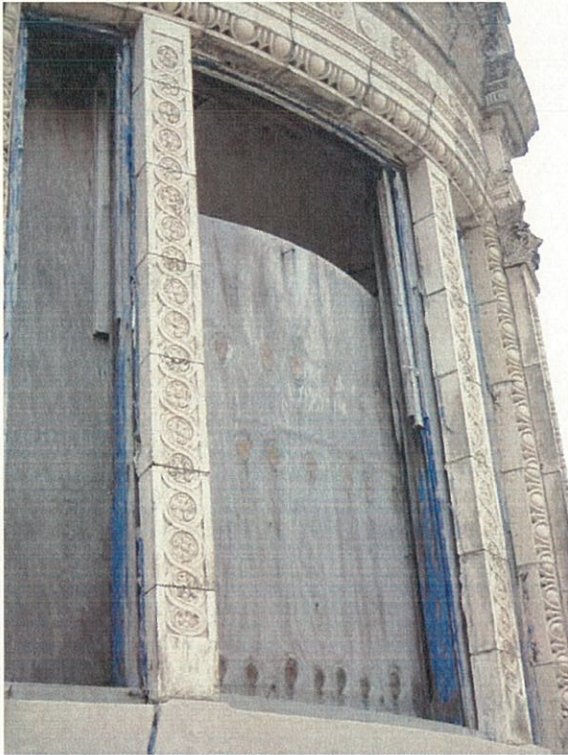
Figure 28. Deteriorated wood frame and missing sash at corner tri-part window.

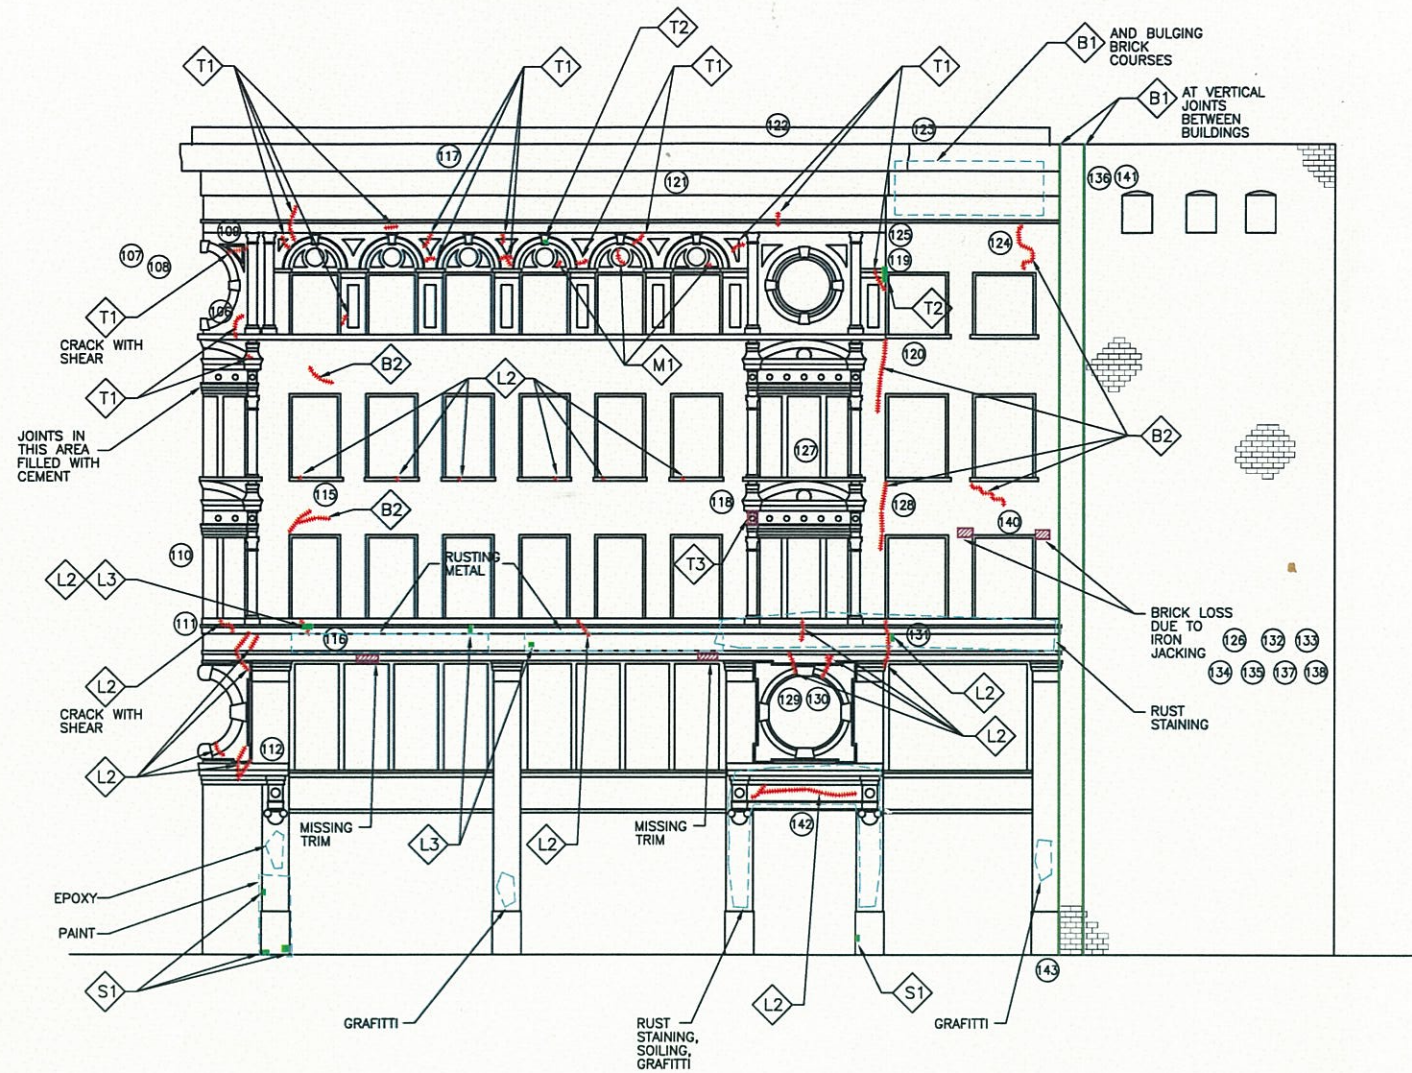
NORTH ELEVATION
N.T.S.

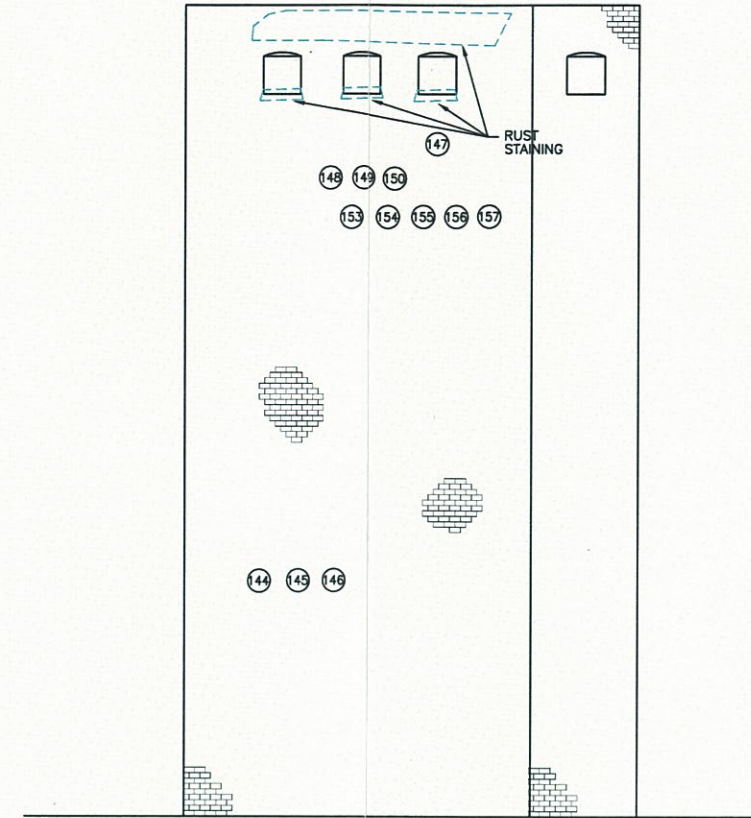
WEST ELEVATION
N.T.S.

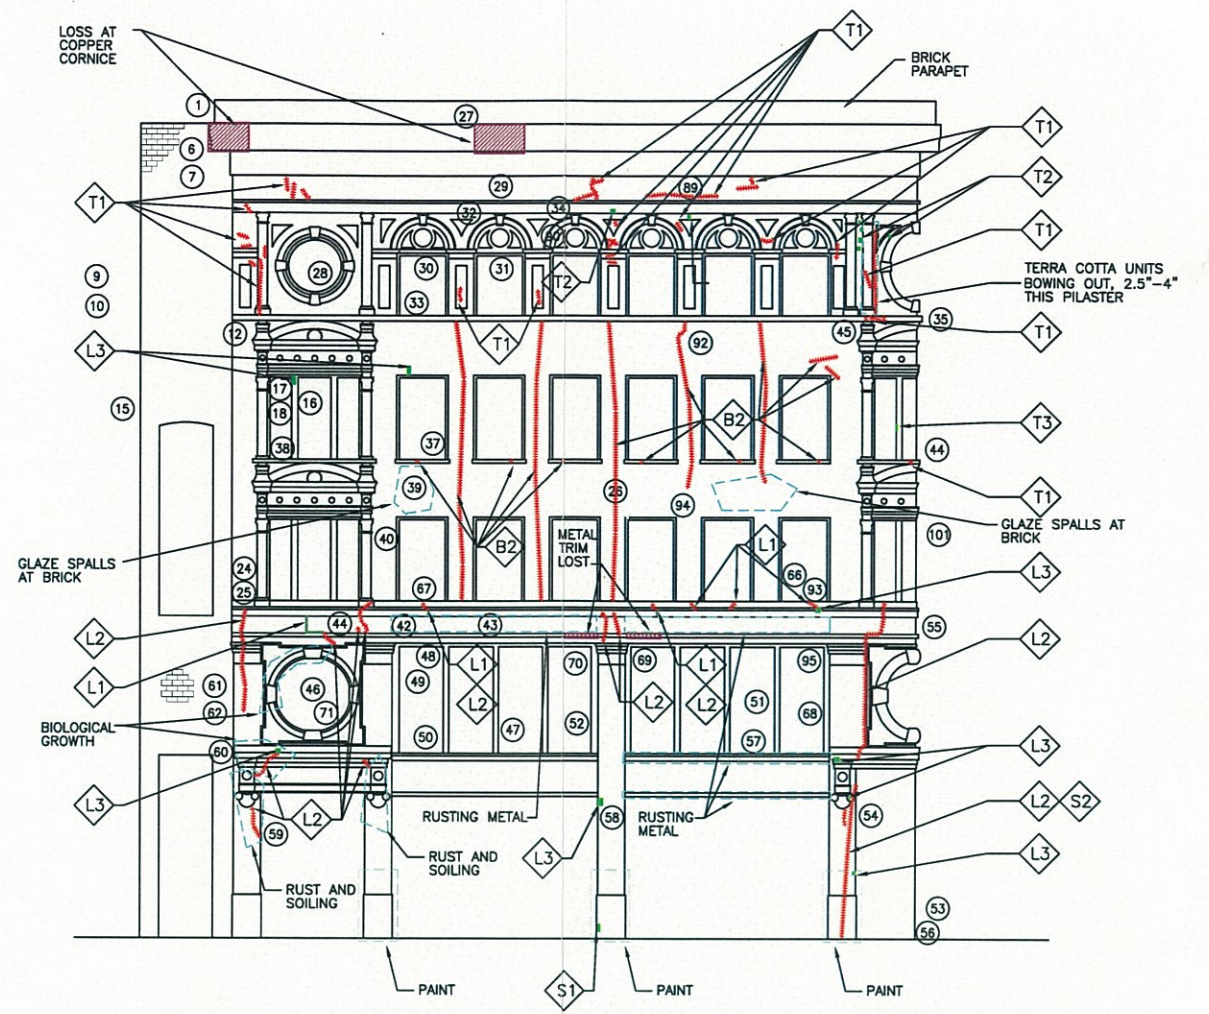
EAST ELEVATION
N.T.S.
