**Article 85 Review – Boston Zoning Code
17-19 Warren Street “Ferdinand’s Blue Store Addition”,
Roxbury, Boston, MA**

Engineering Design for Environmental Remediation
and Site Clearance at Dudley Square
Boston Redevelopment Authority
Project No. 5076

Re: Article 85 Application for 17-19 Warren Street, Roxbury, MA
New City Municipal Building
Phase 1 - Engineering Design for Environmental Remediation and
Site Clearance at Dudley Square, Roxbury, MA

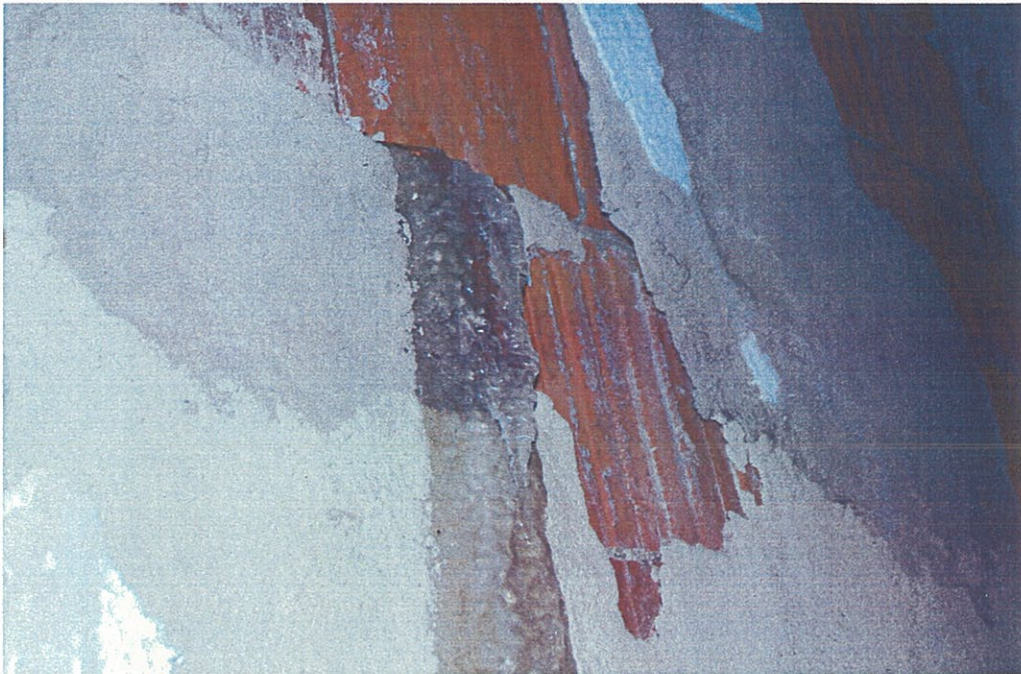
Photo G0.1 - Basement

Ice covering exterior wall indicative of water infiltration through foundation.

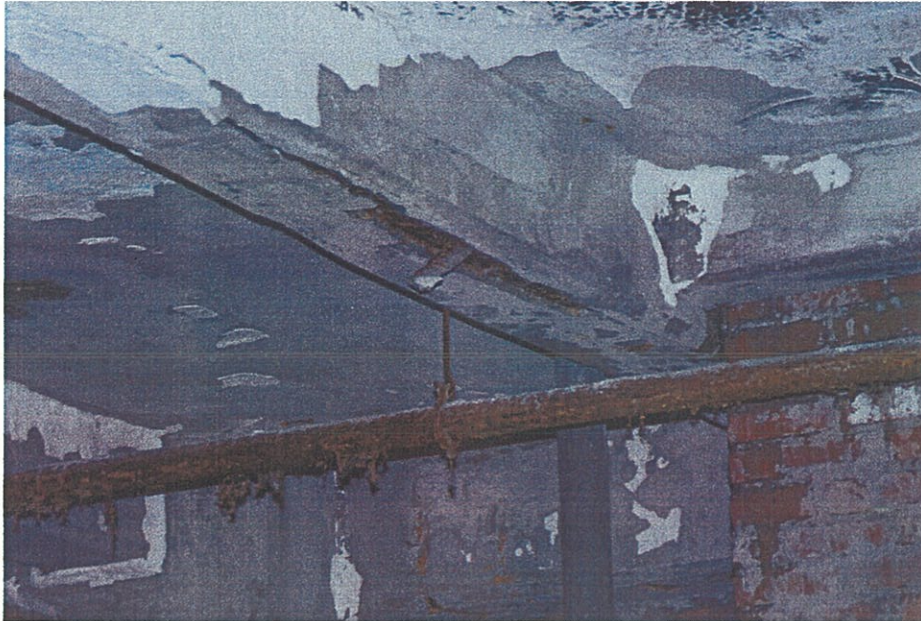
Photo G0.3 - Basement

Delamination of concrete encasement at underside of beam revealing corrosion of steel section. Ceiling-mounted piping system also shown.

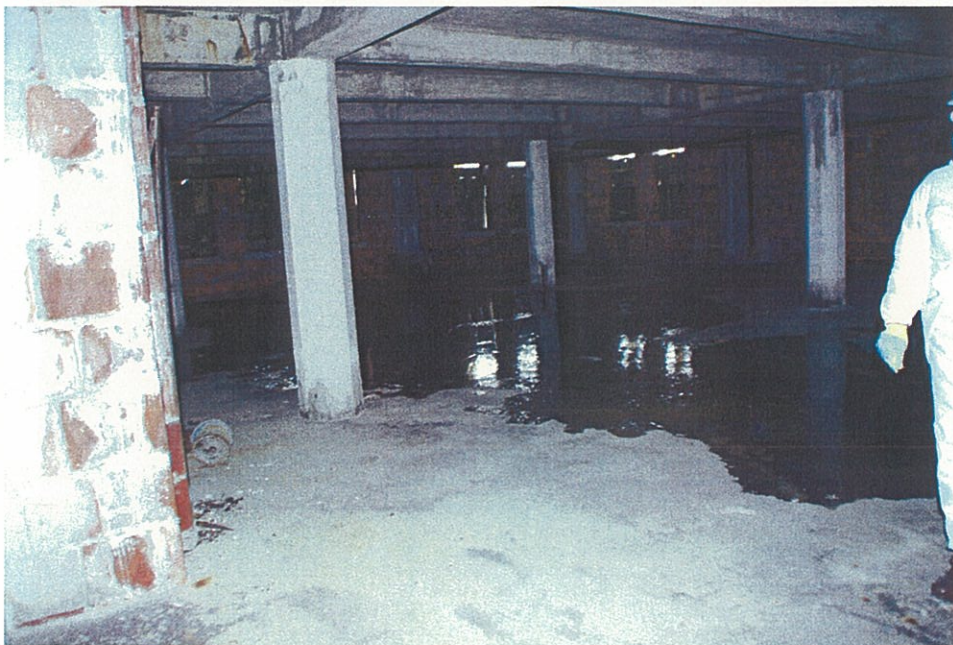
Photo G0.4 - Basement

Typical layout of concrete-encased steel columns shown. Large areas of floor covered with ice. Delaminated clay brick walls shown in foreground.

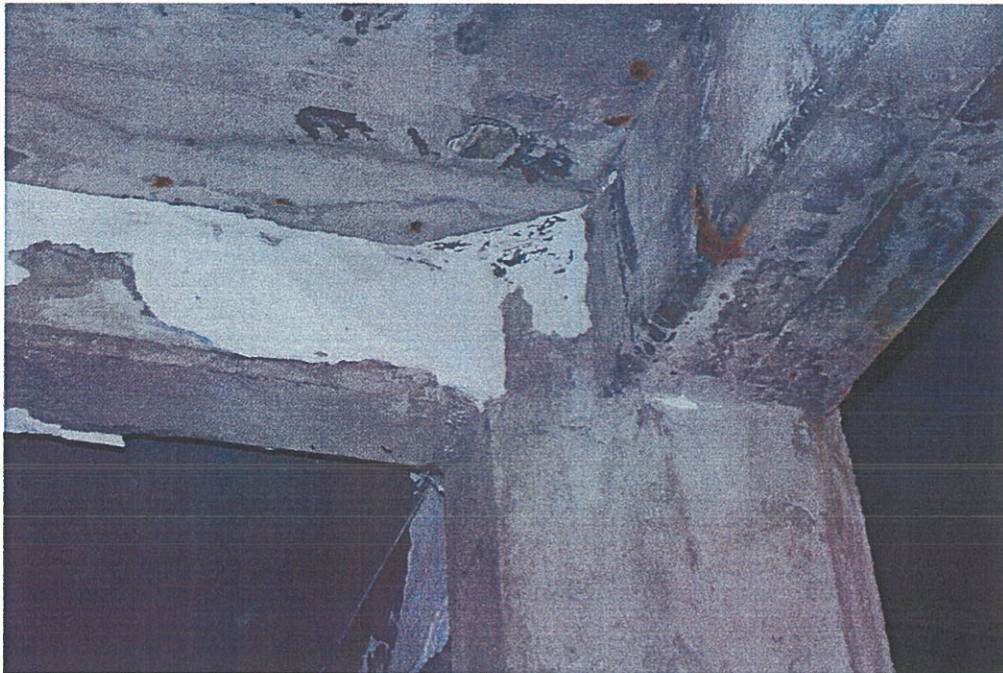
Photo G1.2 – 1st Floor

Minor delamination of concrete encasement at underside of beam revealing corrosion of steel section.

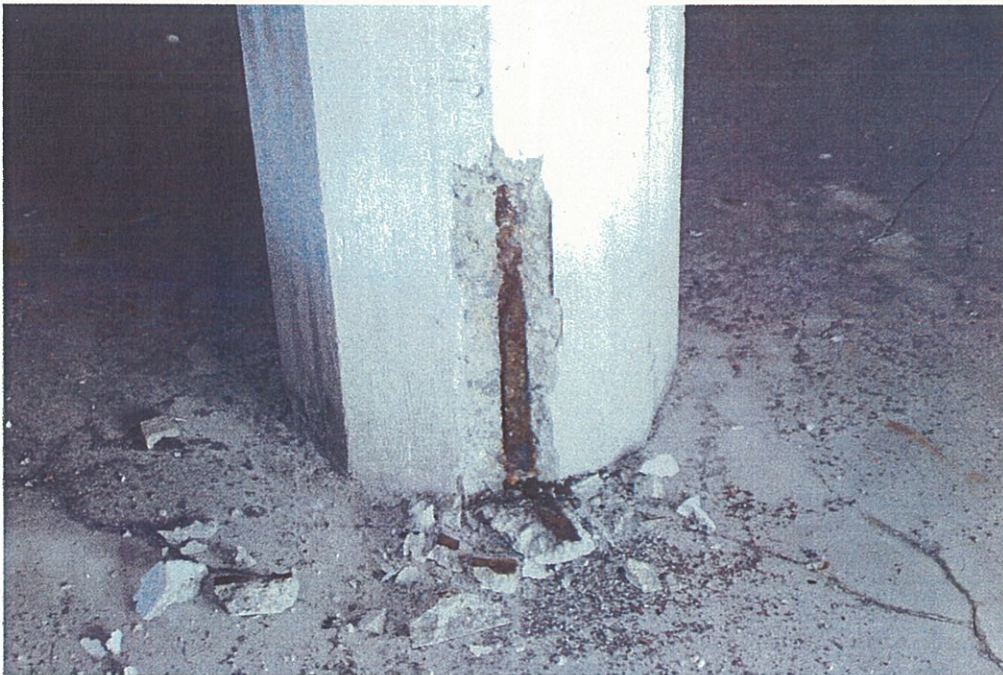
Photo G1.3 – 1st Floor

Delamination of concrete encasement at base of column revealing corrosion and section loss of the steel member.

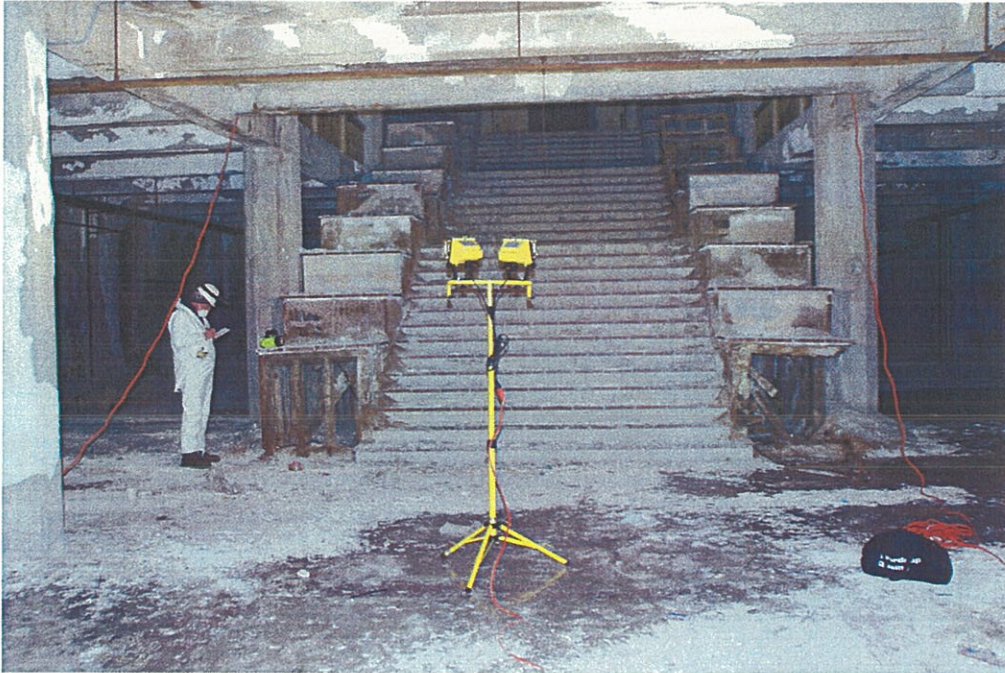
Photo G1.4 – 1st Floor

Concrete staircase to Mezzanine (2nd floor) with wood structure adjacent both sides. A large amount of plaster is seen on floor.

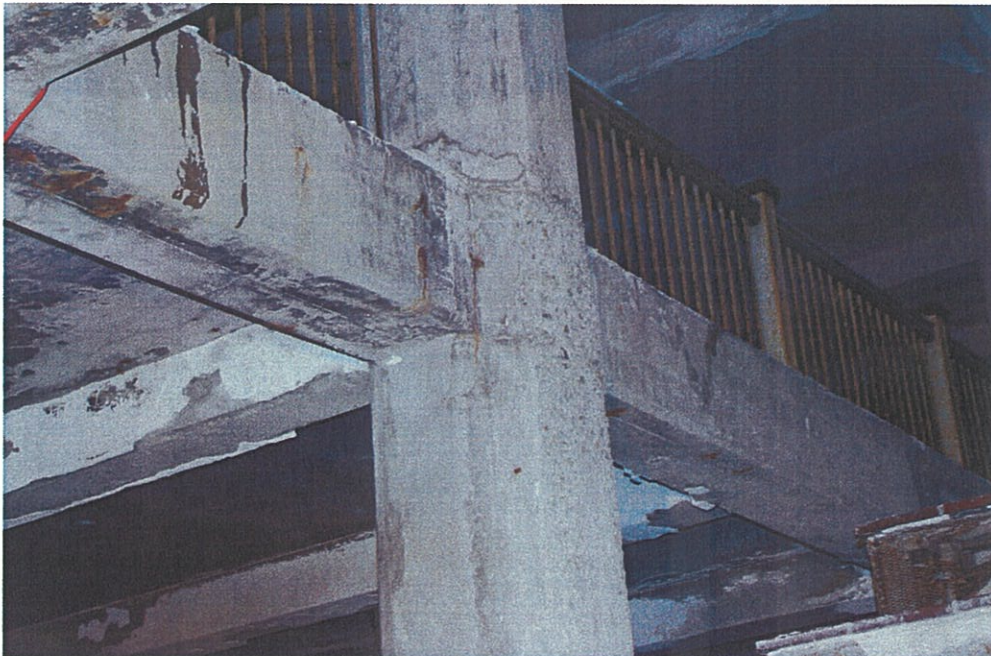
Photo G1.5 – 1st Floor

Typical beam-to-column framing at Mezzanine (2nd floor). Delamination and spalling of concrete encasement is seen. Rust stains indicative of internal corrosion of the encased steel members.

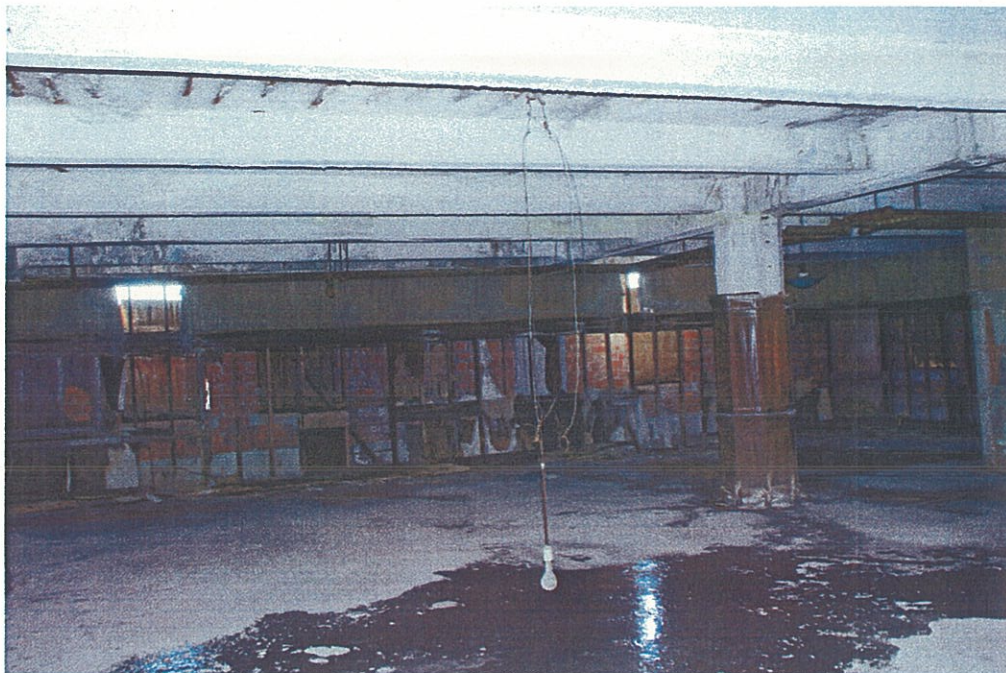
Photo G2.1 – 2nd (Mezzanine) Floor
Exposed abandoned utilities and showroom wood work on walls and columns shown. Floor covered with ice and fallen plaster.

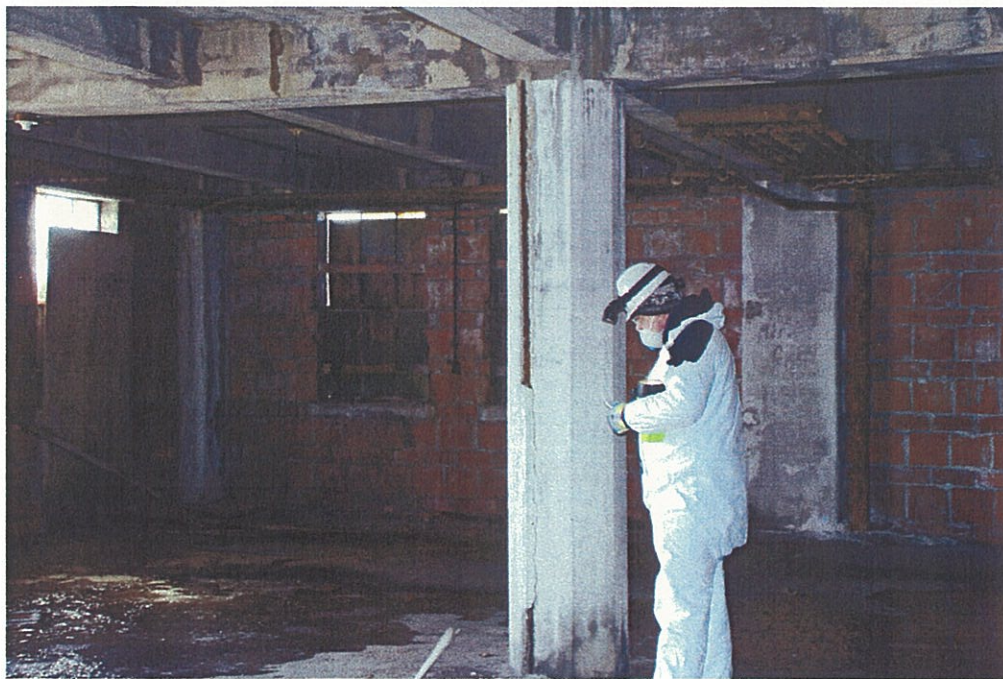
Photo G2.2 – 2nd (Mezzanine) Floor
Delamination and spalling of concrete encasement at column and beams revealing corrosion of steel sections.

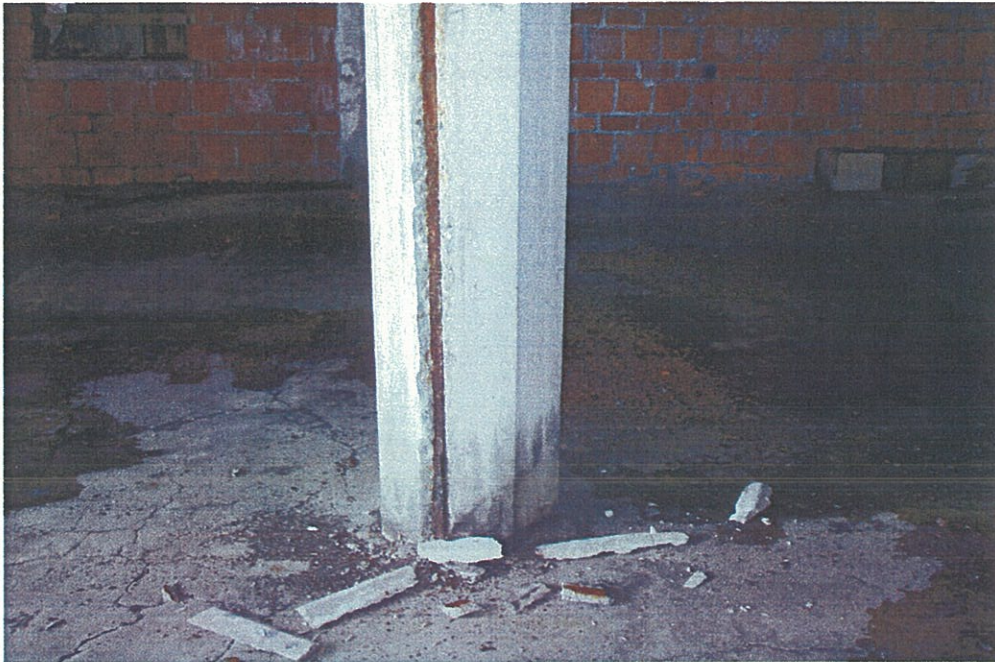
Photo G2.3 – 2nd (Mezzanine) Floor

Delamination of concrete encasement at base of column revealing corrosion and section loss of the steel member.

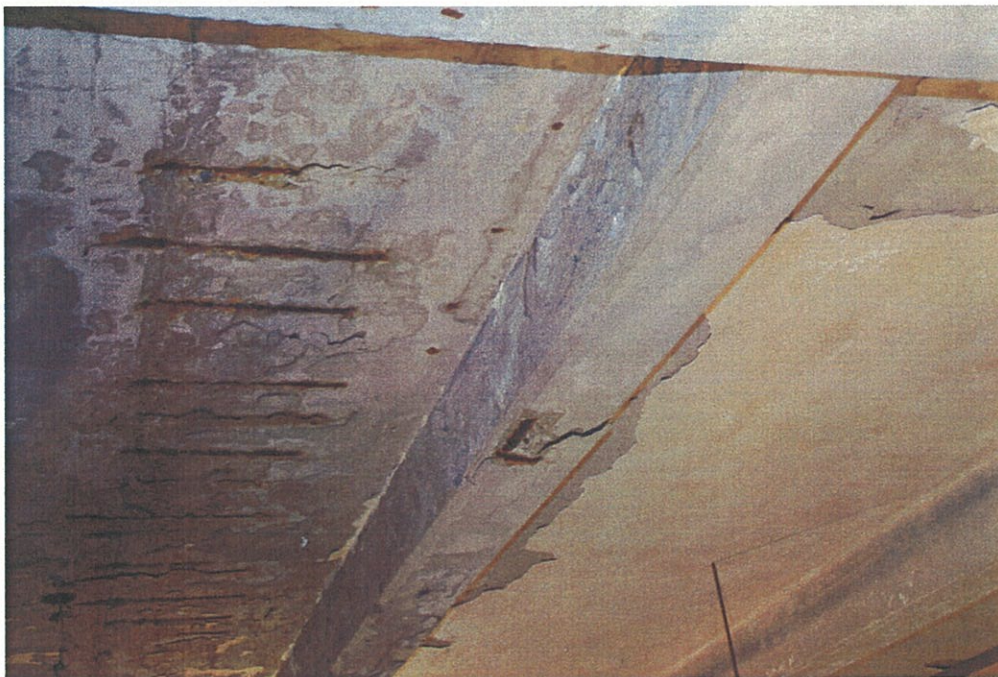
Photo G2.4 – 2nd (Mezzanine) Floor

Loose and spalled concrete at underside of 3rd floor concrete floor slab revealing deterioration of slab reinforcement. Delamination of concrete encasement at underside of floor beam also shown.

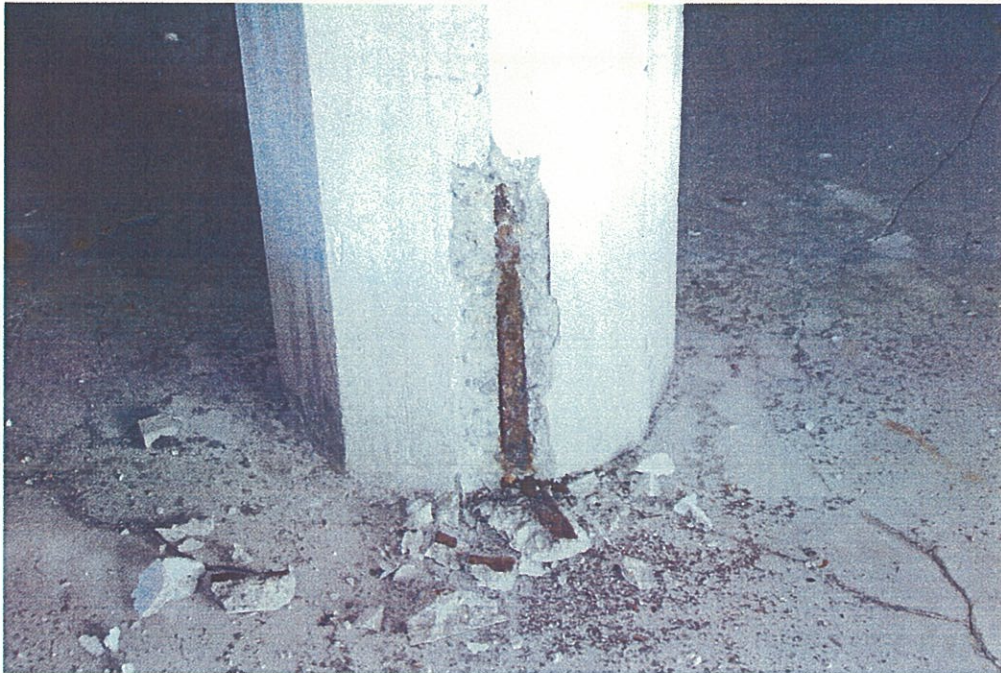
Photo G3.1 – 3rd Floor

Delamination of concrete encasement at base of column revealing corrosion and section loss of the steel member.

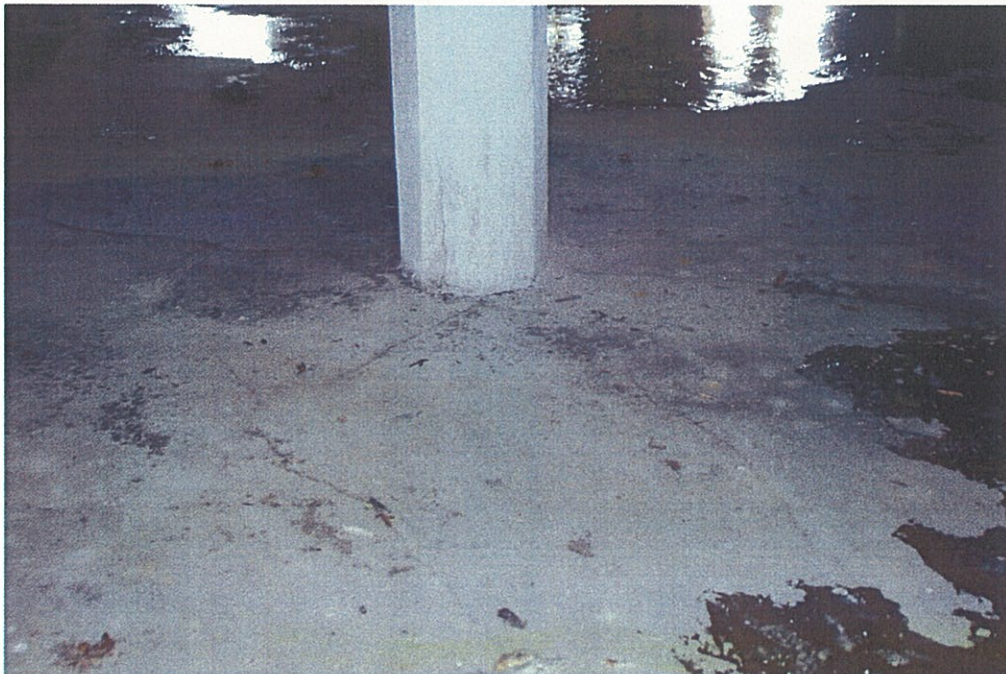
Photo G3.2 – 3rd Floor

Large areas of ice covering the floor.

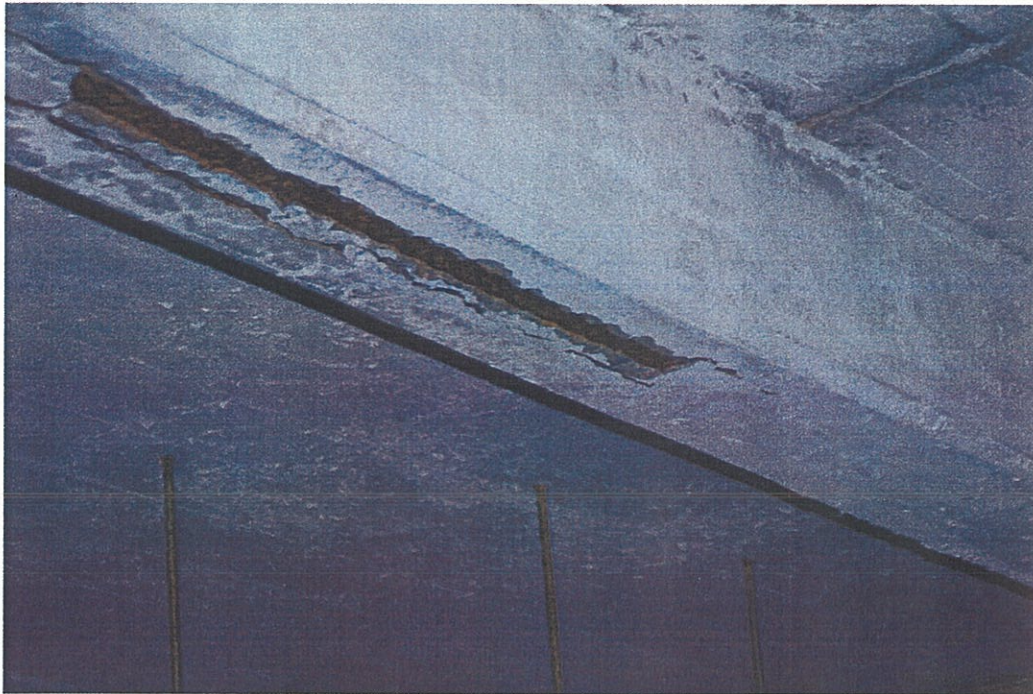
Photo G3.5 – 3rd Floor

Delamination of concrete encasement at underside of beam revealing corrosion of steel section.

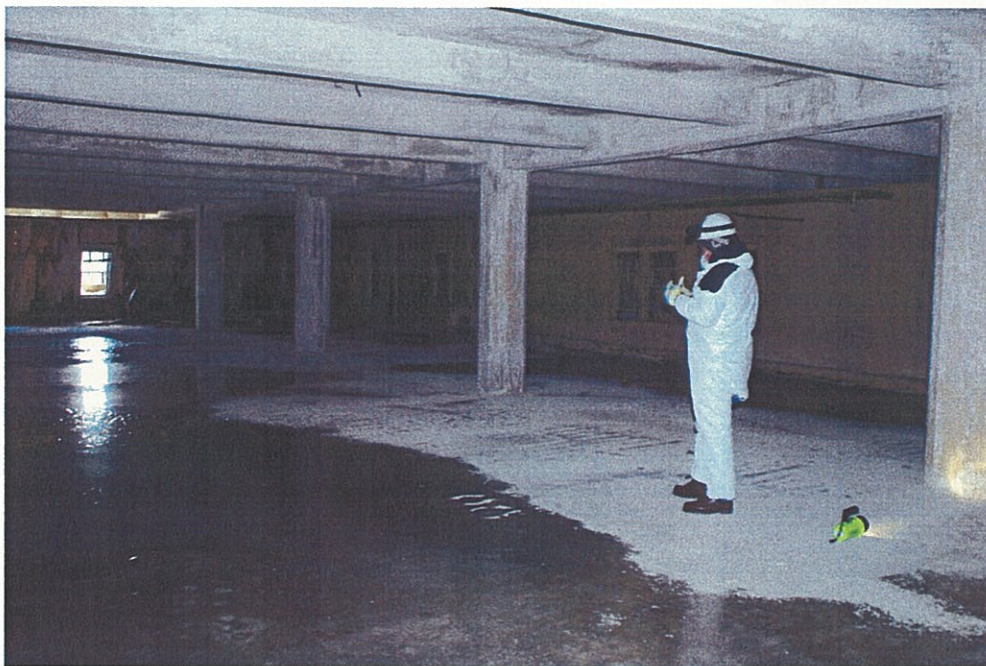
Photo G3.6 – 3rd Floor

Typical beam and column layout shown. Ice present over widespread area of floor.

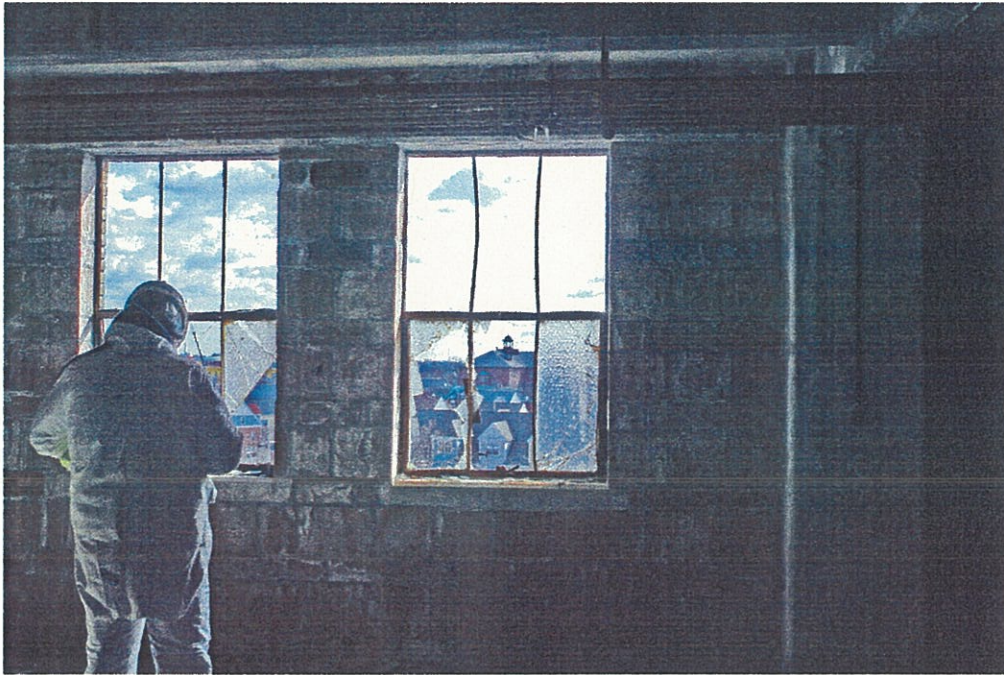
Photo G4.1 – Typical condition for 4th, 5th, & 6th Floors
Broken glass and deteriorated window frames.

Emergency Measures: Rusted window frames, some of which are precarious, should be removed before falling out and injuring the public on the ground or damaging vehicles. There are no signs of imminent structural failure.

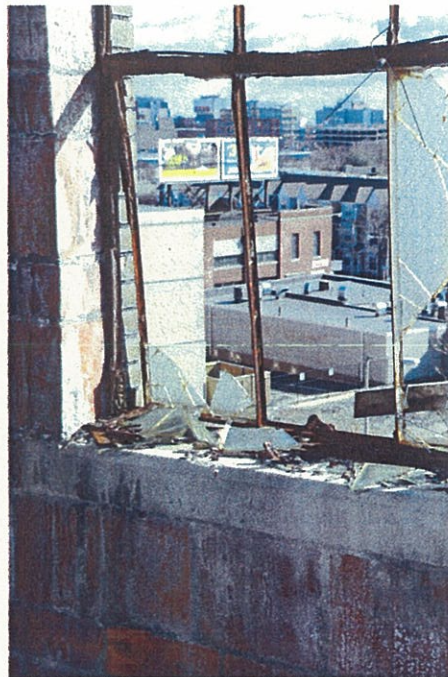
Photo G4.2 – Typical condition for 4th, 5th, & 6th Floors
Broken glass and deteriorated window frames.

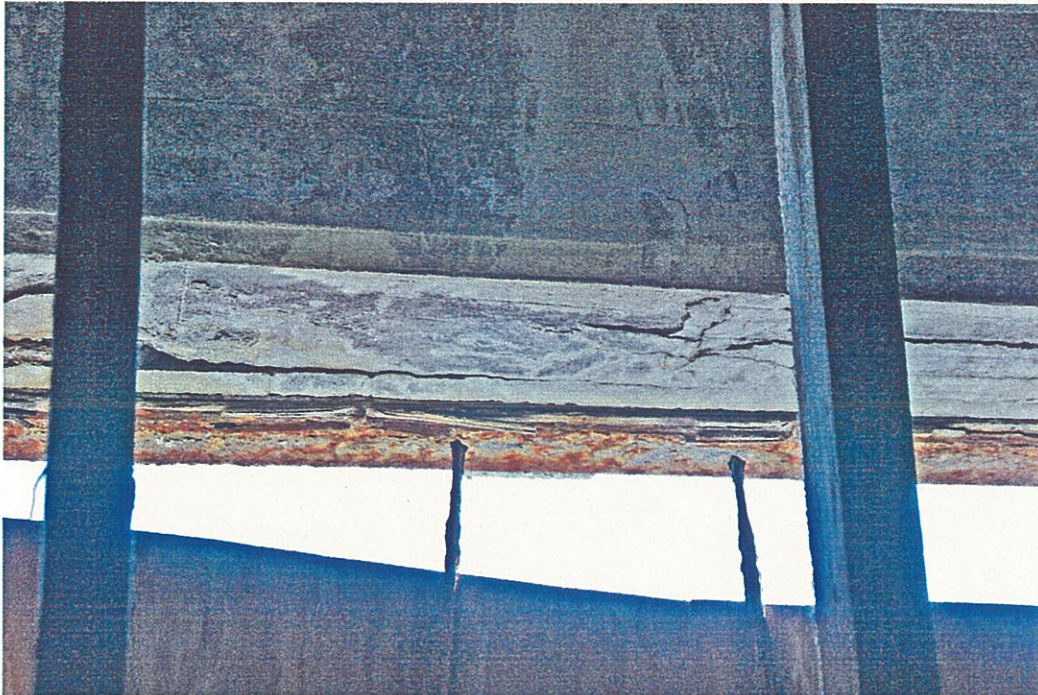
Photo G4.3 – 4th Floor
Deteriorated concrete around window lintels.

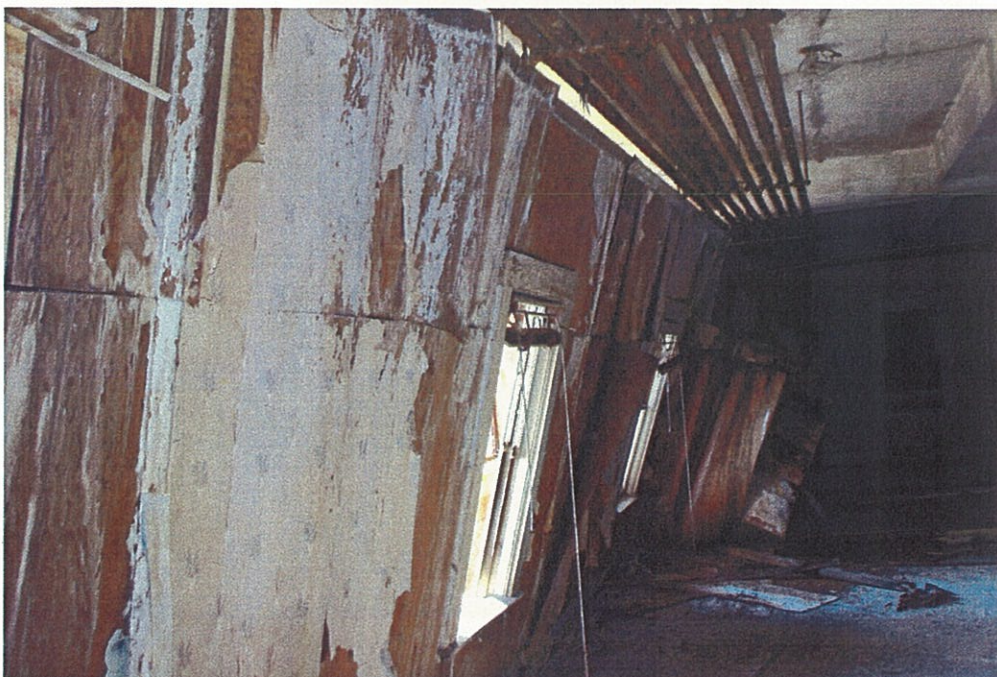
Photo G4.4 – 4th Floor
Unstable wall partitions ready to fall.

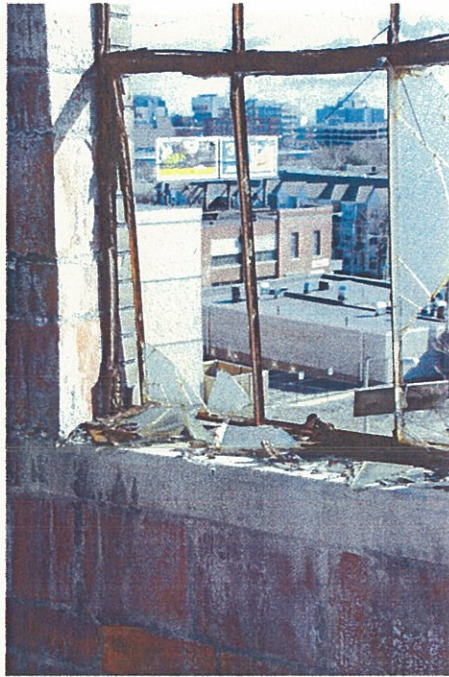
Photo G5.1 - Typical condition for 4th, 5th, & 6th Floors
Broken glass and deteriorated window frames, some located over Warren and Dudley Streets.

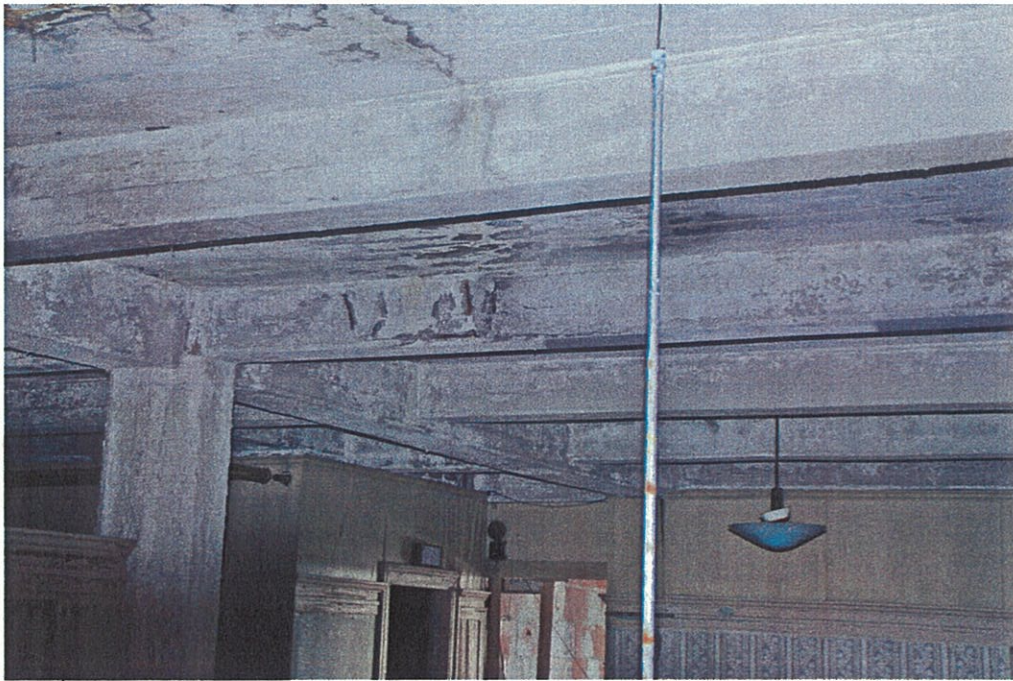
Photo G5.2 - 5th Floor
Spalling at underside of 6th floor slab and concrete-encased steel beams. Water stains follow apparent conduit to fixtures and junction boxes.

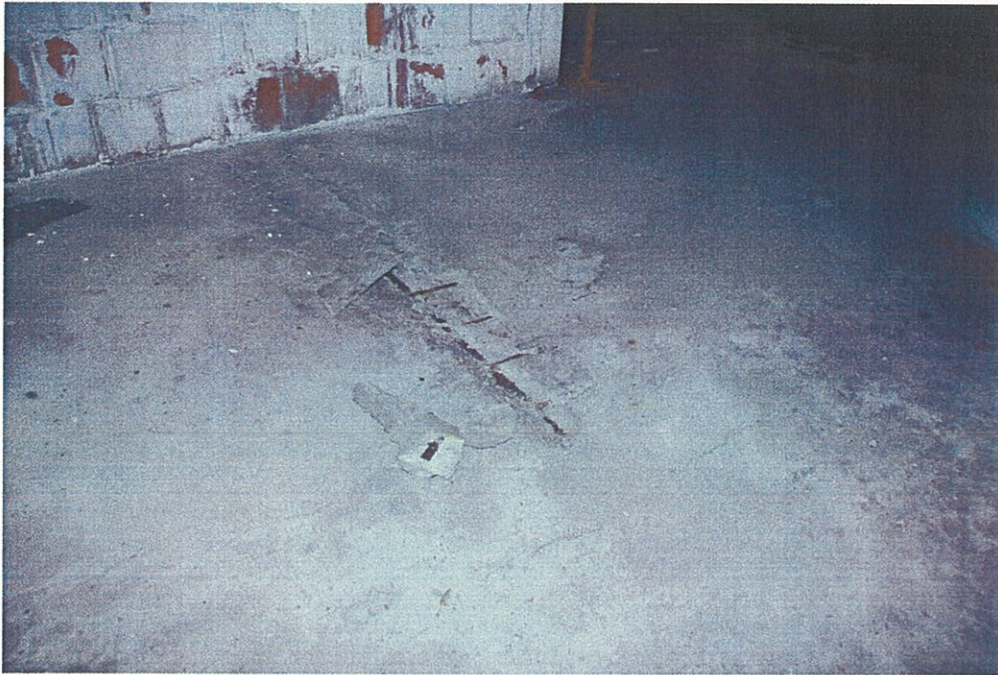
Photo G6.1 – 6th Floor
Exposed, corroded reinforcement in concrete floor.

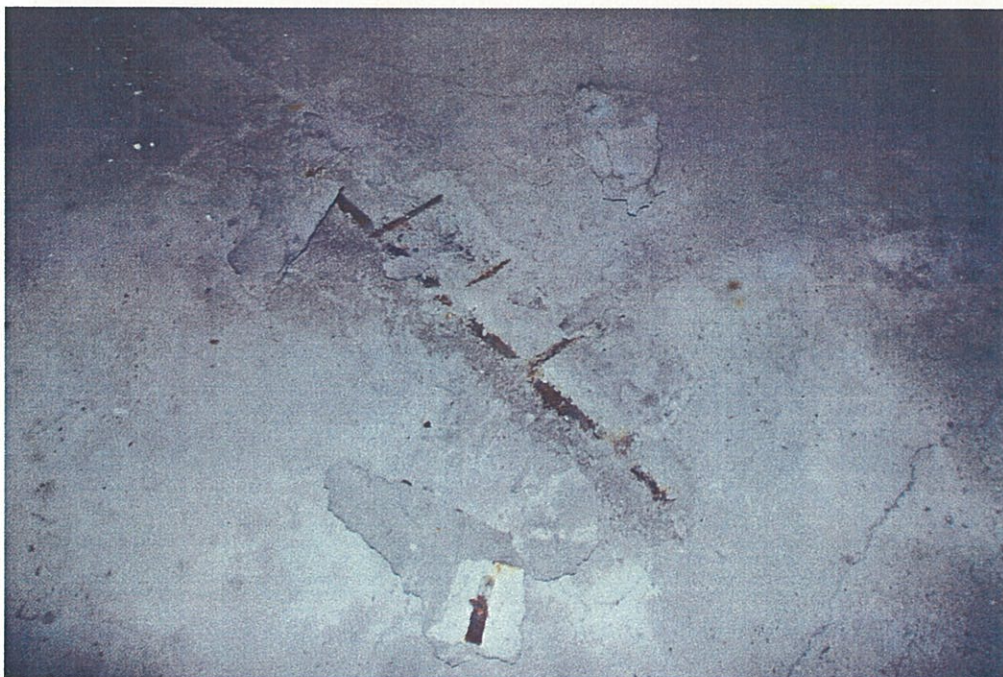
Photo G6.2 – 6th Floor
Exposed corroded reinforcement in concrete floor.

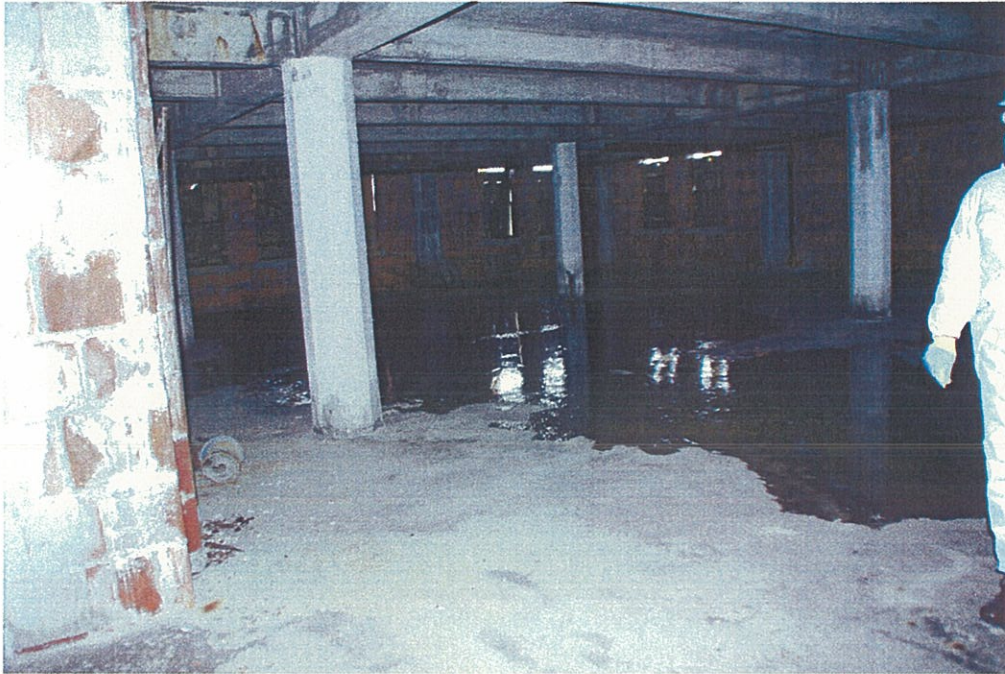
Photo G6.3 – 6th Floor

Typical beam and column layout shown. Ice present over widespread area of floor.

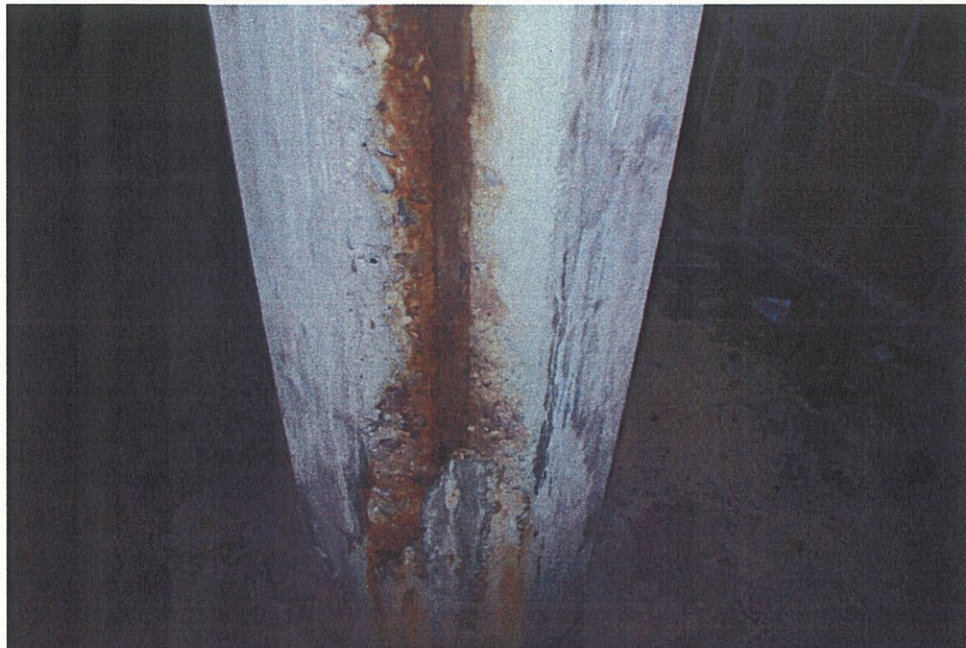
Photo G6.4 – 6th Floor

Typical delamination of concrete column encasement revealing corrosion and section loss of the steel member. Simple taps from hammer crumble additional concrete cover.

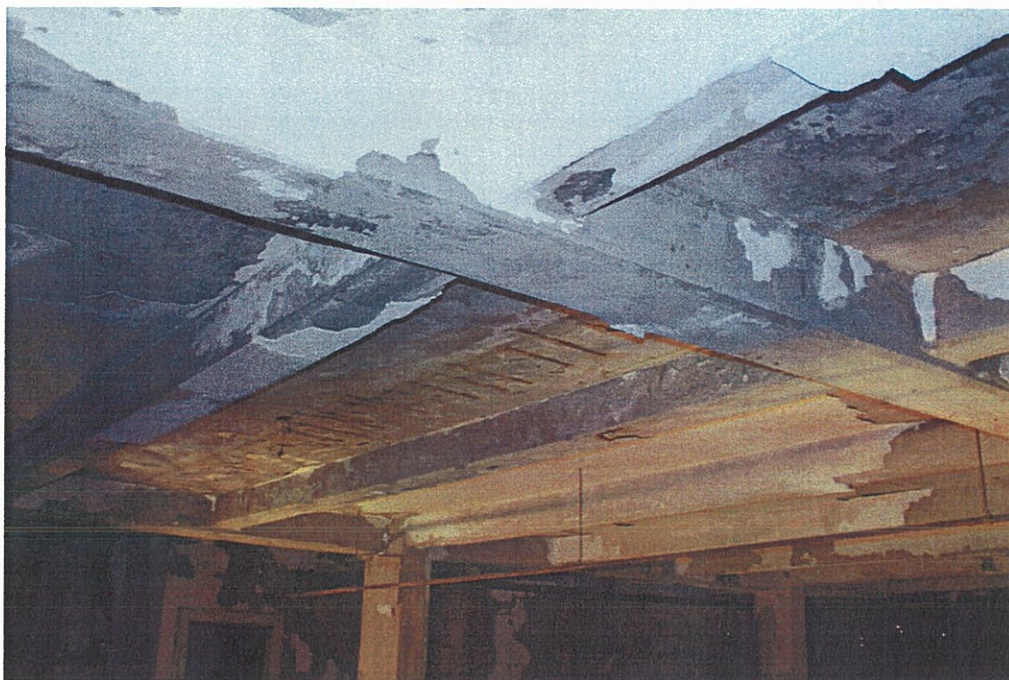
Photo G7.1 – 7th Floor

Representative condition at underside of concrete slab. Widespread evidence of water infiltration, delaminated and spalled concrete, and exposed and corroded slab reinforcement.

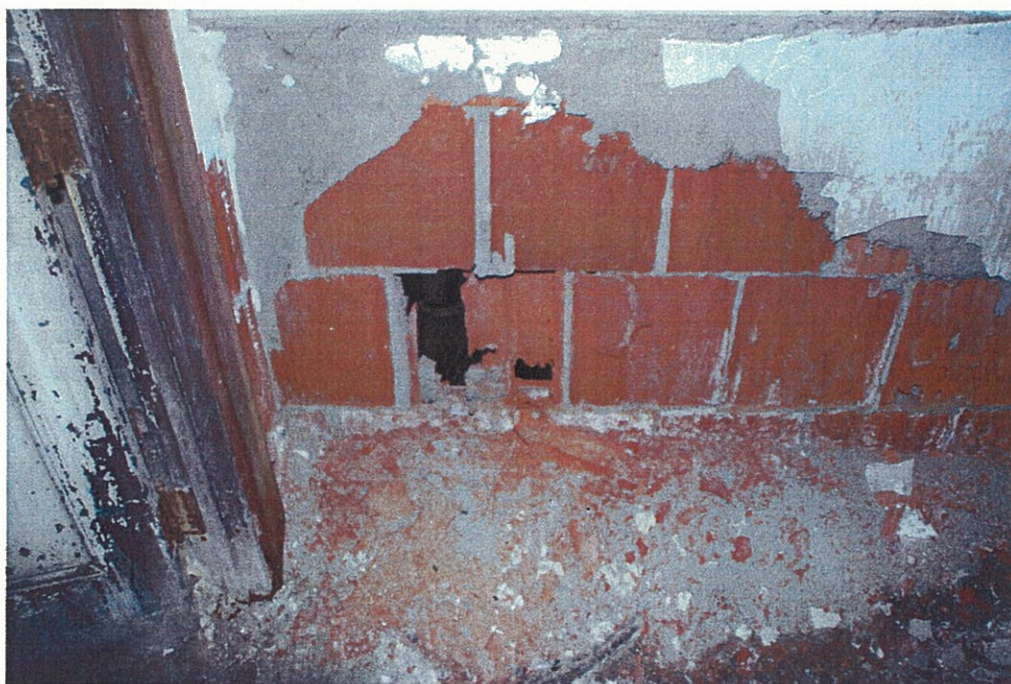
Photo G7.2 – 7th Floor

Clay masonry deterioration at interior wall.

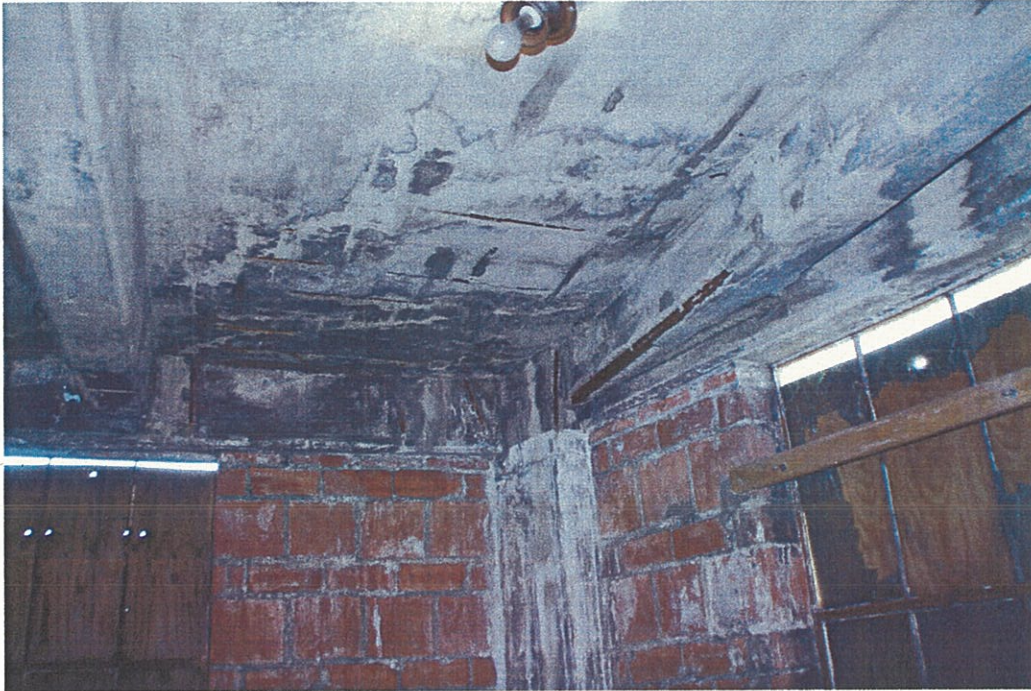
Photo G8.1 – 8th Floor

General configuration of building corner. Sample area reveals evidence of water infiltration, deterioration of underside of concrete slabs, and exposed and rusted reinforcement.

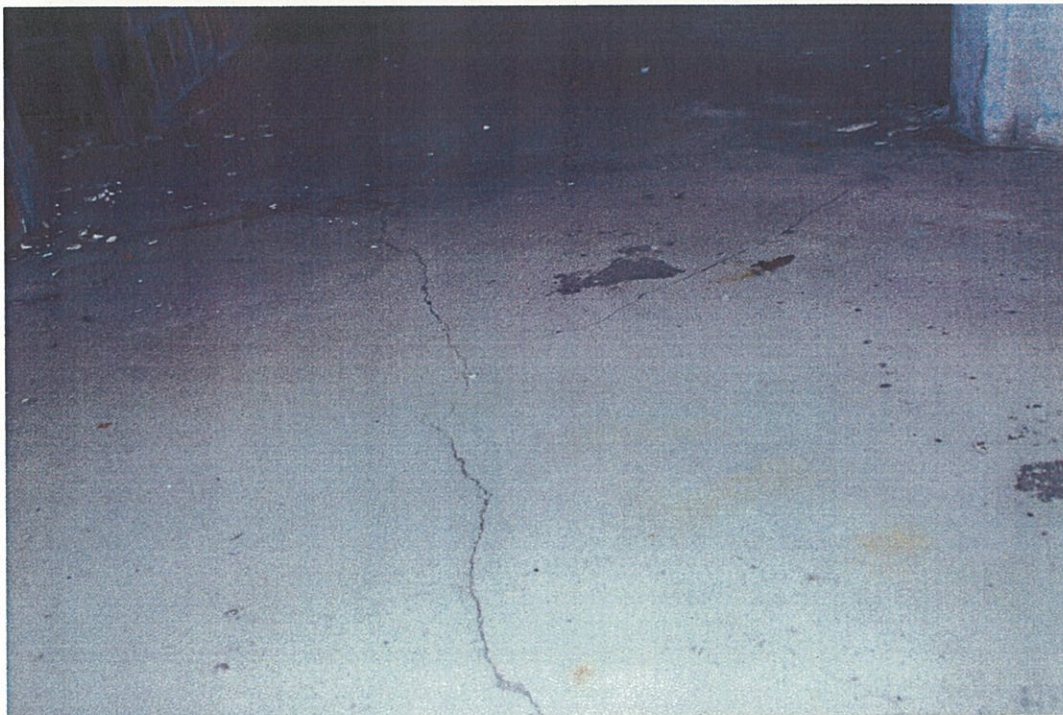
Photo G8.2 – 8th Floor

Spider cracking at top of floor slab (evident in top 3 floors of building).

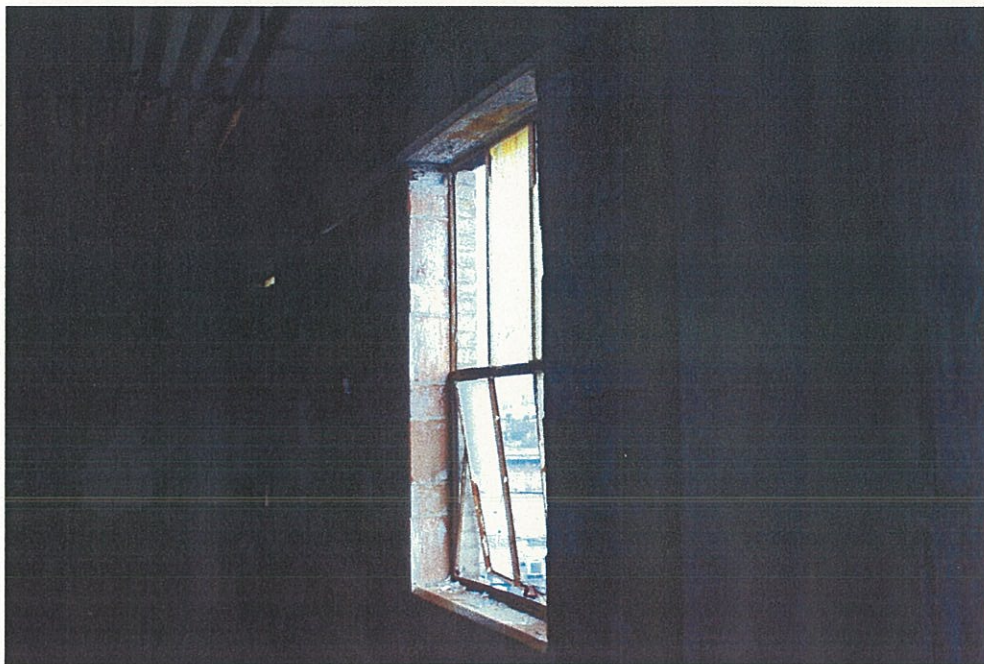
Photo G8.3 – 8th Floor
Broken glass and deteriorated window frame.

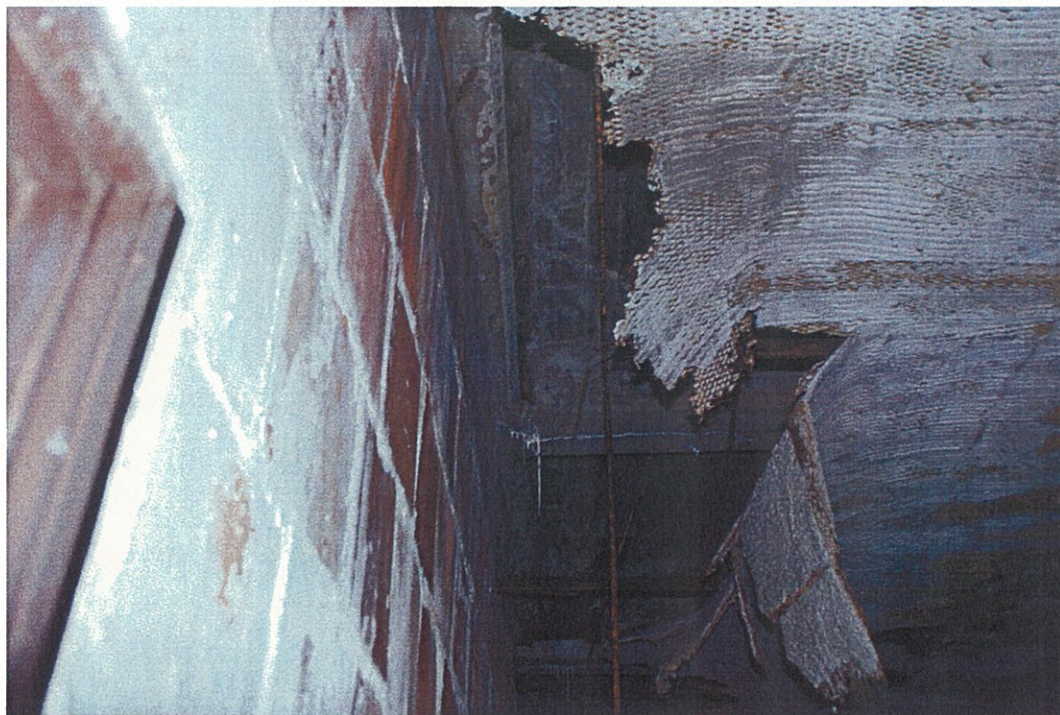
Photo G8.4 – 8th Floor
Ceiling deterioration at exterior walls.

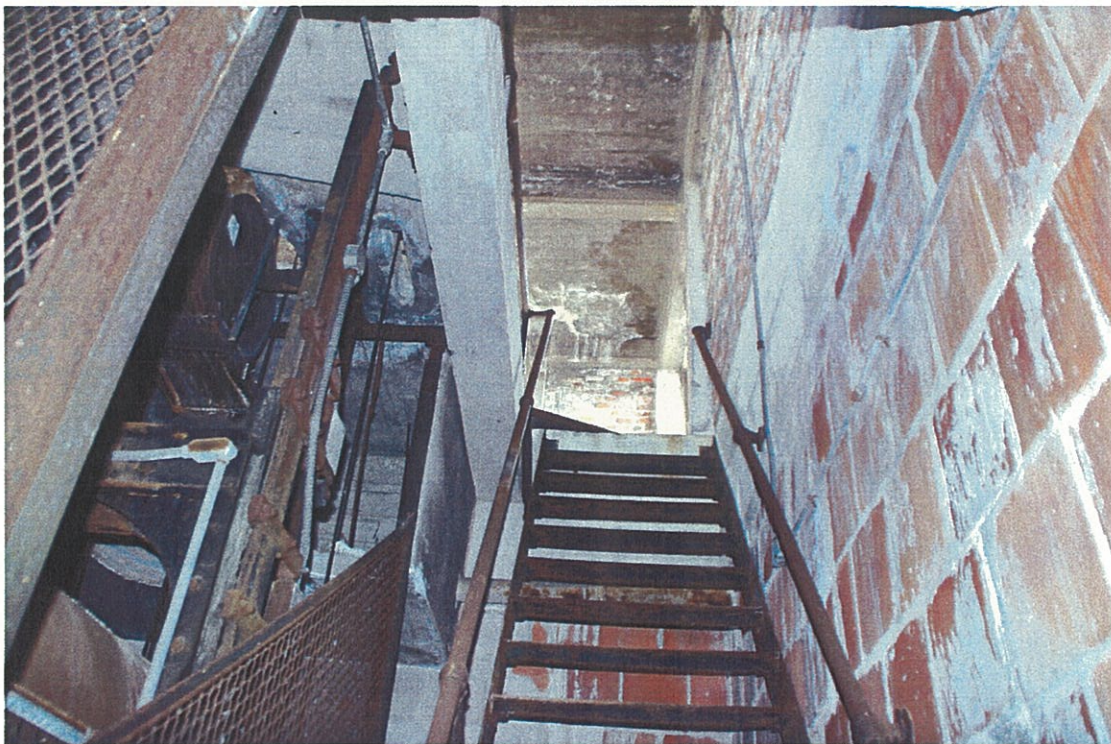
Photo G8.6 – 8th Floor
Highly deteriorated connections along stair leading to building roof.

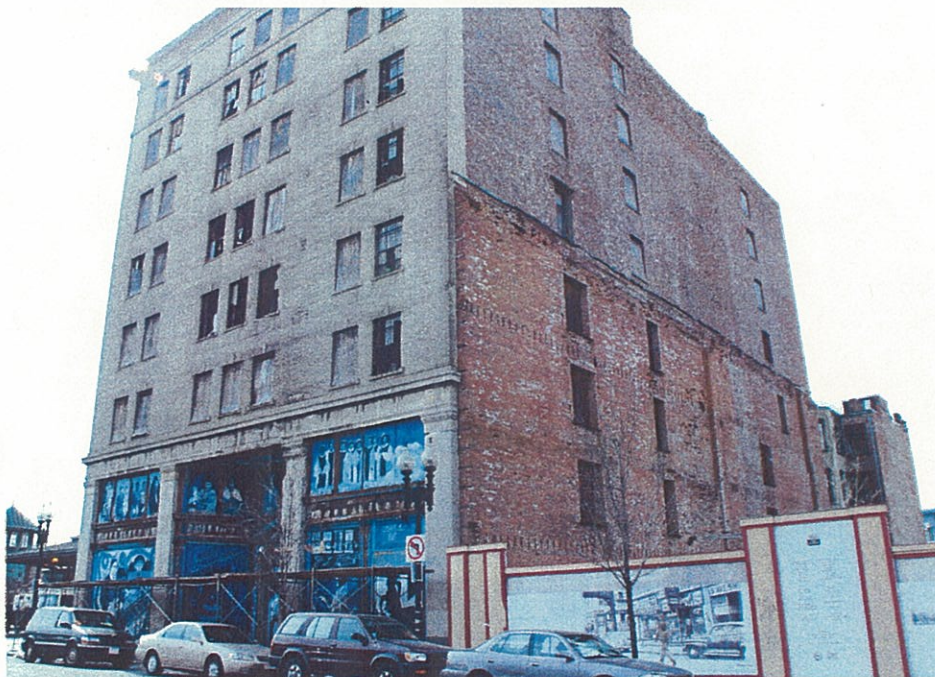
Photo GEX.2 - Elevation
Picture taken from vacant lot opposite side of Warren Street gate. Scaffolding placed along sidewalk to protect pedestrians from falling debris. Deteriorated glass and window frames can be observed.
