**Article 85 Review – Boston Zoning Code
17-19 Warren Street “Ferdinand’s Blue Store Addition”,
Roxbury, Boston, MA**

Engineering Design for Environmental Remediation
and Site Clearance at Dudley Square
Boston Redevelopment Authority
Project No. 5076

Re: Article 85 Application for 17-19 Warren Street, Roxbury, MA
New City Municipal Building
Phase 1 - Engineering Design for Environmental Remediation and
Site Clearance at Dudley Square, Roxbury, MA

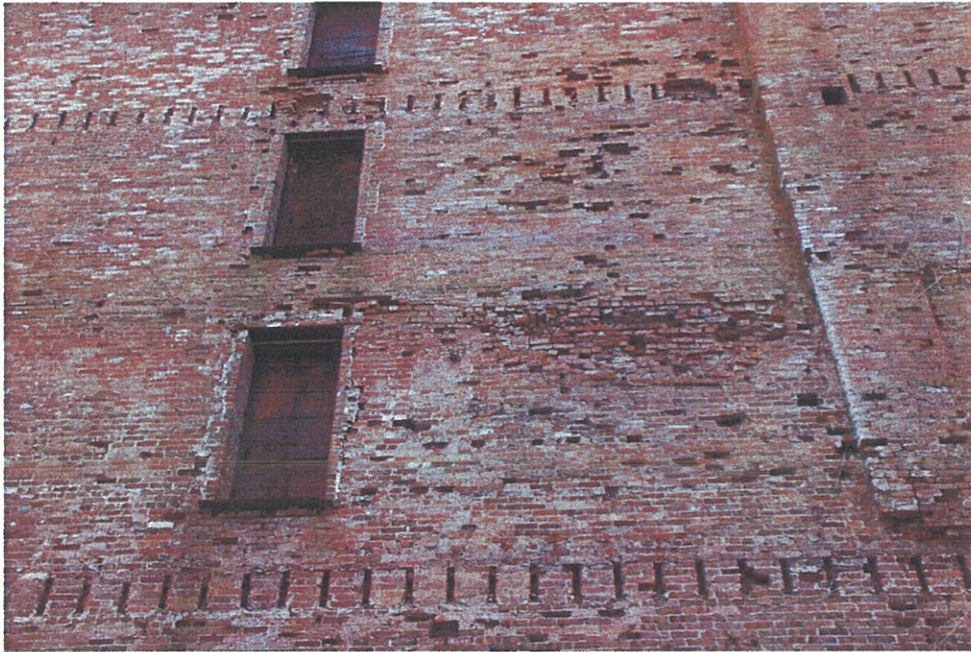
Photo GEX.3 – Exterior Wall

Exterior Masonry Walls: Exterior wall brick construction has experienced loss of mortar and in many areas bricks have been displaced beyond the plane of the wall. There are many opportunities for water to affect the masonry construction and enter the building interior. For example, the remaining party wall facing the previously-demolished building contains dozens of beam pockets that have not been filled in with mortar. These pockets allow water to collect and infiltrate into the wall structure.

Picture taken from vacant lot. Exposed beam pockets remain from previously-demolished building. Widespread masonry deterioration is present.

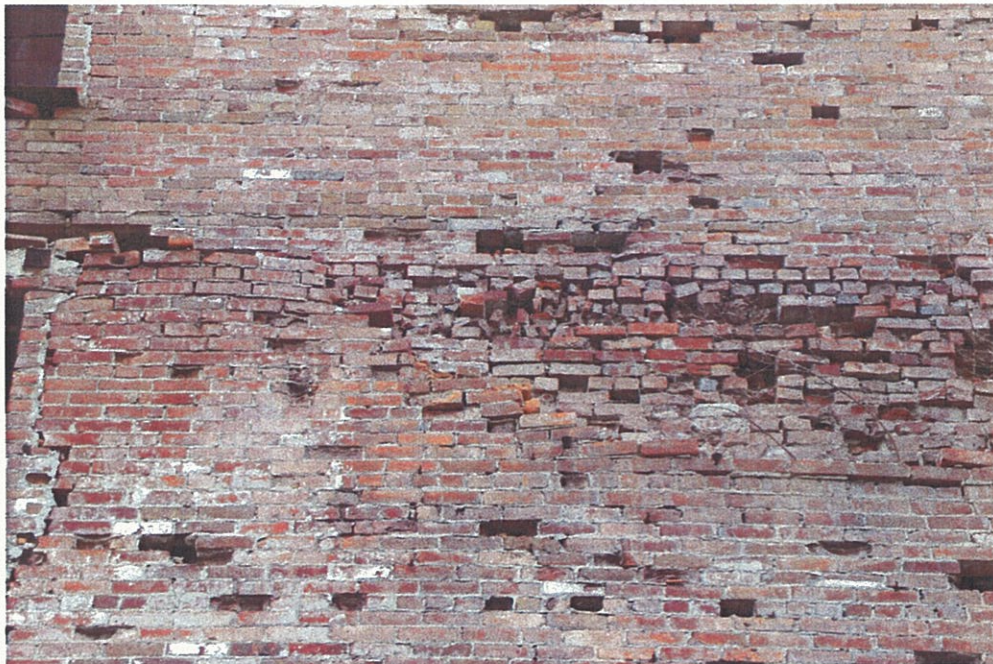
Photo GEX.4 – Exterior Wall

Picture taken from vacant lot. Significant masonry deterioration shown.

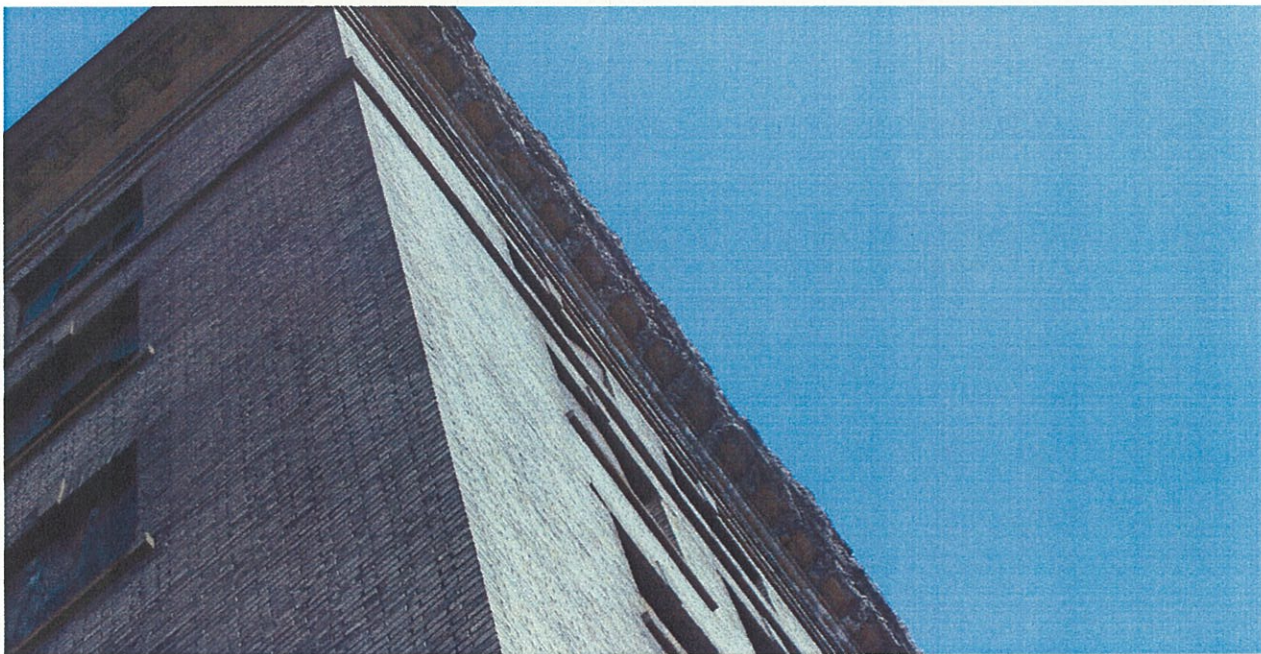
Photo GEX.6 – Elevation

Cornice: The building's cornice exhibits considerable deterioration. The building has an elaborate sheet metal cornice systems on the side fronting on Warren Street. This cornice plays no role in the structure of the building. The fall zone of the cornice hazards has been fenced off to protect the public.

Significant deterioration of cornice over Warren Street.
