Report for:
**Engineering Design Services for
Environmental Remediation and
Building Demolition at Dudley Square**

**Photo Documentation of Adjacent
Buildings and Structures**

Engineering Design Services for Environmental Remediation
and Building Demolition at Dudley Square

Roxbury, Massachusetts

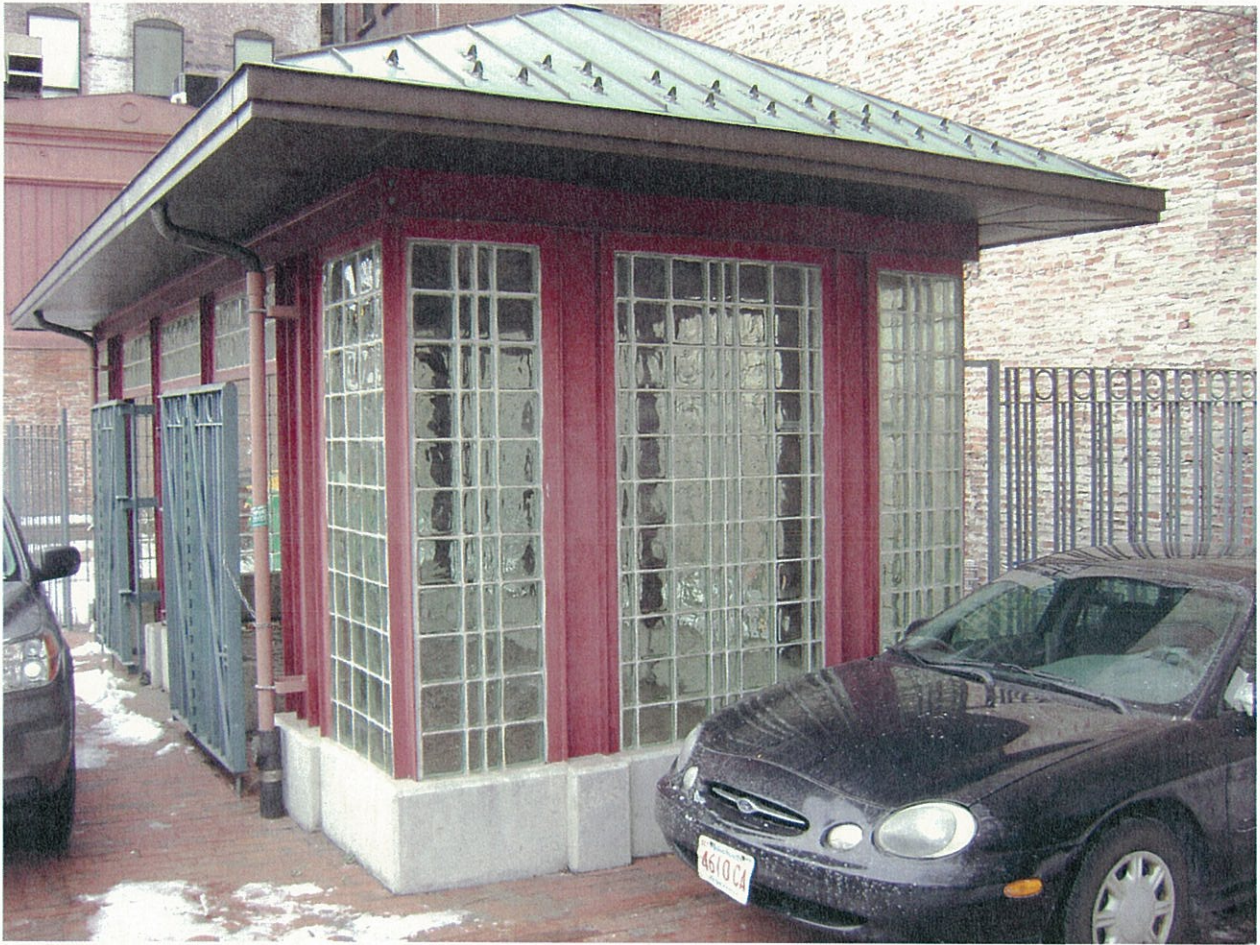
The MBTA bus shelter is in good condition, as seen in Photographs 8 and 9 on pages 10 and 11.

Photograph 8
MBTA Bus Shelter

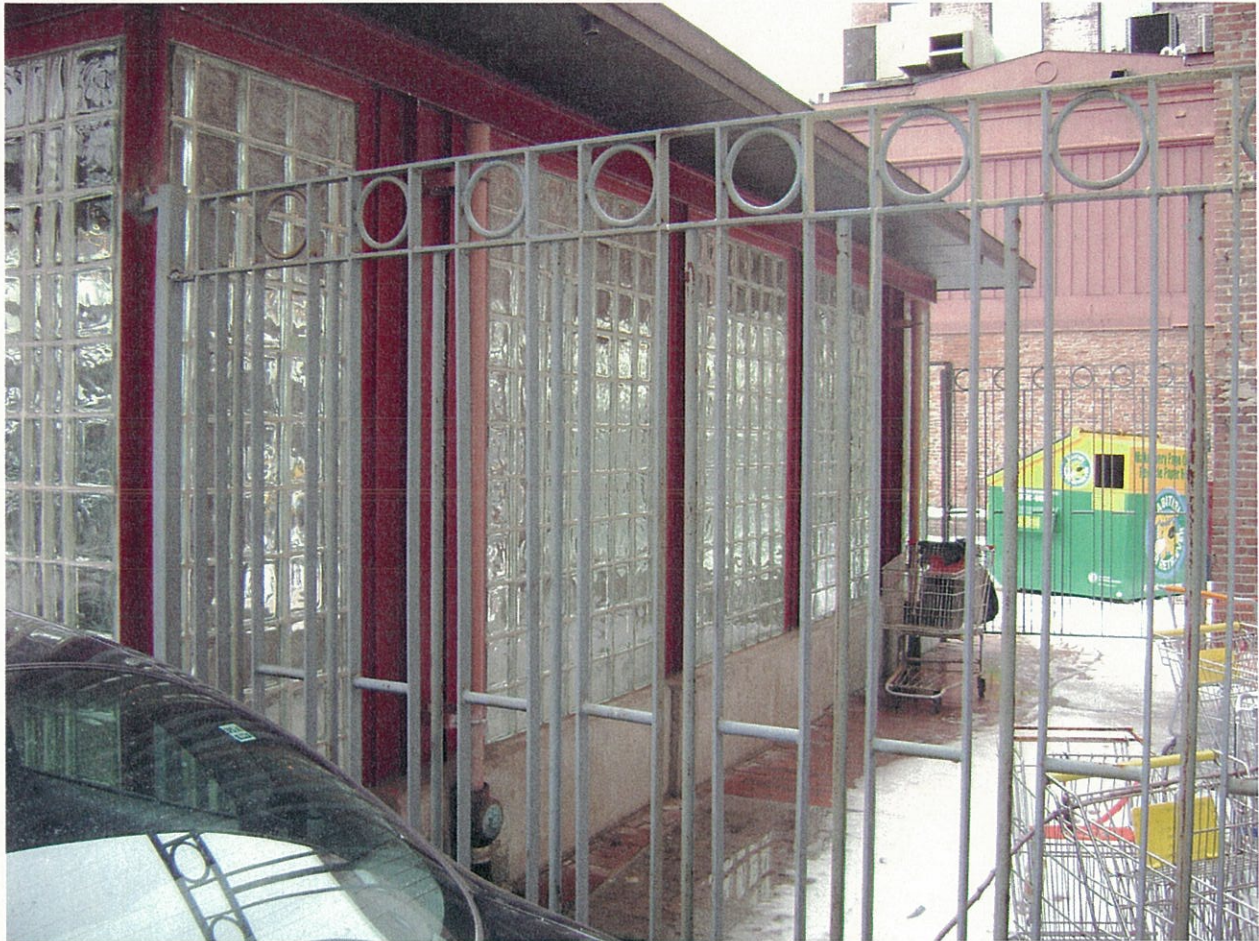
Photograph 9
MBTA Bus Shelter

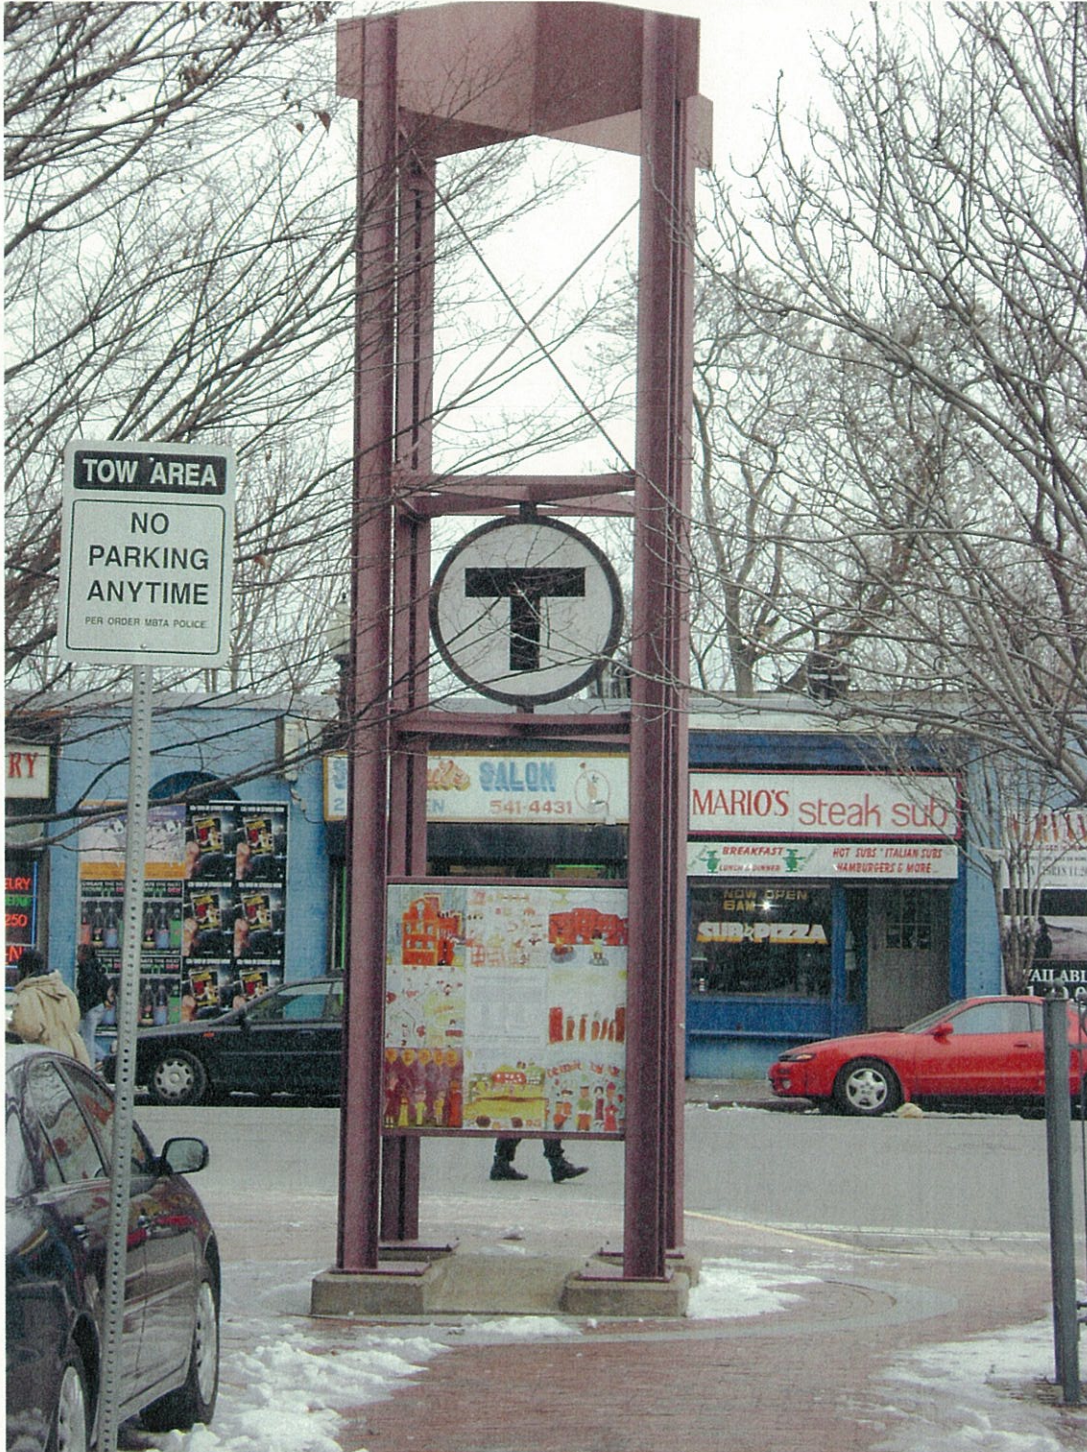
The MBTA sign is also in good general condition except for concrete deficiencies at the base of the sign. Photograph 10 on page 12 documents the sign; Photographs 11 and 12 show the cracks in the concrete base.

Photograph 10
MBTA Sign

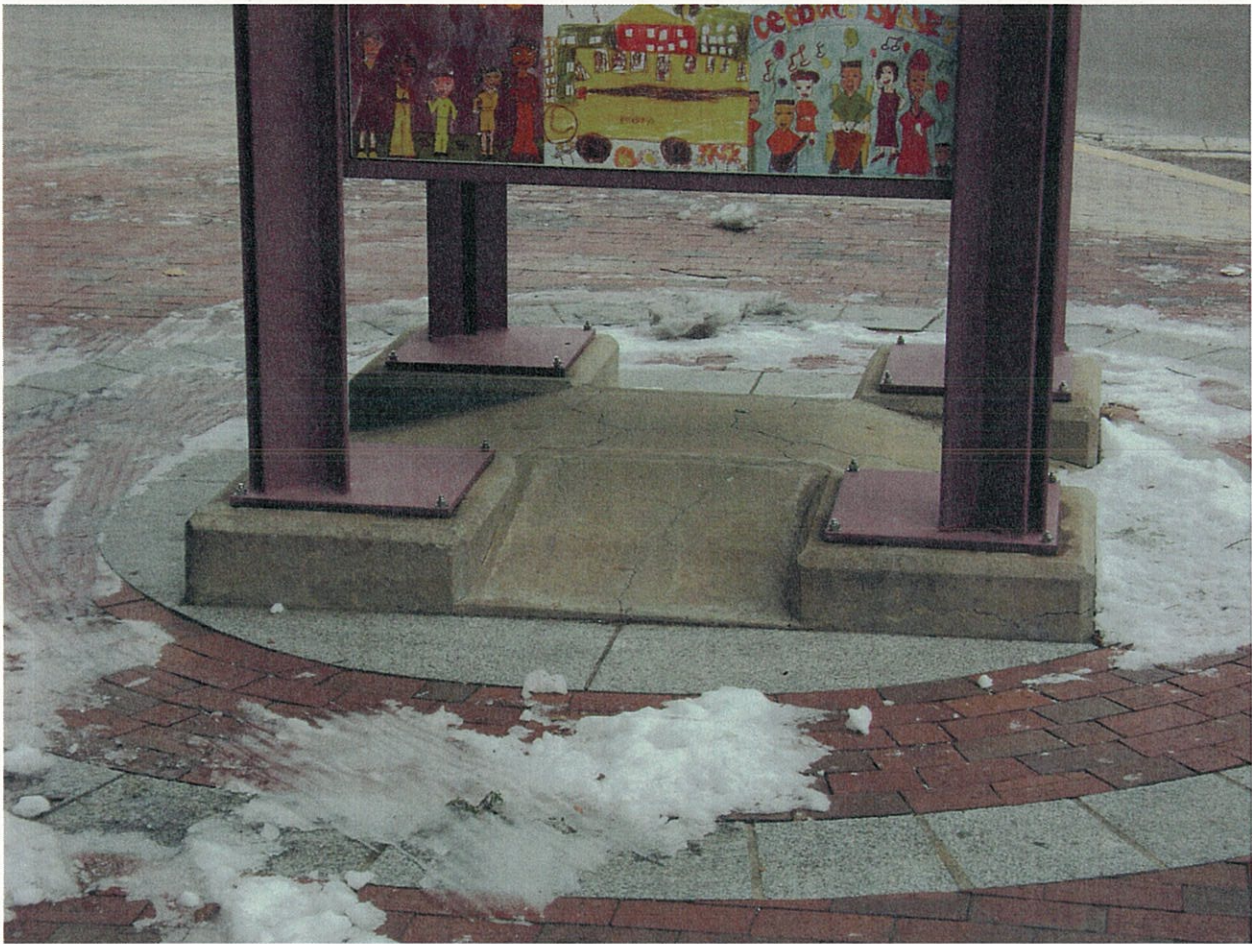
Photograph 11
MBTA Sign Base

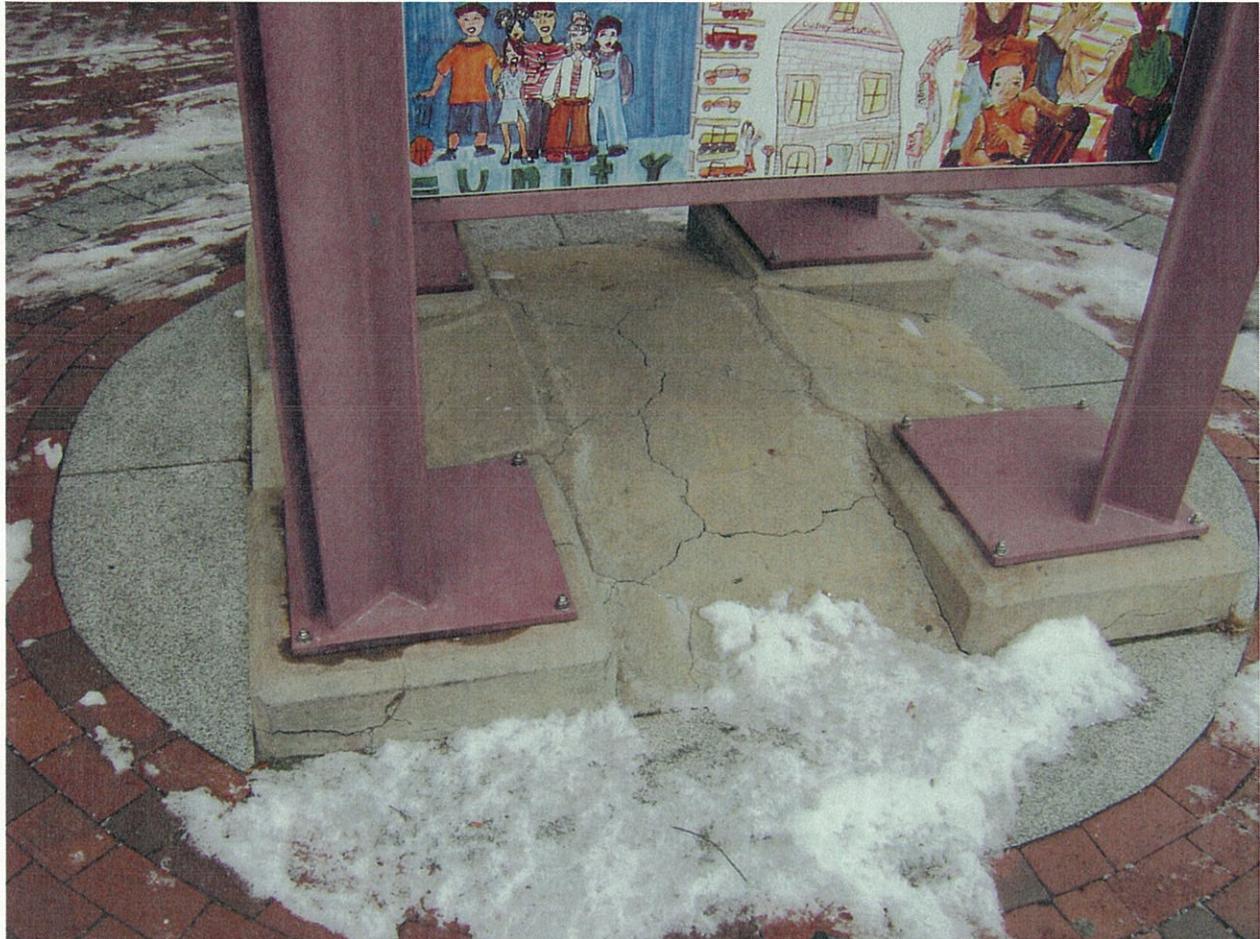
Photograph 12
MBTA Sign Base

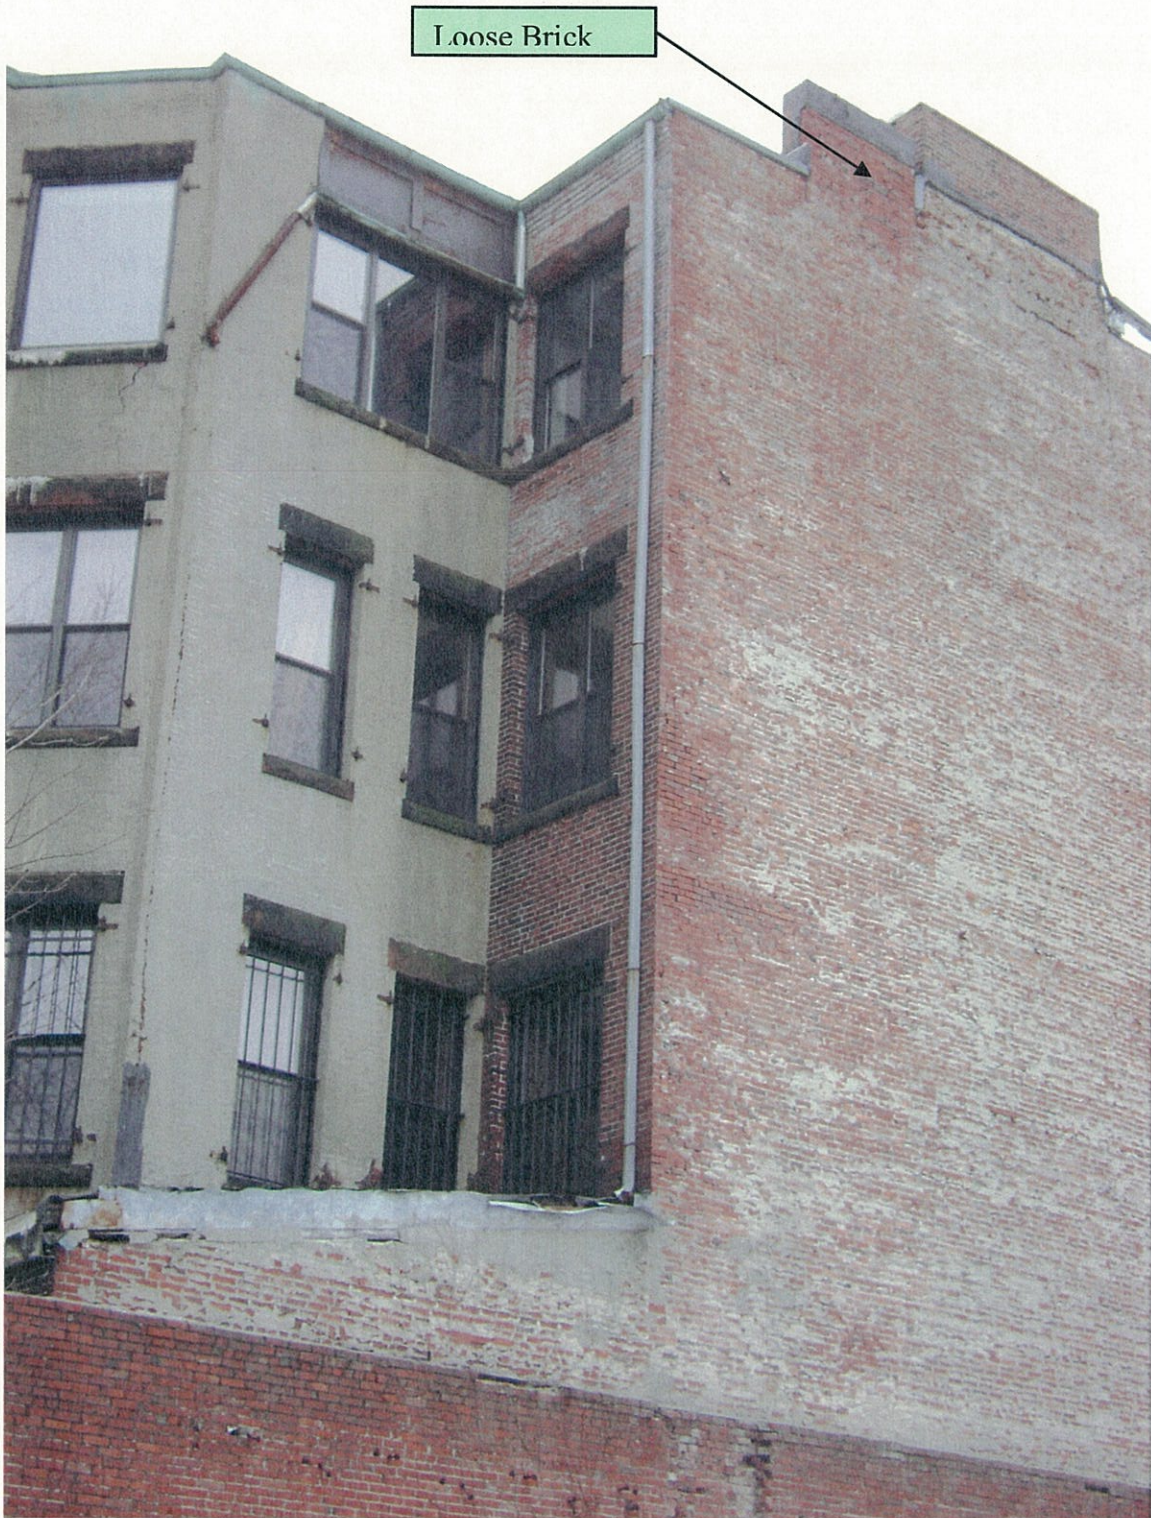
Photograph 13

- A relatively large crack below a window on the east face of the building, visible in Photograph 14.
- Lose brick resulting from deteriorated mortar near the top of the building on the north face, visible in Photographs 13 and 17.
- Also on the north face near the top of the building, loose flashing or similar material, visible in Photograph 17 and 18.
