# Pier 5

Engineering Report & Visioning Session

# Pier 5 Waterfront Inspection and Assessment

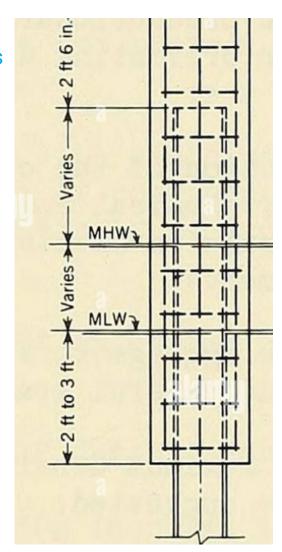
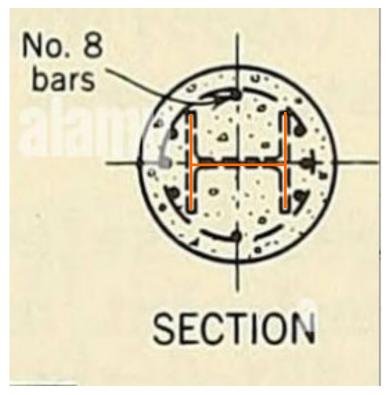
- H-Piles H-shaped steel members. Pier 5 piles are assumed to be H-14x102 piles, approximately 14" "H" made of just under ¾" steel.
- H-Piles originally encase in rebar reinforced concrete.
- Most of concrete has deteriorated, exposing steel H-piles and reinforcing rebar.
- Falling rebar and concrete, and tight spacing of the pilings, limited safe access and inspection to the outer piles.
- H-Piles are not one continuous pile from the deck down to the bottom, but are spliced with welded plates. Typical of WWII construction.

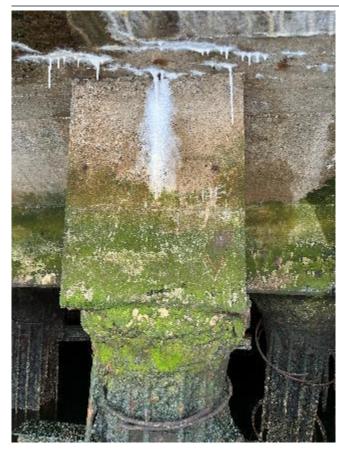
Minor Damage 8% of Caps **Small Cracks**

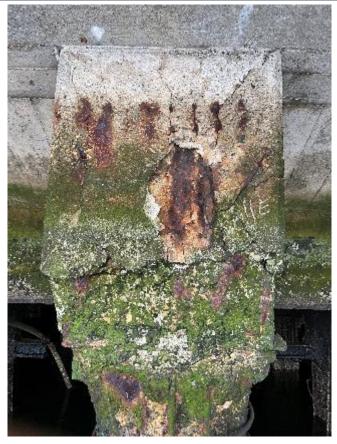
Major Damage 74% of Caps Exposed Reinforcement >30% Section Loss

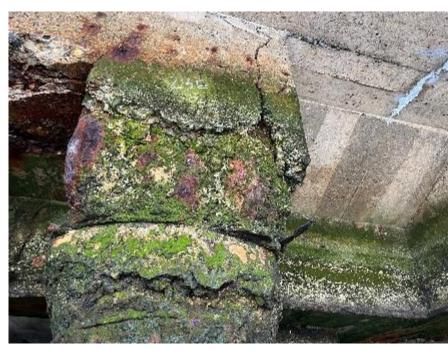
Severe Damage 18% of Caps

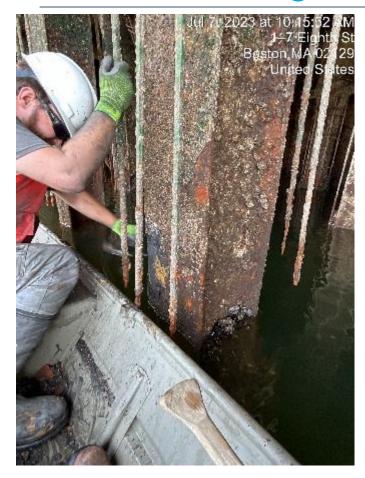
Minor Damage 0%-15% Steel Loss 30% of Piles

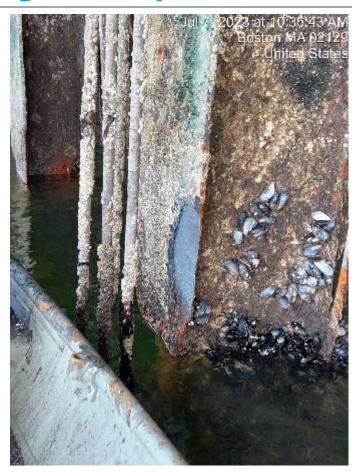
Major Damage 30-50% Steel Loss 21% of Piles

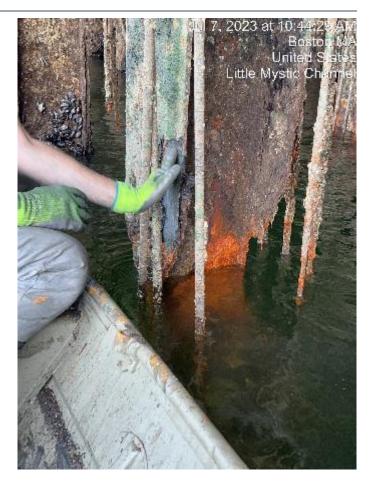
Severe Damage 50%-100% Steel Loss 36% of Piles

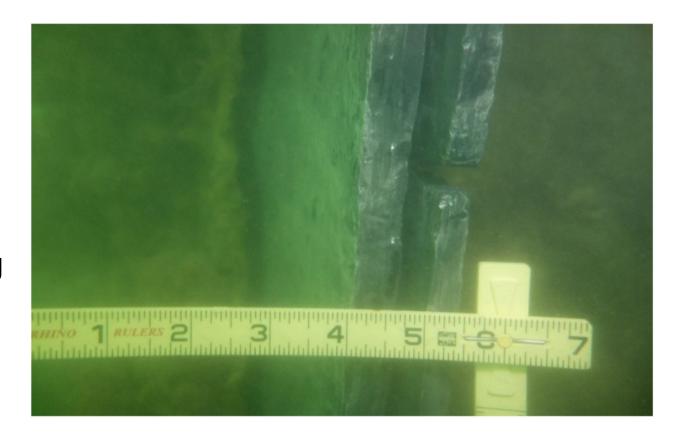
## **Splice Plate Conditions**

- 2017 dive inspection showed conditions of total loss of H-Pile splice plate welds.
- Foth final assessment does not use this information.
- Should an alternative requiring rehabilitation of existing piles be pursued, condition of the spliced piles will need further investigation.
