**DATE** November xx, 2012  
**TO** Boston Region Metropolitan Planning Organization  
**FROM** Mark Abbott and Bill Kuttner  
MPO Staff  
**RE** Safe Access to Transit for Pedestrians and Bicycles: Morton Street  
Commuter Rail Station

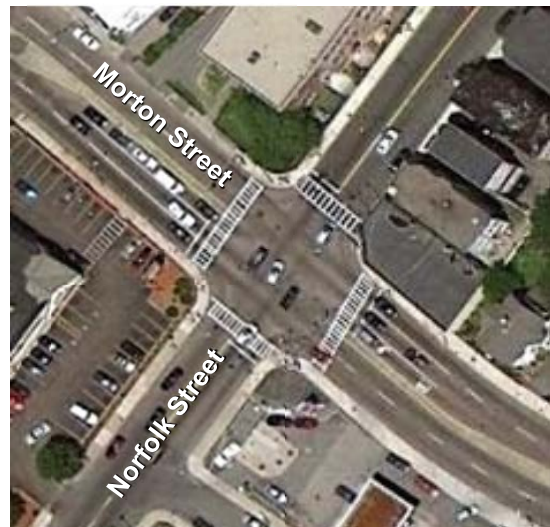
**Morton and Norfolk streets**

Traffic on Morton Street has left-turn signals in both directions. Norfolk Street from the south has a right-turn signal that shows green during the Morton Street left-turn phase. Right-on-red turns are not permitted.

Norfolk Street has one wide lane in each direction, allowing right-turn storage at the intersection and on-street parking further away. Morton Street has two travel lanes in each direction. A fifth, left-turn lane and a narrow, granite rumble-strip center divider consume any spare pavement on Morton Street at this intersection. Parking is allowed on Morton Street west of Norfolk Street, but not to the east, which is the direction of the commuter rail station. There are no bicycle-specific features.

While traffic speeds appeared to be within the speed limit, traffic could be characterized as “hurried,” with jackrabbit starts and tailgating. Vehicles were observed passing the through-traffic queue on the rumble strip in order to reach the short left-turn lane. After

the left-turn signal had turned red, some vehicles were observed turning left, apparently if the driver perceived what he or she considered a safe opportunity.

All legs of this intersection have ladder-style crosswalks, although they are faded. All of the sidewalks were in acceptable condition except on the northwest corner adjacent to the bus stop. The ramps were in acceptable physical condition. There were two on each corner, but only one had a detectable warning pad. There is a concern about the pedestrian signal buttons: on two corners there are large audible buttons, but on the other two corners there are old-style buttons. In addition, the audible buttons were not programmed to say "wait." Pushing a button results in a dedicated pedestrian phase, but there is no countdown feature. The pedestrian signal timing is 20 seconds, which is sufficient for the lengths of crossings at this intersection.

- Upgrade pedestrian signals so that they are consistent at all corners of the intersection, including being fully accessible and having countdown features. A uniform set of equipment and protocols for all pedestrian signal equipment along Morton Street will help pedestrians acclimate to the safe and approved alternatives for crossing of this busy corridor.
- Restripe the existing crosswalks.
- Install ADA-compliant detectable warning pads on all pedestrian curb-cut ramps.
- Stripe shared-lane markings (for bikes and motor vehicles) and install "Bicycles May Use Full Lane" (MUTCD R4-11) signs along Morton Street.

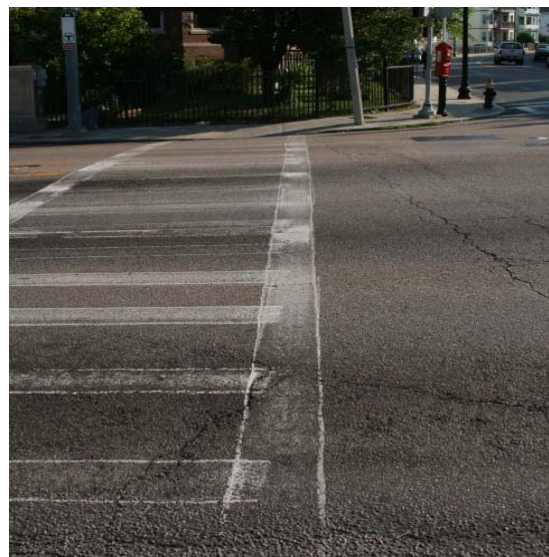
**Faded crosswalk at intersection of Morton and Norfolk streets**

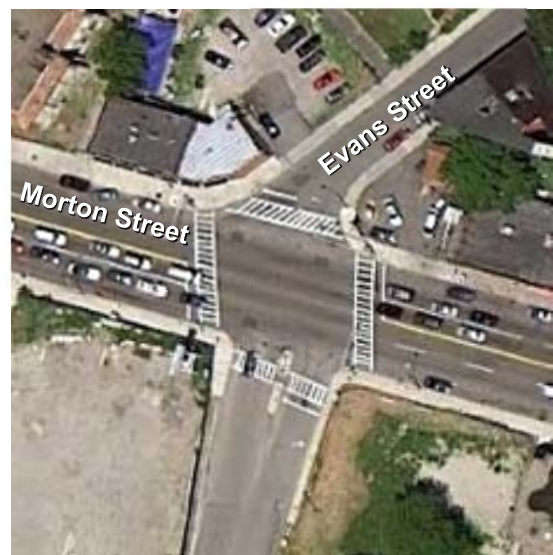
**Morton and Evans streets**

Immediately east of Norfolk Street, Morton Street becomes a bridge as it rises to cross the commuter rail line, and then descends to a signalized intersection with Evans Street as it approaches the bridge. Evans Street approaches Morton Street from the north and has two travel lanes in each direction. A wide commercial driveway approaches Morton Street from the south. The only traffic generator for the driveway at this time is a large plumbing and heating supplier, which could account for trucks and vans making up a large portion of the traffic. Accessible parking and a kiss-and-ride lane at the station will use this driveway when full two-track service resumes on the Fairmount Line. Also, there is a Dunkin' Donuts under construction, as well as a small development parcel, that will utilize this driveway.

During the site visit, traffic was observed to be light on both Evans Street and the driveway. The driveway entrance is wide and has a short median, which is helpful for channeling trucks into and out of the driveway. There are no left-turn signals, and right-on-red is permitted throughout this intersection. There are no bicycle-specific features.

Traffic on Morton Street is heavy and clearly "hurried," as observed during the site visit. Eastbound traffic appeared to possibly be exceeding the speed limit. Racing yellow lights and trying to beat on-coming traffic to make a left turn were observed to be commonplace.

Sidewalks, ramps, and crosswalks are in good condition, although one ramp has collected substantial debris. As at Norfolk Street, the pedestrian signals are problematic. Three corners have audible buttons, and one corner has an old-style button. The audible buttons tell when to walk, but are currently programmed for a quiet hum rather than the more intrusive chirp, despite having commercial uses on all four corners. Also, the pedestrian phase has been programmed to occur automatically every cycle, despite few pedestrians crossing. This loss of green time on Morton Street may exacerbate the practice of hurried driving. The pedestrian signal timing is 20 seconds, which is sufficient for the lengths of crossings at this intersection.

- Ensure that sidewalks and roadways are well maintained and clear of debris and excessive dirt.

- Upgrade pedestrian signals so that they are consistent with the pedestrian signals at Morton and Norfolk streets; include fully accessible and countdown features. A uniform set of equipment and protocols for all pedestrian signal equipment along Morton Street would help pedestrians acclimate to the safe and approved alternatives for crossing of this busy corridor.
- Sign and stripe five-foot bike lanes in both directions along Morton Street, from Evans Street to Norfolk Street. Although shared-lane markings would be required for the majority of Morton Street due to right-of-way constraints, bike lanes would be valuable along this section of Morton Street because of the reduced visibility, since traffic rises and descends crossing the Fairmount Line tracks.

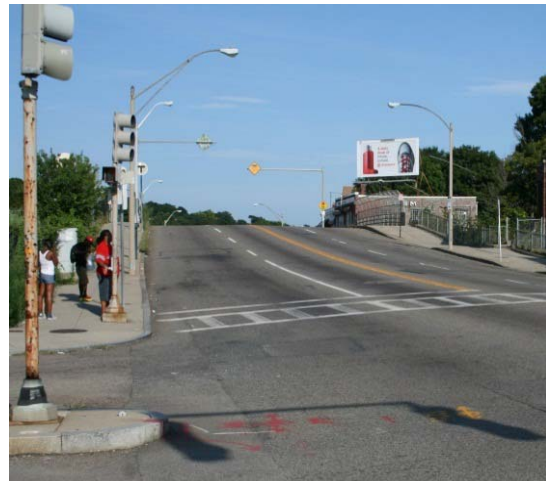
**Morton and Evans streets: Wide ROW to accommodate bike lanes**

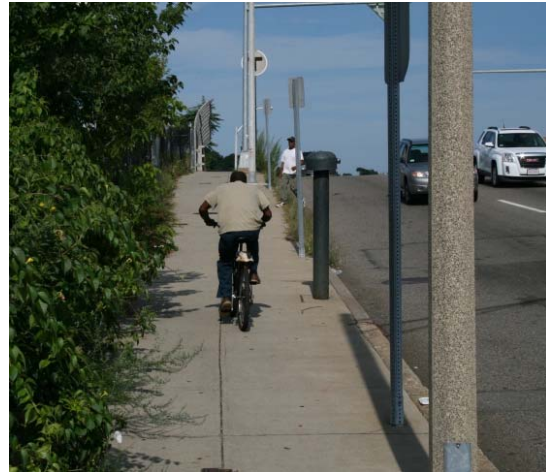
**Morton Street: Bicyclist riding on sidewalk**

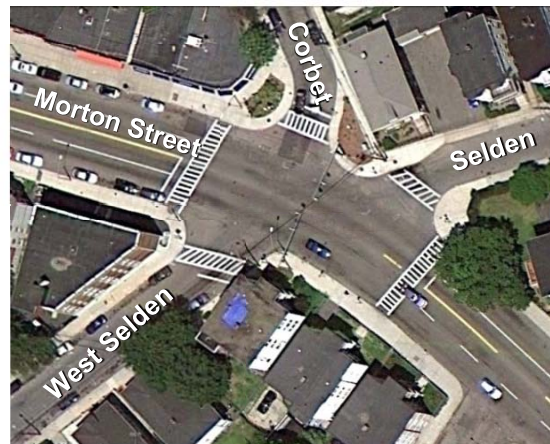
**Morton, Corbet, Selden, and West Selden streets**

About 1,800 vehicles approach on Morton Street during the AM peak hour and about 9% turn onto the side streets, evenly split between left and right turns. Of the 265 vehicles approaching from the side streets, over 60% turn onto Morton Street. Frequent conflicts result from side street traffic making left turns, exacerbated by the occasional

vehicle from Corbet Street making a hard left turn to Selden Street. There is significant truck traffic on Morton Street, but no trucks were observed on the side streets. Rights-on-reds are permitted and there are no specific bicycle features.

Morton Street has four travel lanes and on-street parking on both sides of the street. During the site visit, traffic appeared to be within the speed limit, but seemed hurried with both jackrabbit starts and tailgating observed.

Sidewalks, ramps, and crosswalks are in good condition. As is the case in the other two signalized intersection, the five corners provide a mix of audible and old-style crossing buttons. Pushing a button results in a dedicated pedestrian phase, but there is no countdown feature. The pedestrian signal timing is 21 seconds, which is sufficient for the lengths of crossings at this intersection.

- Upgrade pedestrian signals so that they are consistent with the pedestrian signals at Morton and Norfolk streets, including with fully accessible and countdown features. A uniform set of equipment and protocols for all pedestrian signal equipment along Morton Street will help pedestrians acclimate to the safe and approved alternatives for crossing of this busy corridor.
- Stripe shared-lane markings (for bikes and motor vehicles) and install “Bicycles May Use Full Lane” (MUTCD R4-11) signs. The width of Morton Street to the west and east of this intersection, and the presence of on-street parking, suggests that shared-lane markings would be the appropriate method to indicate and encourage the use of Morton Street by bicycles. Given the size of the intersection, the shared-lane markings should continue through the intersection as bicycle priority lanes (picture, right).

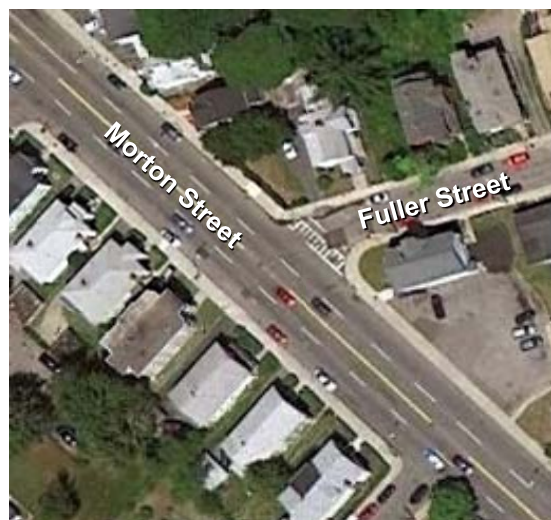
### Morton and Fuller streets

There were 3 crashes, including one with a pedestrian, at the intersection of Morton Street and Fuller Street, which is located approximately three blocks southeast of the Morton Street Station. Fuller Street is a one-way street that approaches Morton Street from the north, ending at a “T” intersection and a stop sign. The double yellow line in the middle of Morton Street has a gap, allowing lawful left turns. Only a handful of vehicles were seen using Fuller Street, all of which made right turns.

The heavy traffic on Morton Street at this location moves rapidly here at roughly the midpoint between two major intersections. While parking is permitted on Morton Street, few vehicles were parked in the vicinity, effectively widening the right travel lane and inviting higher speeds. Morton Street traffic included a number of trucks, and there are no specific bicycle facilities.

The sidewalks are wide and in good condition. The ramps are also in good condition, although the pavement adjacent to the concrete ramp on one corner has subsided more than an inch. There is a crosswalk painted across Fuller Street, but none across Morton Street.

- Stripe shared-lane markings (for bikes and motor vehicles) and install “Bicycles May Use Full Lane” (MUTCD R4-11) signs along Morton Street east of Selden Street. The presence of on-street parking that is not fully utilized is especially beneficial to cyclists. Shared-lane markings striped along the ample right lane in this section may calm traffic. The paucity of parked cars would also afford cyclists

more room and allow them to focus their vigilance on a limited amount of parked cars and parking activity.

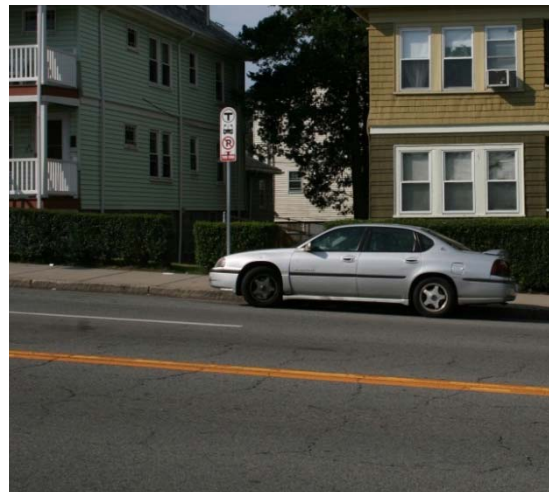
The most dangerous circumstance at this intersection is the presence of a pair of MBTA bus stops on each side of Morton Street at Owen Street, 140 feet east of Fuller Street and also lacking a marked crosswalk over Morton Street. While use of an unmarked crosswalk is permitted, this would be a less-safe option for crossing Morton Street, especially if pedestrians are rushing to catch an approaching bus. Pedestrian traffic in this area, transit related and otherwise, would probably not warrant the installation of a marked crosswalk.

**Morton and Fuller streets:  
Midblock bus stop with no  
crosswalk**

- Eliminate the existing bus stops at Owen Street and replace with new bus stops at the junction of Morton Street and Gallivan Boulevard.

Bus stops are not currently practical at this location because of the requirement that eastbound buses merge left to continue their routes on Gallivan Boulevard. However, a recently completed Intersection Alternatives Design Report (MassDOT, June, 2012) proposes improved traffic channels and crosswalks at the junction of Morton Street and Gallivan Boulevard. Incorporating new MBTA bus stops into the final design is recommended as a high priority for both safety and user benefits.

East of Selden Street, bus stops for routes 21 and 26 are spaced an average of 575 feet apart. Since buses cannot currently stop at the junction of Morton Street and Gallivan Boulevard, the closest stops are at the remote and problematic Owen Street to the west, and at Wilmington Avenue to the east. Replacing the Owen Street and Wilmington Avenue bus stops with one stop at the junction of Morton Street and Gallivan Boulevard will speed bus service through the net elimination of one stop, and add service at an important neighborhood nexus. With this modification, the average stop spacing would be 863 feet, and a preliminary analysis suggests that the maximum spacing would be about 955 feet, which falls within MBTA's bus stop spacing guidelines.
