Memorandum

Re: A Street/Binford Street
Traffic/Intersection Assessment

**GE Headquarters Project
Boston, Massachusetts**

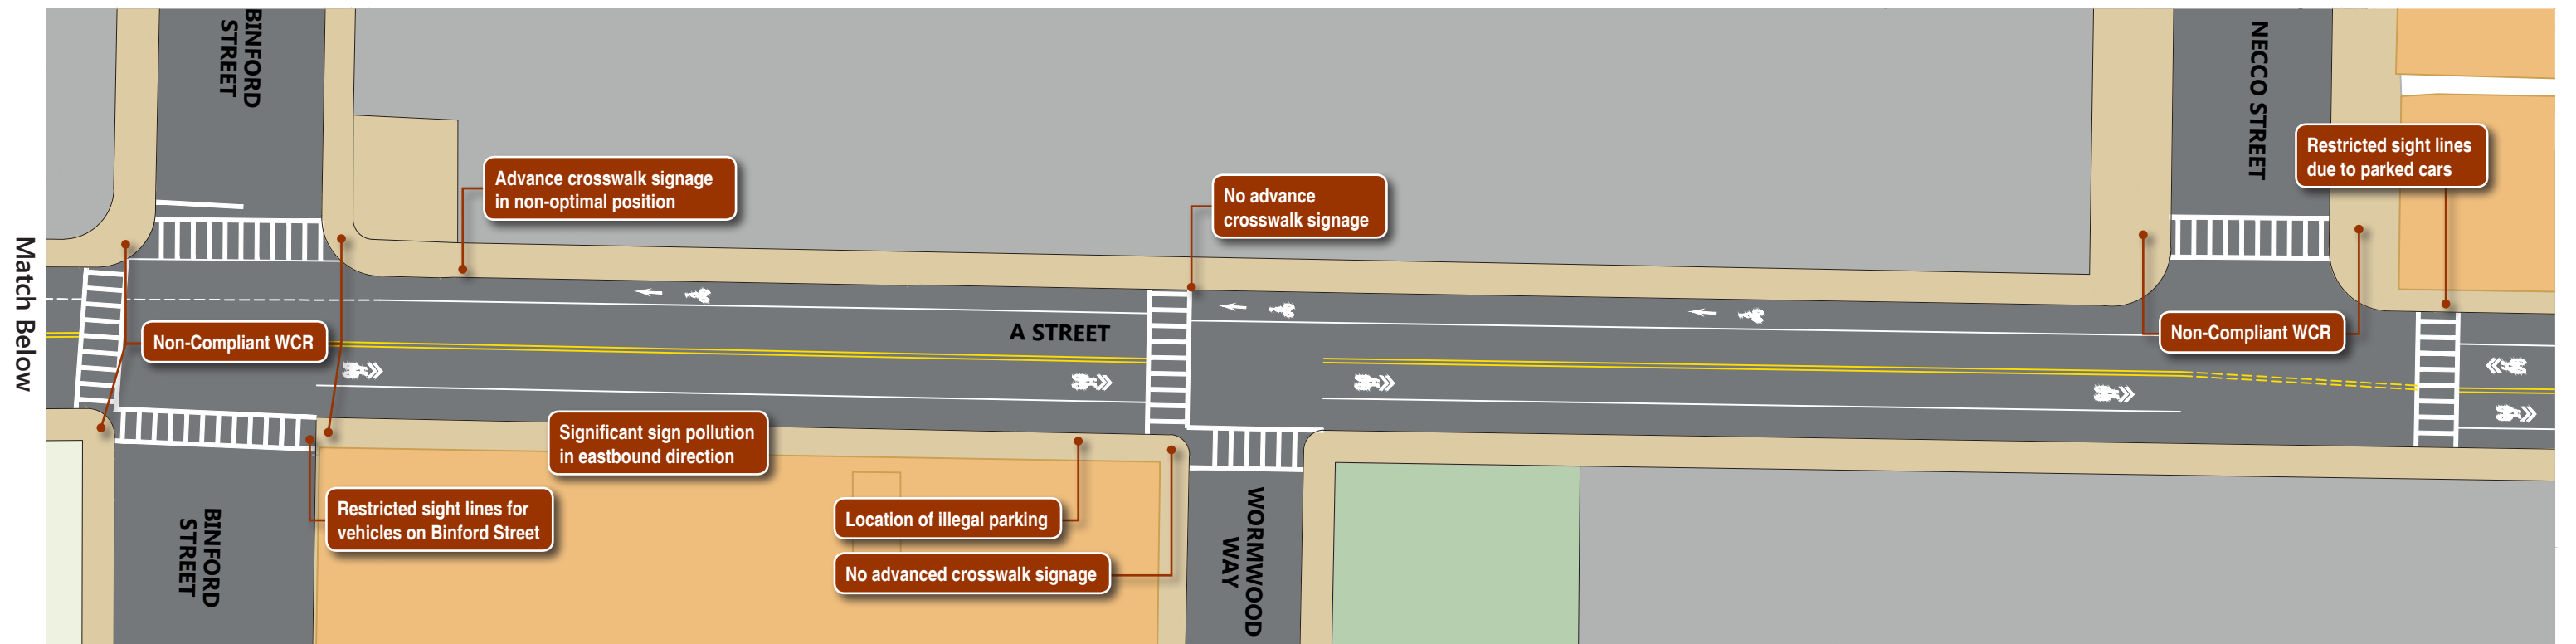
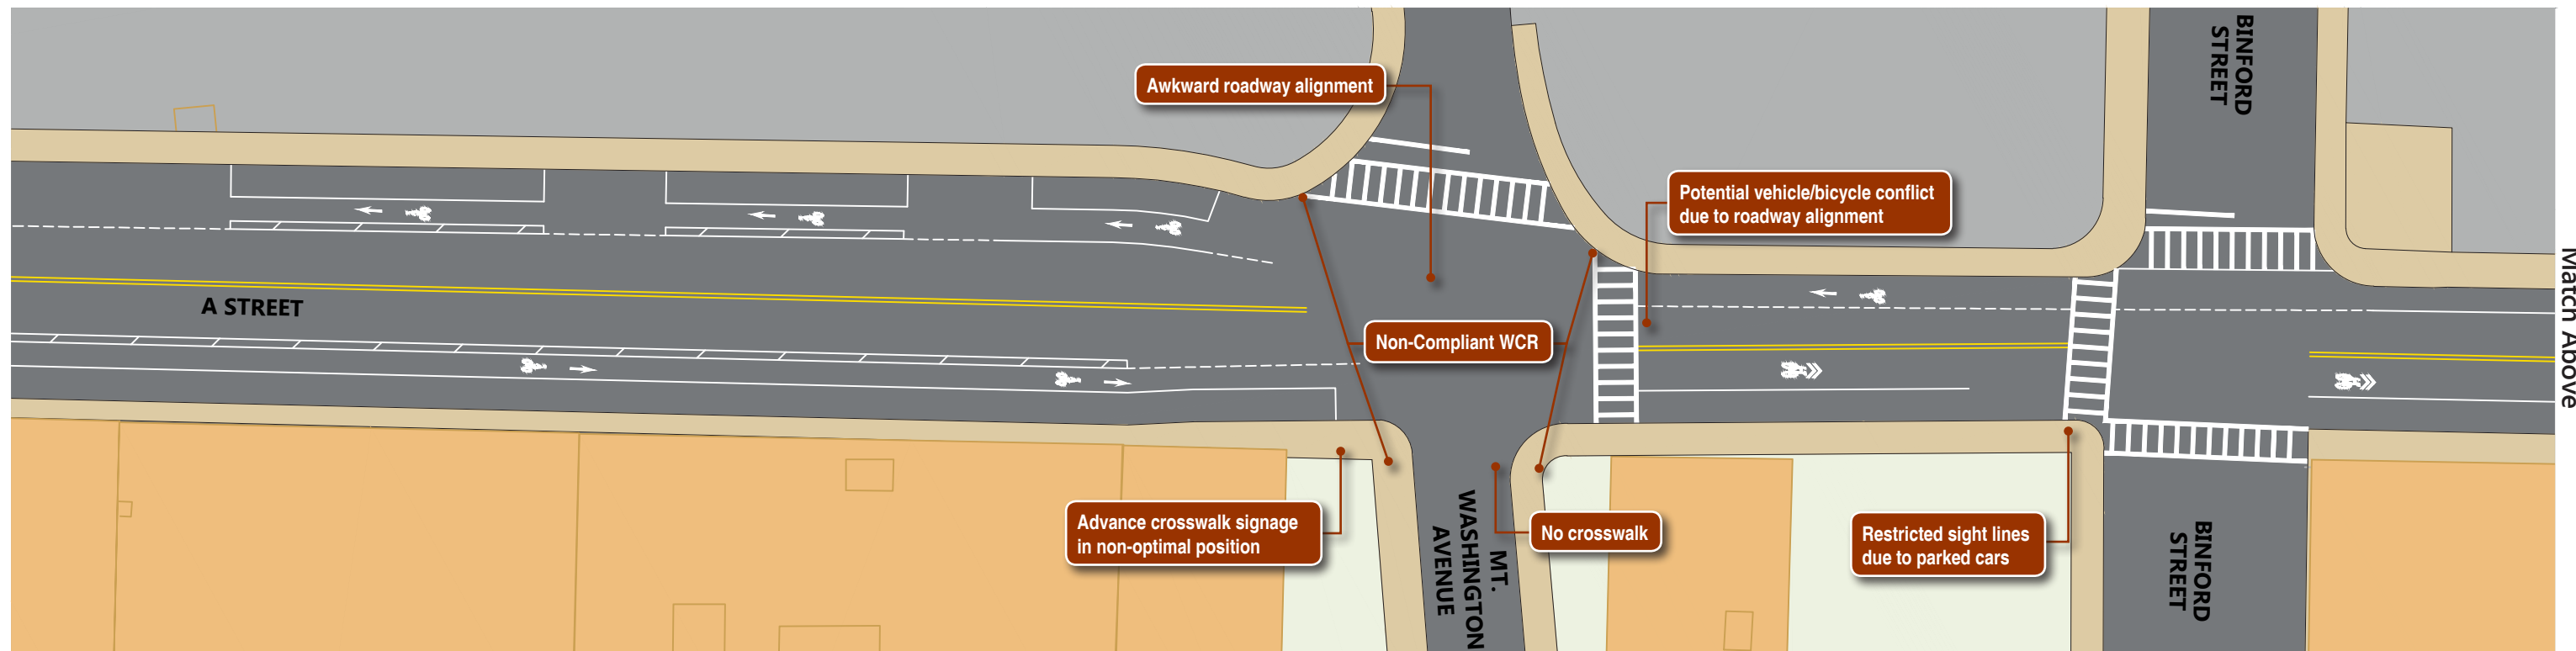
Figure 4
A Street
Identified Issues

as a vehicle travels in the southbound direction, the sign is located on the incorrect corner of the intersection, 50 feet ahead of the crosswalk. Other crosswalks, such as the Wormwood Street crossing, do not have any signage.

The intersection of A Street and Mt. Washington Avenue contains an abrupt shift in the roadway alignment due to the A Street curb to curb width increase from 34 feet to approximately 60 feet as it adds a buffered bicycle lane. The shift of about ten feet wholly occurs within the 50-foot long intersection itself. Due to this shift, vehicles traveling in both directions were observed entering the bike lane (starting the shift early) and crossing the double yellow centerline (ending the shift late).

During the PM peak observations, queueing was observed to be an issue along the corridor in the southbound direction (for traffic headed out of the immediate area toward Broadway). This can lead to a standing queue along portions of A Street and thus poor visibility of pedestrians as they walk through queued vehicles in the crosswalks. We observed that many pedestrians are very cautious when making these crossings as northbound drivers cannot see pedestrians until they enter the northbound lane. As these observations occurred in January, street lighting conditions were examined during the PM peak and lighting generally seems adequate to illuminate the roadway.

Other general observations include a high density of signage along portions of A Street, especially in the northbound direction from Mt. Washington Street to Necco Street. This can lead to drivers disregarding or missing important signage due to the amount of signage along the roadway. Also, many pedestrian curb ramps within the study area appear to be not ADA-compliant. Many of these ramps are apex ramps, with some A Street crosswalks not having any ramp but sharing a ramp facing the side street crosswalks.

A summary of these issues is shown in Figure 4.
