# Forest Hills Improvement Initiative

## Transportation Action Plan

- Short Term Recommendations ONLY  
Final Draft as of April 30, 2008  
*For Community Review and Feedback*

Traffic Solutions LLC with Planners Collaborative and Von Grossman & Company

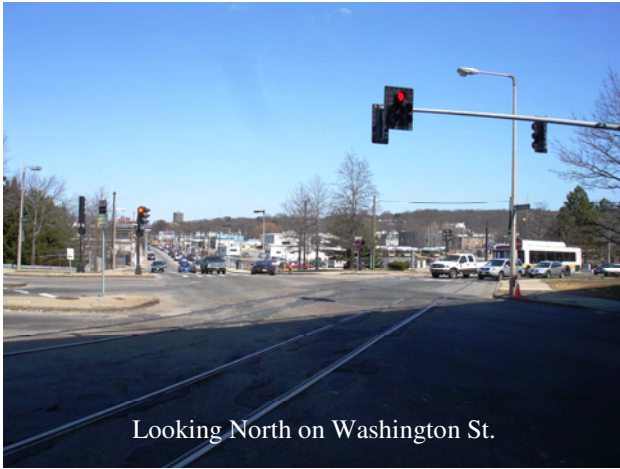
Looking North on Washington St.

- **Intersection Geometry**
  - Due to the wide expanse of pavement, and limited pavement markings, the intersection can be confusing to drivers, particularly those making left turns.
  - On the northeast corner, there is a wide right turning lane that receives very little traffic.
- **Pavement Markings**
  - Most of the pavement markings in this area are worn.
  - The crosswalk markings were faded, inconsistent with those in the area, and not on pedestrian desire lines.

- **Signal Coordination**
  - The signal timing should be updated to reflect suggested changes.
- **Intersection Geometry**
  - The right-turn slip lane on the northwest corner may be eliminated due to the relatively light volume. This will create opportunities (e.g. additional green space) at the intersection while making it more pedestrian friendly.

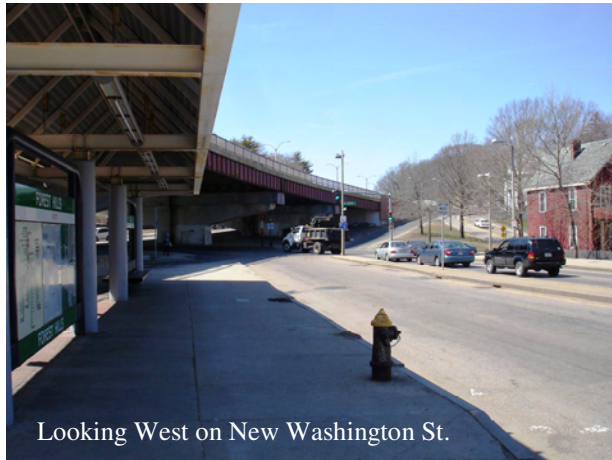
Looking West on New Washington St.

- **Intersection Geometry**
  - Due to the wide expanse of pavement, and limited pavement markings, the intersection can be confusing to drivers, particularly those making left turns.
  - On the southbound approach, busses turning left are waiting in queue and blocking the other vehicles from entering the intersection.
- **Pavement Markings**
  - Many of the pavement markings in this area are worn
  - The crosswalk markings were faded, inconsistent with those in the area, and not on pedestrian desire lines.

- **Signal Coordination**
  - The signals at the northern and southern ends of this intersection should run on the same cycle to eliminate red-time queuing under the Arborway.

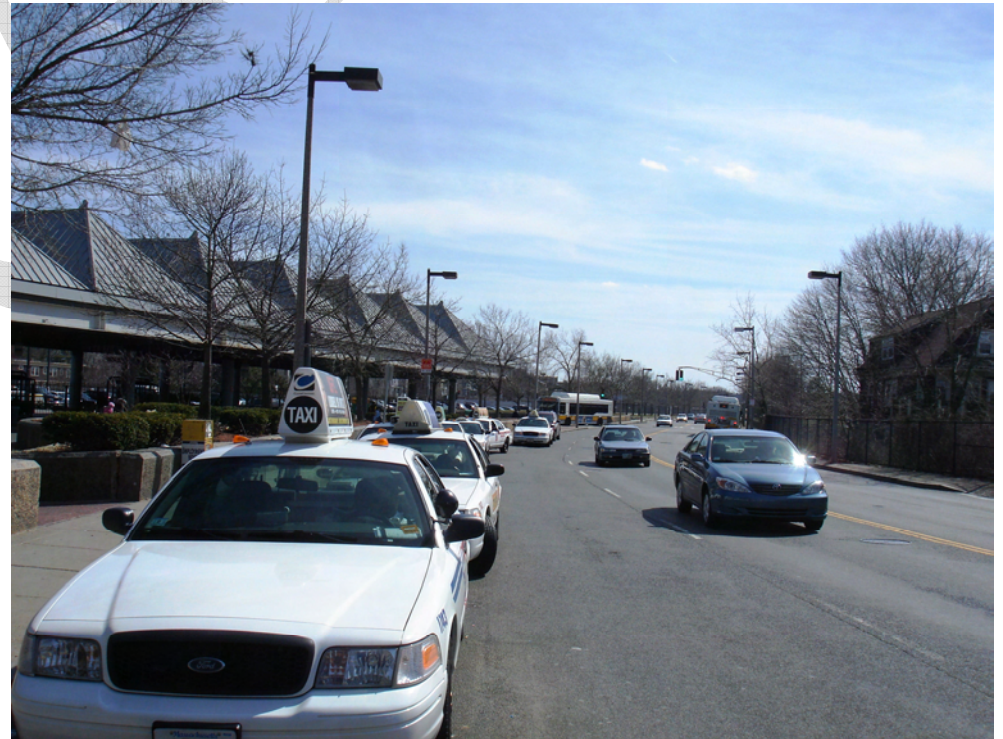
- **Pavement Markings**
  - Many of the pavement markings in this area are worn.
- **Station**
  - The cab stand is very long and there are many cabs queued in front of the station. This limits drivers' ability to effectively use the pick-up/drop-off area; causing congestion and lane blockage during the peak hour.
  - The allotted pick-up/drop-off area, south of the cab stand, was not being used and vehicles were double parking behind it.
  - There was an excessive amount of trash along this section of Washington St. and the garbage bins were overflowing.

Looking South on Washington St.

- **Pavement Markings**
  - The lane markings on Washington St. southbound should be maintained.
- **Signs**
  - A Sign informing drivers to park on New Washington St. should be introduced to reduce double parking on Washington St.
- **Station**
  - The cab stand should be relocated to behind the pick-up/drop-off lane.
  - Police enforcement of the pick-up/drop-off lane should increase.
  - Garbage disposal and street cleaning should occur on a regular basis.

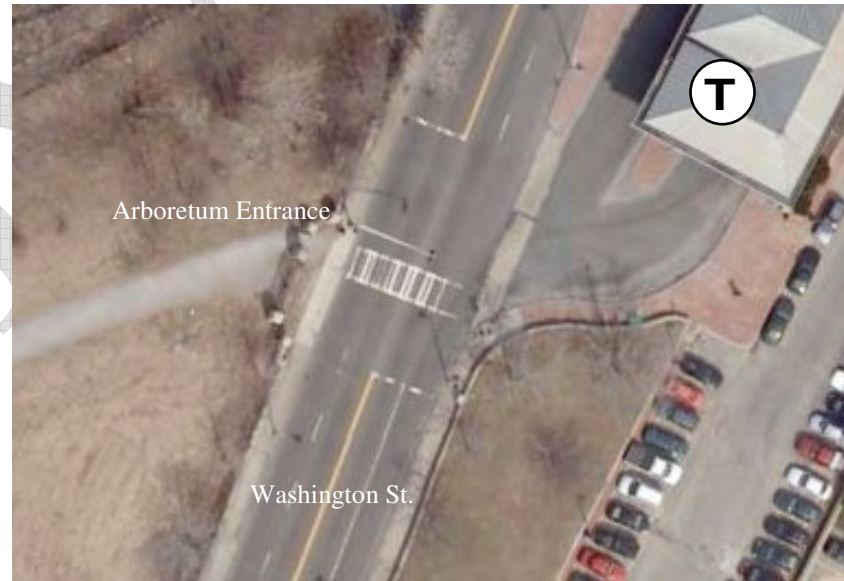
**FIGURE 5**

TITLE:  
**SHORT TERM IMPROVEMENTS  
 WASHINGTON ST @ BUS ENTRANCE**

- **Pavement Markings**
  - The lane markings on Washington St. should be maintained.
- **Signs**
  - Signs should be added in advance of the intersection on Washington St. to inform drivers of the restrictions. This will prevent drivers from making hasty decisions at the intersection.
- **Crosswalks**
  - All crosswalks should be maintained, and consistent (e.g., ladder type) throughout the area.
  - The crosswalk across the bus lane on the eastern side of Washington Street should be redone to match the other crosswalks.

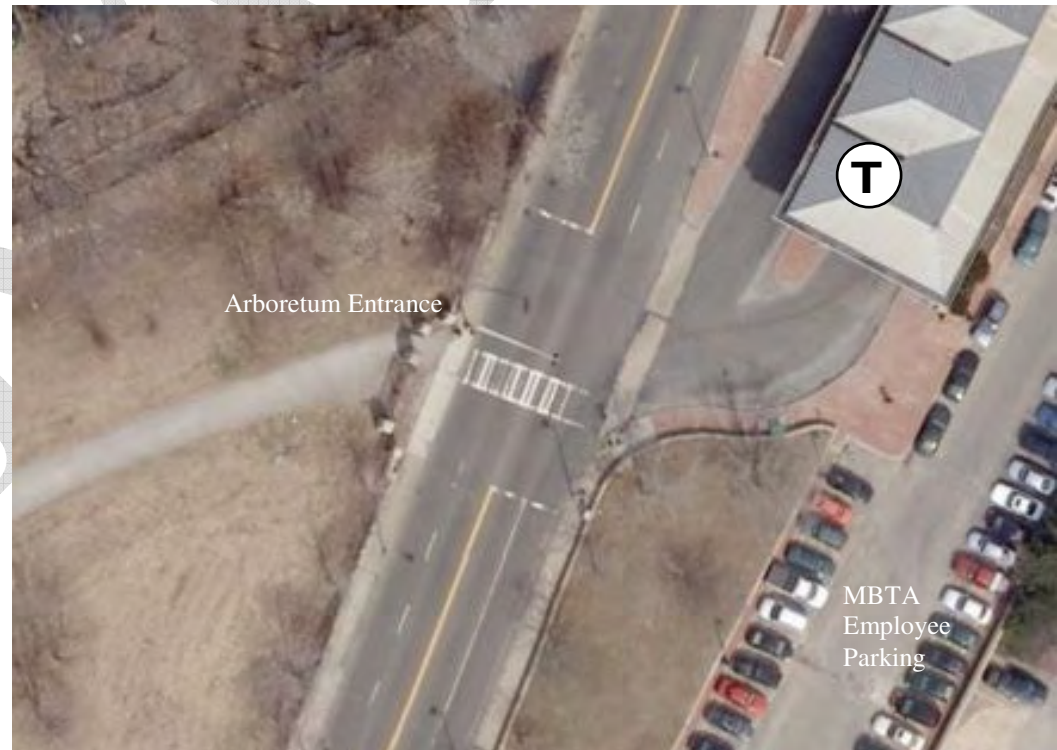
- **Pavement Markings**
  - The lane markings on Washington St. should be maintained.
- **Crosswalks**
  - All crosswalks should be maintained, and consistent (e.g., ladder type) throughout the area.
  - The crosswalk across the bus lane on the eastern side of Washington Street should be installed to match the other crosswalks.

MAINTAIN CROSSWALK

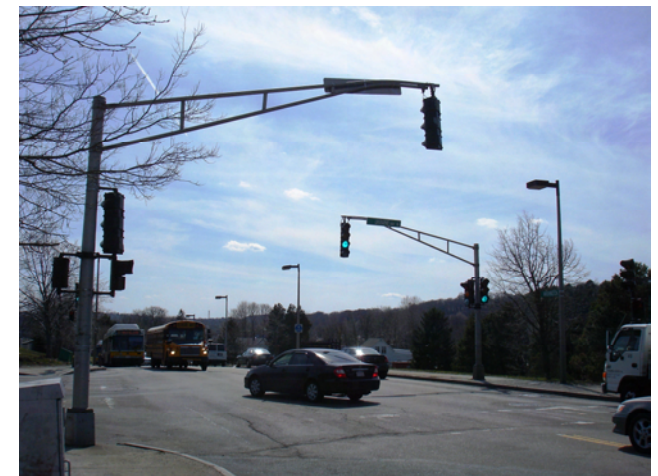
- **Intersection Geometry**
  - Due to the wide expanse of pavement, and limited pavement markings, the intersection can be confusing to drivers, particularly those making left turns.
- **Pavement Markings**
  - Most of the pavement markings in this area are worn.
  - The crosswalk markings were faded.
- **Signs**
  - A sign on Ukraine Way was not visible for westbound drivers due to an overgrown tree.

Looking South on Washington at Ukraine Way

- **Pavement Markings**
  - Lane line extensions should be added so that drivers turning left can better distinguish their lanes.
  - The lane markings on Washington St. and Ukraine Way should be maintained.
- **Signs**
  - Signs should be added in advance of the intersection on Washington St. to inform drivers of the lane configurations. This will prevent drivers from making hasty decisions at the intersection.
  - Existing signs should be maintained so they are visible to all drivers.
- **Crosswalks**
  - All crosswalks should be maintained, and consistent (e.g., ladder type) throughout the area..
  - Crosswalks should be installed on the northern end of Washington St. and across the western end of Ukraine Way.

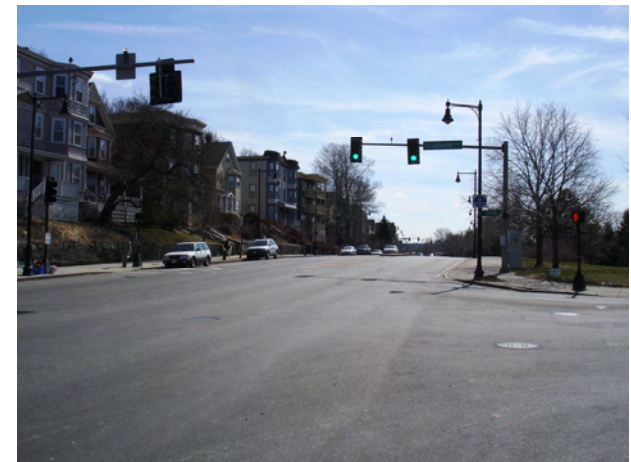
- **Intersection Geometry**
  - Due to the wide expanse of pavement, and limited pavement markings, the intersection can be confusing to drivers, particularly those making left turns.
- **Pavement Markings**
  - Most of the pavement markings in this area are worn.
  - The crosswalk markings were faded and inconsistent with the rest of Forest Hills.

Looking South on Hyde Park at Ukraine Way

- **Pavement Markings**
  - Lane line extensions should be added through the intersection so that drivers turning left from Hyde Park Ave. Northbound to Ukraine Way Westbound, and from Ukraine Way Eastbound to Hyde Park Ave. Southbound, can better distinguish their lanes.
  - The lane markings on Hyde Park Ave. and Ukraine Way should be maintained.
- **Signs**
  - Signs should be added in advance of the intersection on Hyde Park Ave. to inform drivers of the lane configurations. This will prevent drivers from making hasty decisions at the intersection.
- **Crosswalks**
  - All crosswalks should be maintained, and consistent (e.g., ladder type) throughout the area.
  - Crosswalks should be installed on Washington St. and across the eastern end of Ukraine Way.

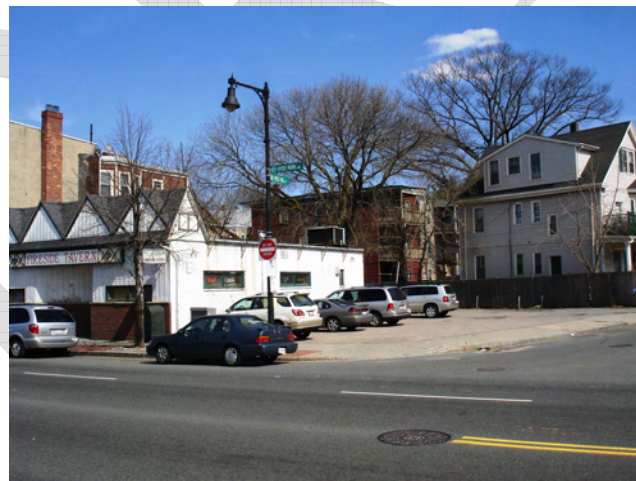
Hyde Park at Weld Hill- Looking East

- **Signs**
  - The Weld Hill Street sign should be relocated to the top of the One Way sign for easier identification by drivers.
- **Crosswalks**
  - All crosswalks should be maintained, and consistent (e.g., ladder type) throughout the area.
  - Crosswalks should be repainted across the parking lot and Woodlawn St.
  - A Crosswalk should be installed across Weld Hill St.

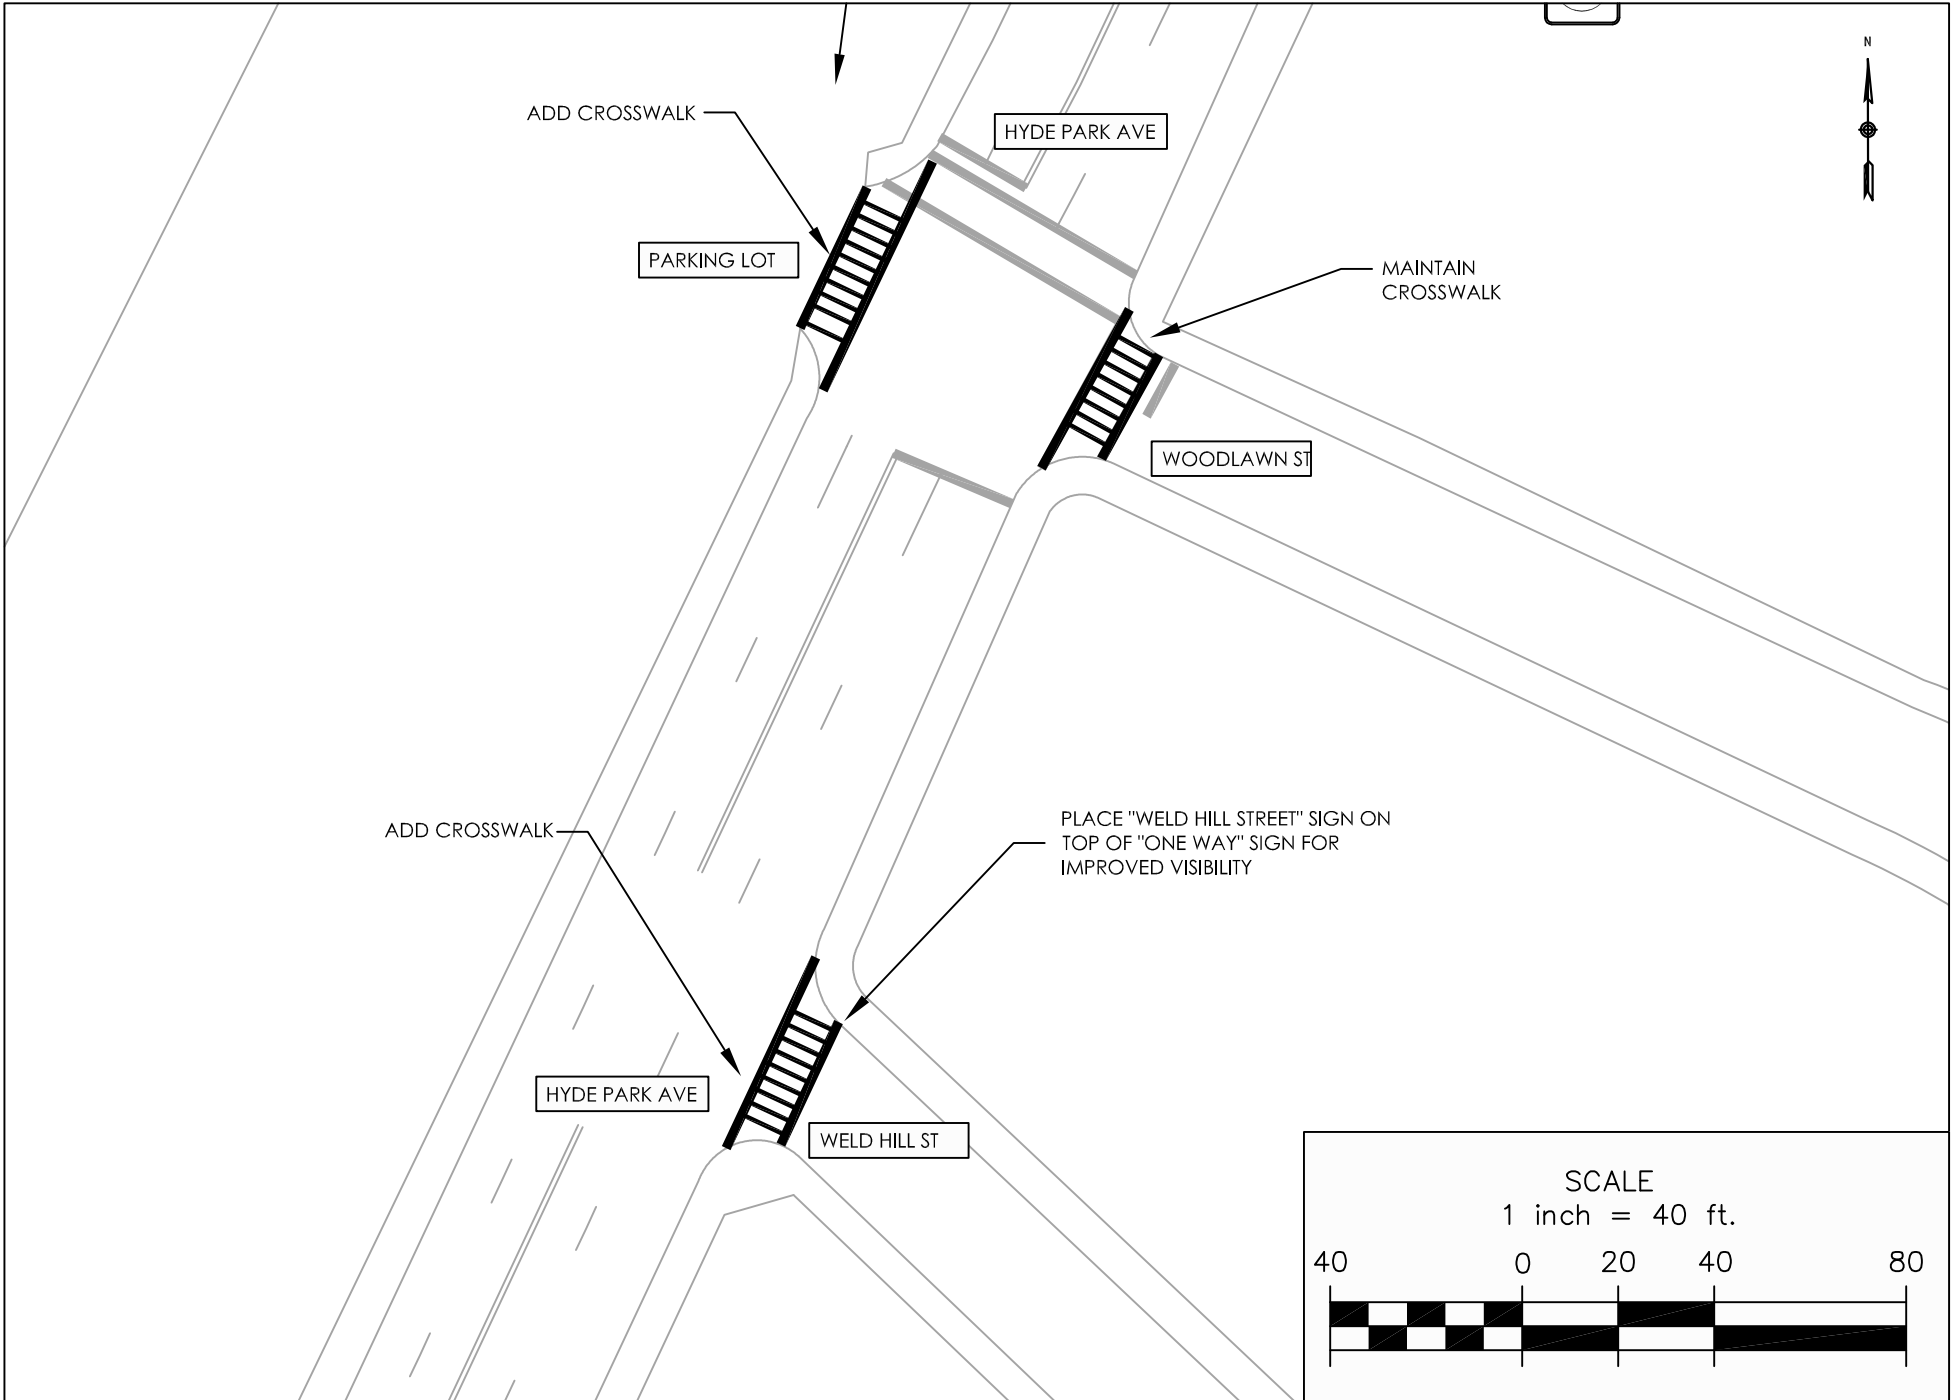
Planning, Permitting, & Design Two Center Plaza, Suite 700 Boston, Massachusetts 02108	TITLE: <b>SHORT TERM IMPROVEMENTS</b> <b>HYDE PARK AVE @ WELD HILL ST &amp; WOODLAWN ST</b>	PROJECT: <b>FOREST HILLS</b> <b>BOSTON, MASSACHUSETTS</b>	PREPARED FOR: <b>BOSTON REDEVELOPMENT</b> <b>AUTHORITY</b>	<b>FIGURE 9</b>
---	---	---	--	-----------------

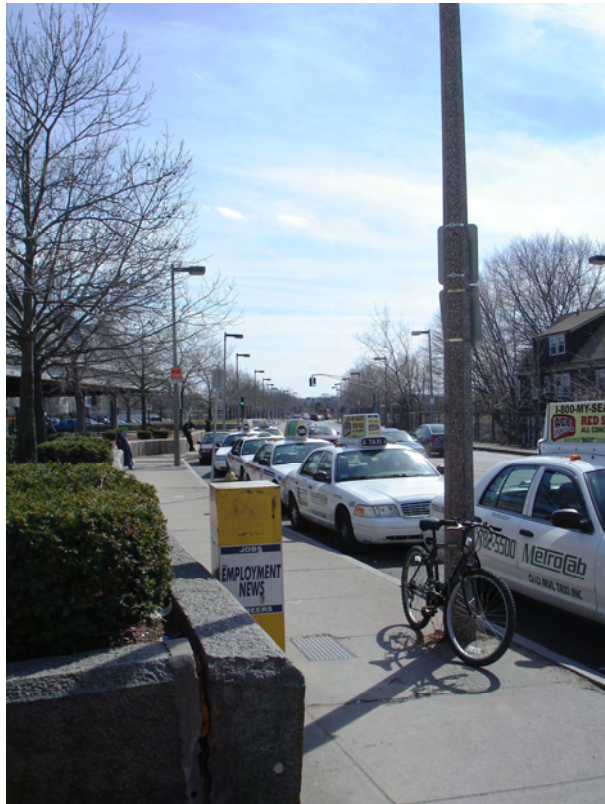
Looking South on Washington St. – Cab Stand

- **School Buses**
  - In the AM peak period, school buses are often found parked in the street blocking traffic on New Washington St. and Hyde Park Ave.
- **Cabs**
  - The cab stand on Washington St. overflows into the pick-up/drop-off lane forcing those drivers into the street.
- **Bicycles**
  - Bicycle theft is a problem around the station.

- **School Buses (Figures 14 & 16)**
  - Buses should use the cab stand on New Washington St. in the AM peak.
  - On Hyde Park Ave, if the pick-up/drop-off lane across from Tower St. is full, buses should pull into the turn-around across from Woodlawn St.
- **Cabs (Figure 15)**
  - The cab stand on Washington St. should be relocated to behind the pick-up/drop-off lane.
  - Signage should be provided within the station informing users of the cab stand on Hyde Park Ave.
  - Cab stand lengths should be enforced.
- **Bicycles (Figure 15)**
  - Safe bicycle storage should be provided within Forest Hills Station.

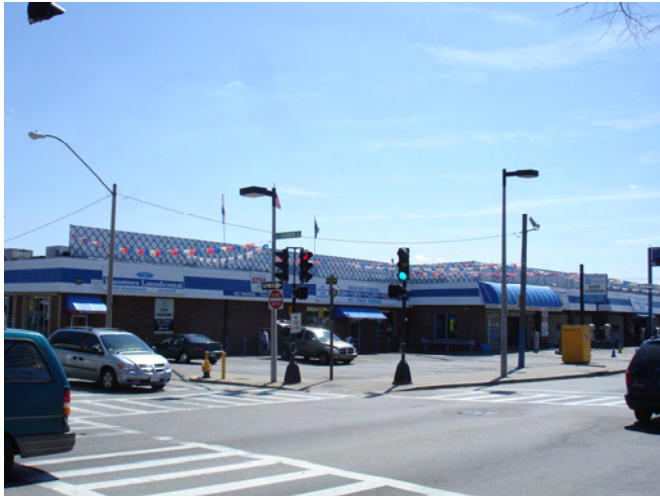
Looking Southwest on Washington Street

- **Bus Stop**
  - The bus stop in the northbound direction is located before the intersection, which blocks through movements.
- **Pavement Markings**
  - Most of the pavement markings in this area are worn.
- **Signs**
  - The angles and locations of signs make them difficult to see while approaching the intersection.
- **Sidewalks**
  - The sidewalks along the eastern side of Washington St. are in severe disrepair.

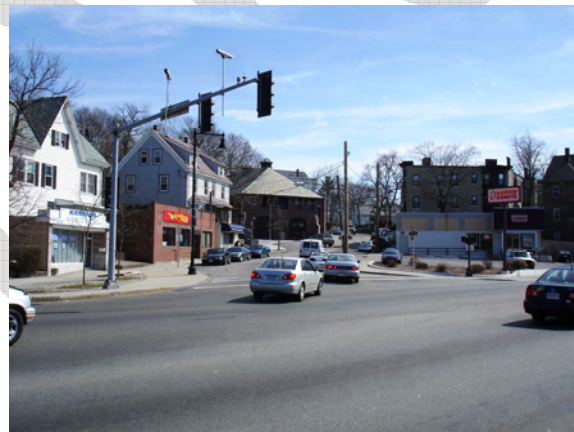
Hyde Park at Walk Hill St. Looking South East

- **Bus Stop**
  - Relocate the bus stop to a location just south of the intersection.
- **Crosswalks**
  - All crosswalks should be maintained, and consistent (e.g., ladder type) throughout the area.
