Report of Findings

Pier 5 Waterfront Facilities Inspection and Assessment

Boston Planning and Development Agency

January 4, 2024
Project I.D.: 23B004

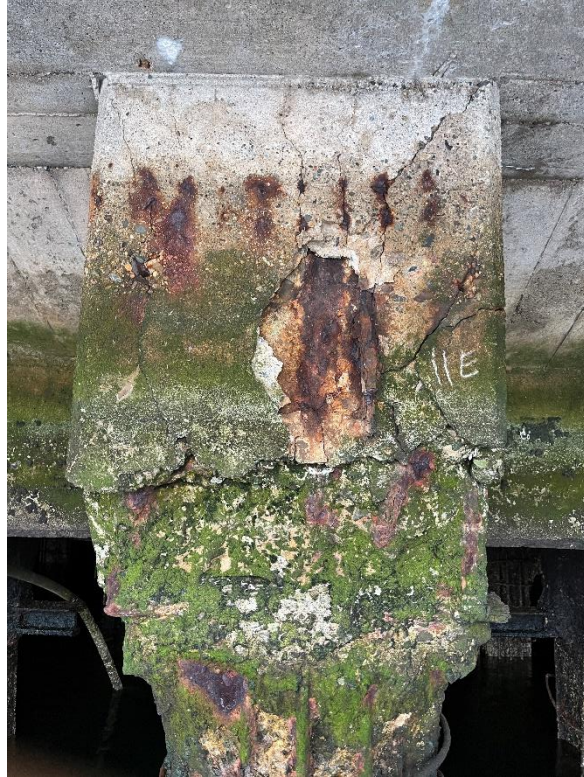
Figure 3 Example of "Major" damage pile cap. Corresponds to corrected pile 18E on the Foth pile plan. Note exposed reinforcement and chemical deterioration with structural cracks.

Pile caps were inspected visually from the exterior of the pier, and damage ratings were assigned with guidance from "Manuals and Reports on Engineering Practice No. 130" published by the ASCE and shown in Table 1 and Figure 2 below. Figure 3 shows pile cap 18E, which is an example of a "Major" damage element. Exposed reinforcement and chemical deterioration are the primary reasons for this damage assessment, with structural cracks and partial breakage supporting the assessment. Figure 4 shows pile cap 30E, which is an example of pile caps that were rated as having "Severe" damage. Specifically cited in this assessment are structural cracks wider than ¼" and exposed steel due to chemical deterioration. Figure 5 shows pile cap 26E and is an example of pile caps that were rated as having "Minor" damage.

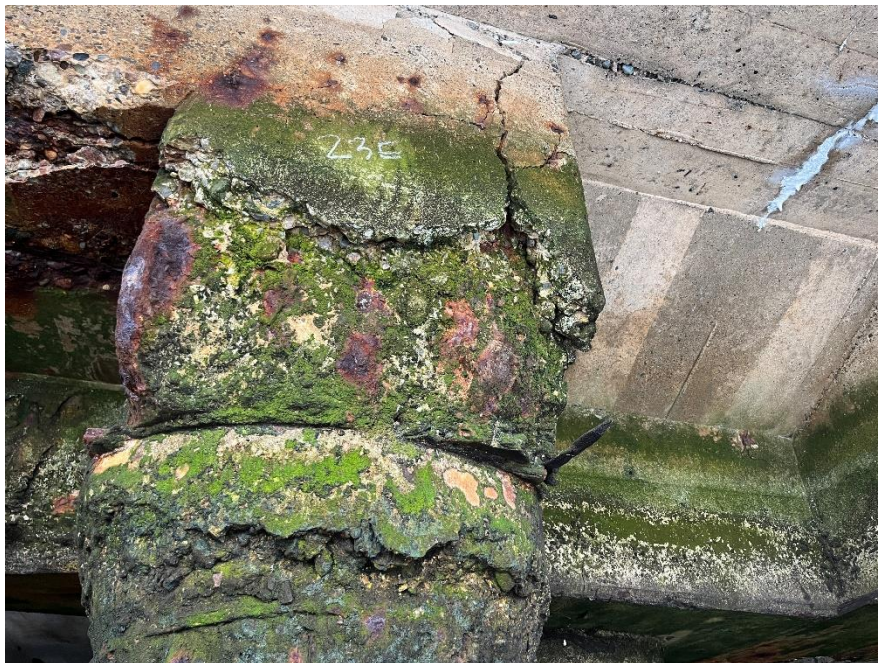
Figure 4 Example of "Severe" damage pile cap. Corresponds to corrected pile 30E on the Foth pile plan. Note exposed reinforcement due to chemical deterioration and structural cracks $>1/4$ ".

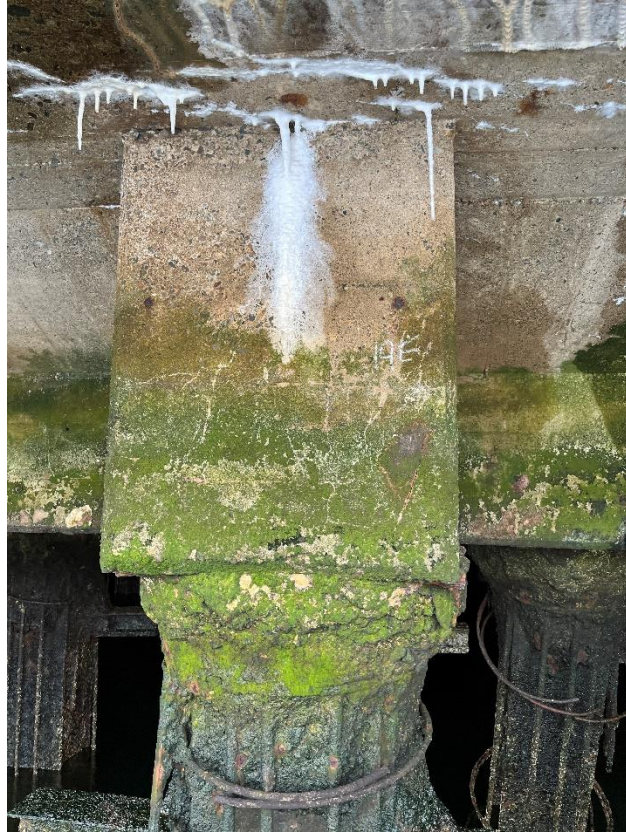
Figure 5 Example of "Minor" damage pile cap. Corresponds to corrected pile 26E on the Foth pile plan. No visible corrosion cracks or chemical deterioration. Note corrosion stains and non-structural cracks <math>< 1/16</math>".

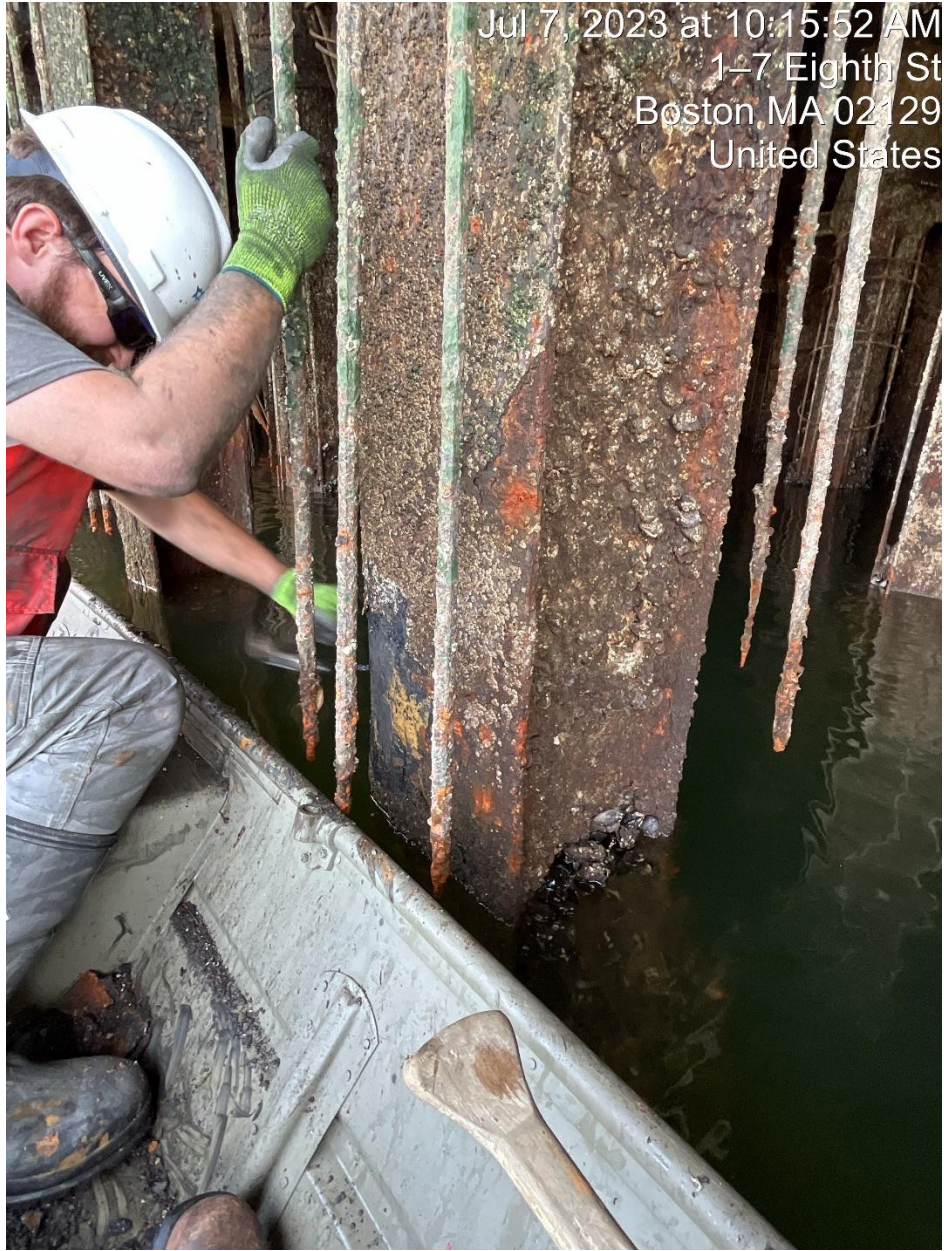
Figure 6 Minor damage H-pile example, pile 38-W on the Foth plan.

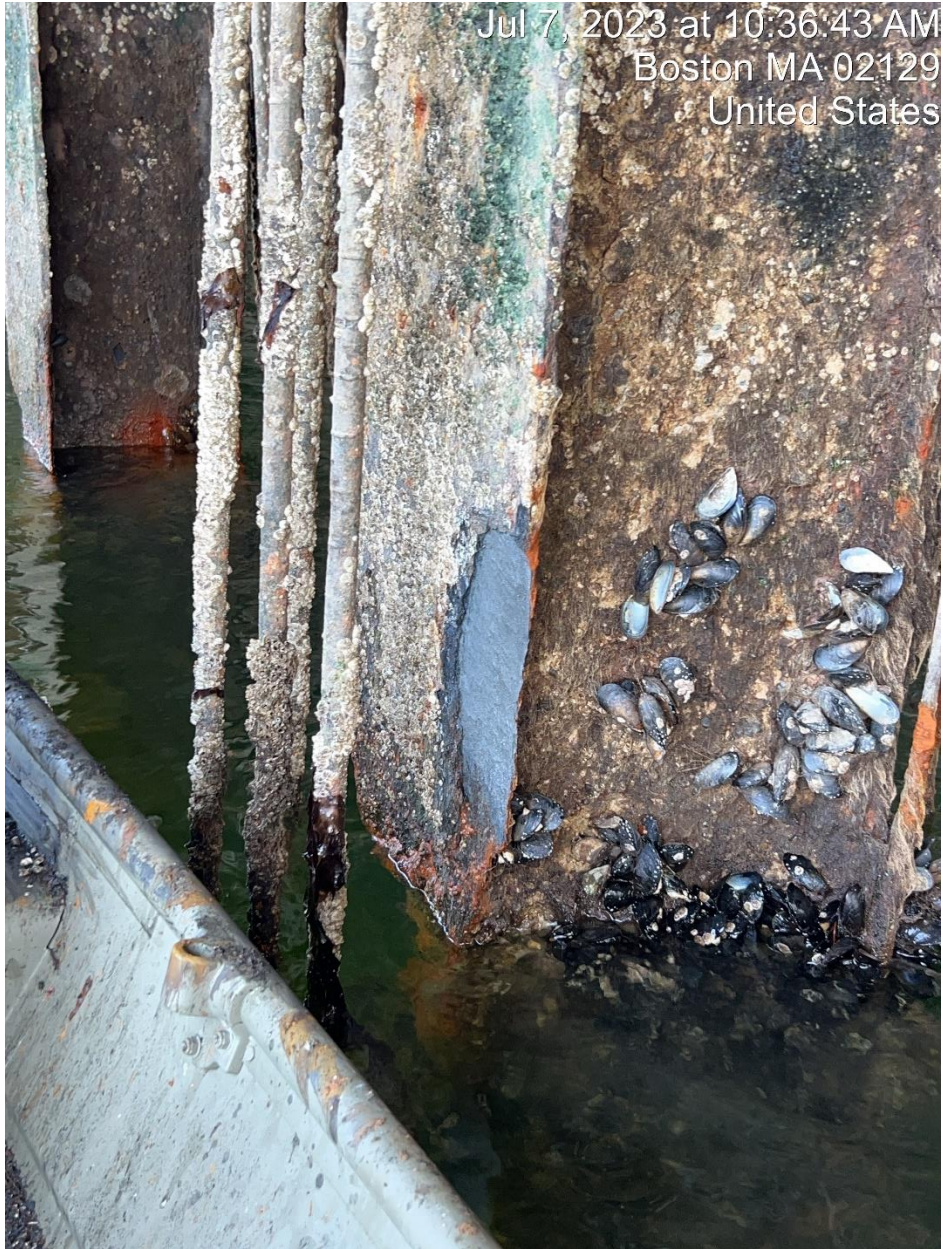
Figure 8 Pile 111-W, and example of a Major damage pile. Measured steel thickness of 0.47", 33% loss. Note the knifed edge that has corroded almost all the way through.

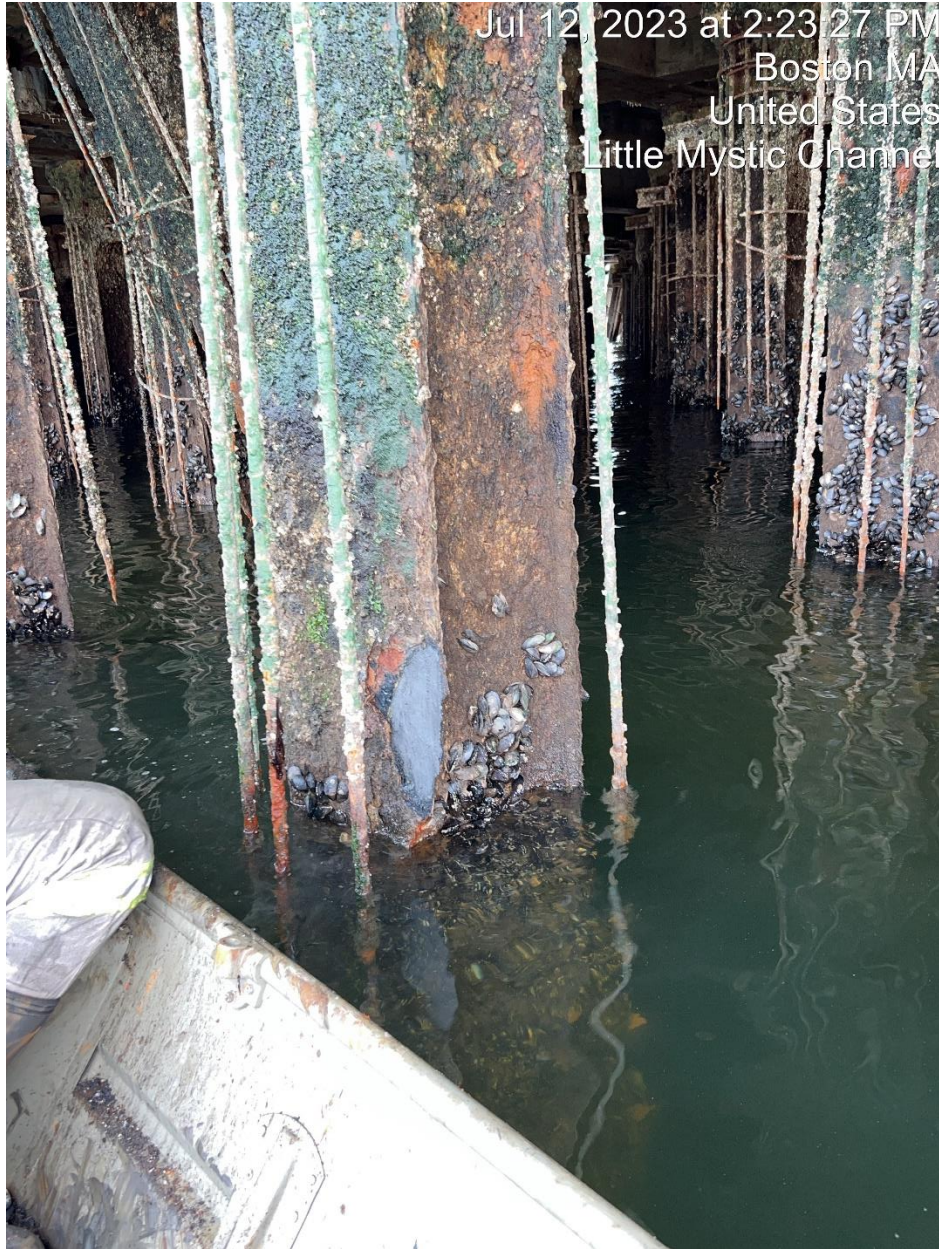
Figure 9 Pile 103-E, example of a Severe damage pile. Measured thickness of .015", 79% loss. Below the waterline it was noted that corrosion goes all the way through the flange.

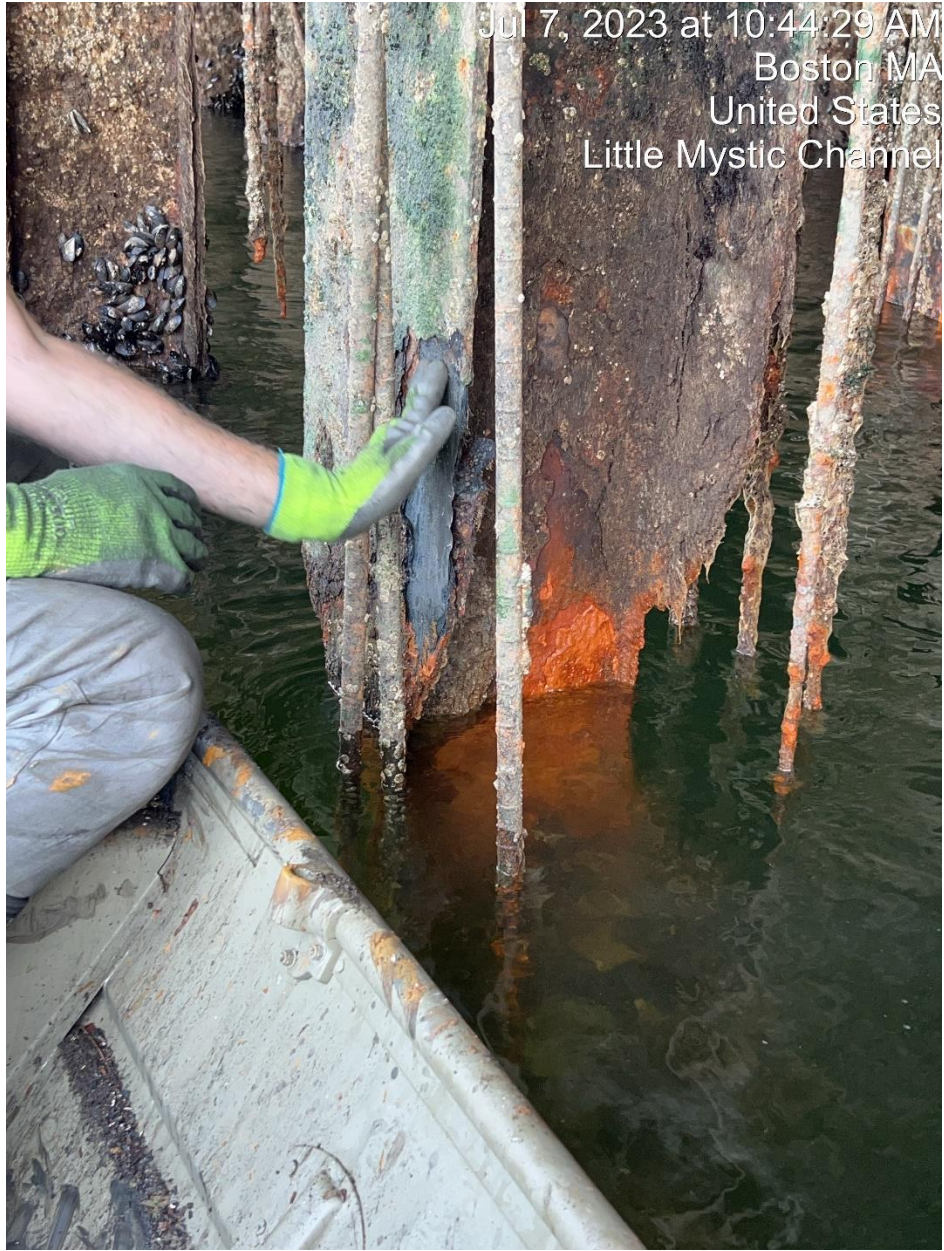
Figure 10 Pile 102-W, another example of a Severe damage pile. 0.13" of steel measured, 82% loss. Complete loss of flange just below waterline.

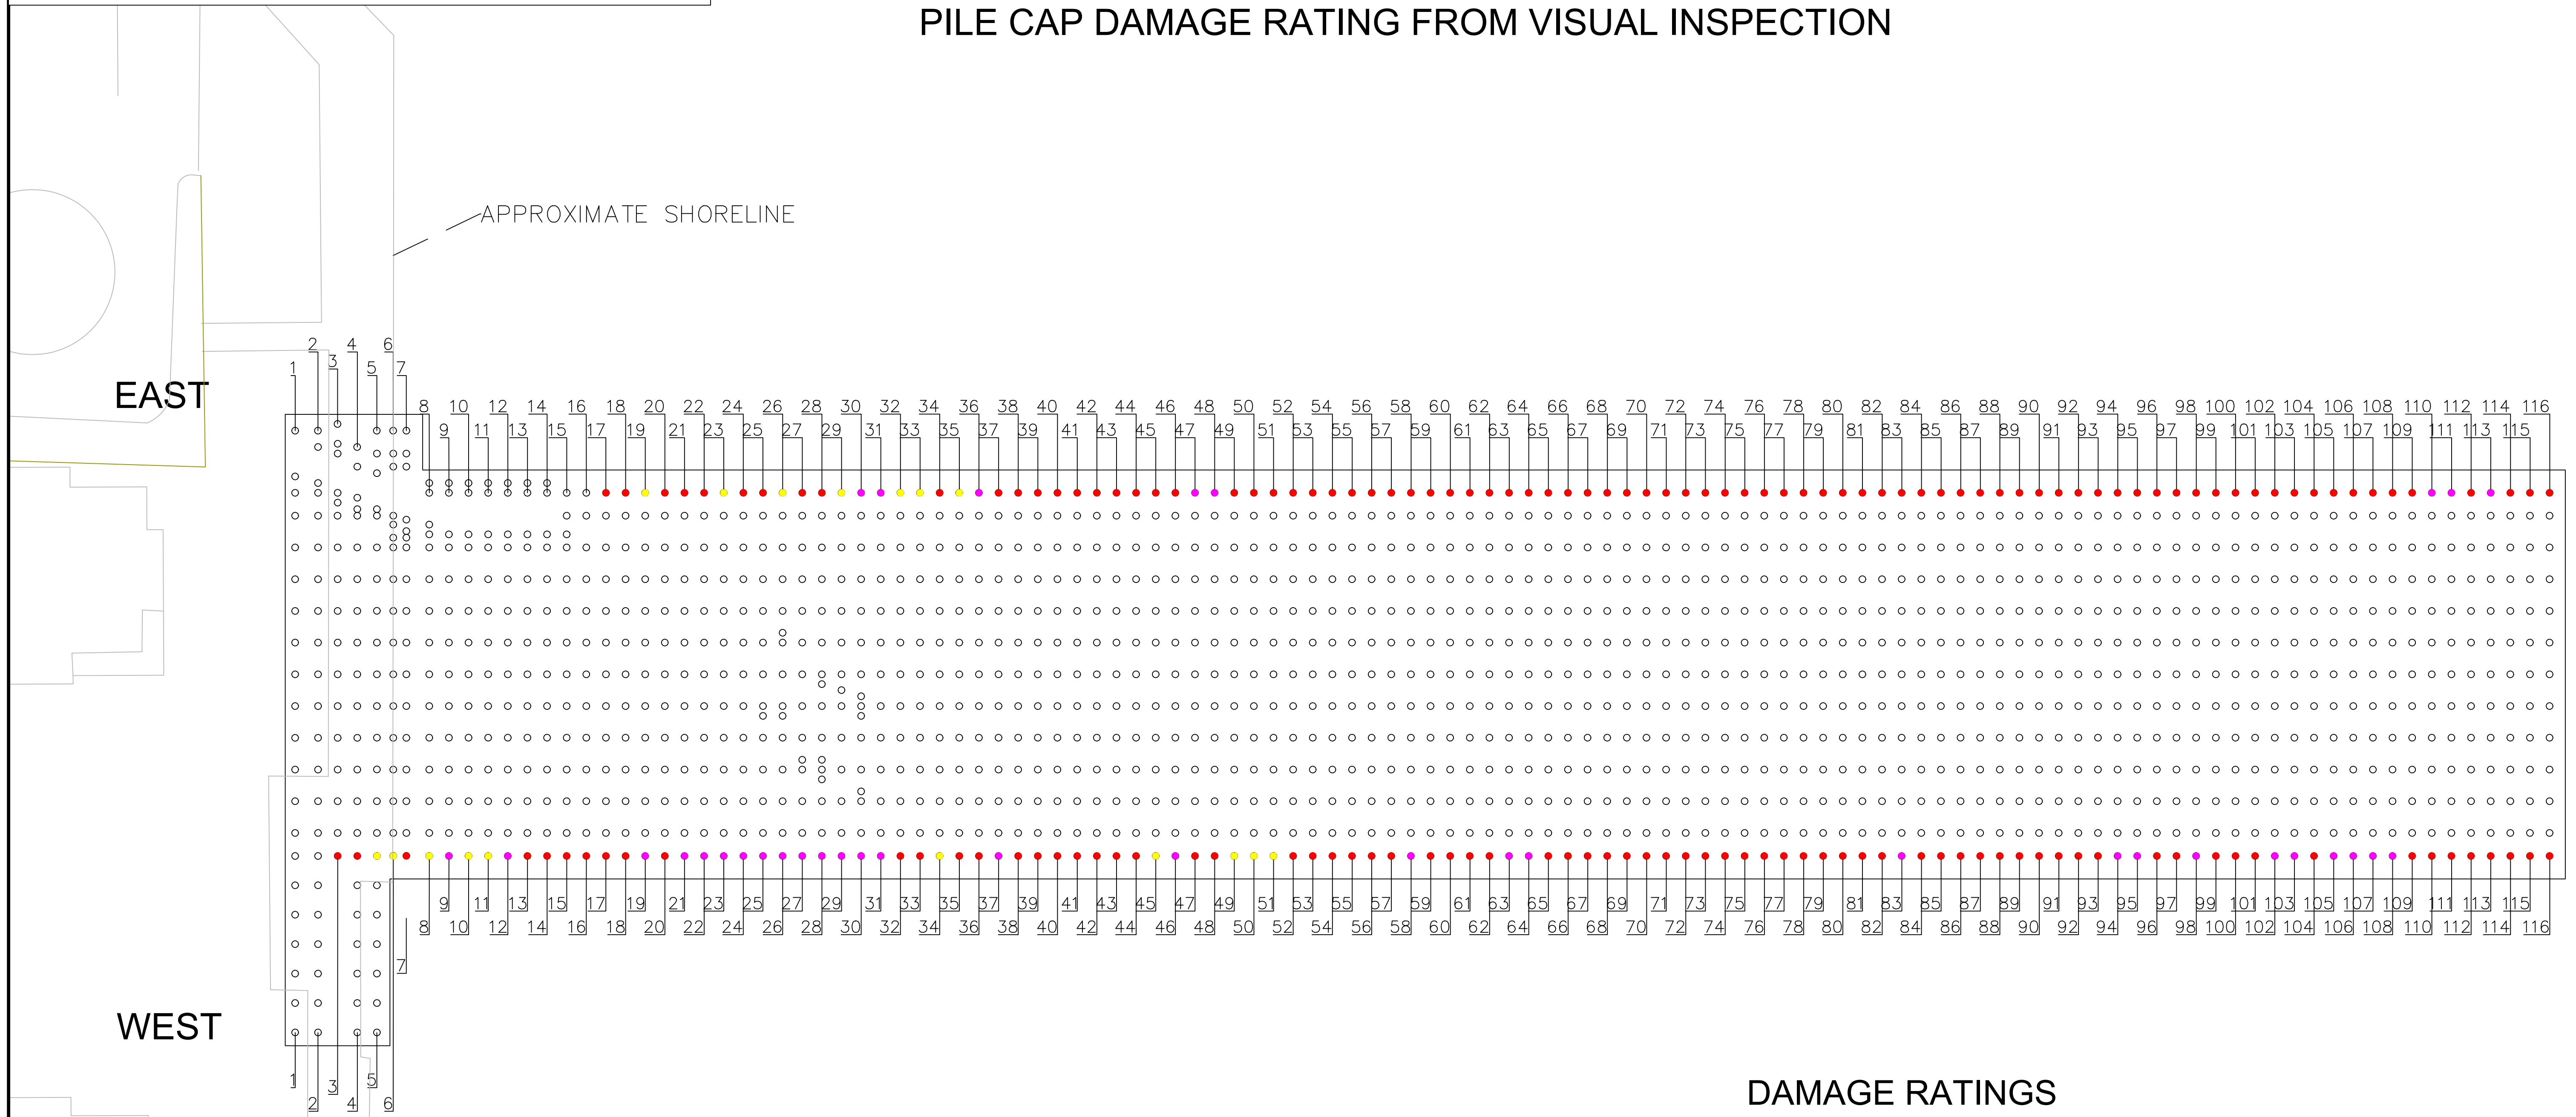
SHEET TITLE:
**BPDA PIER 5
PILE CAP DAMAGE RATINGS**

In all, 74% of pile caps were found to have "Major" damage with 18% found to have "Severe" damage. The remaining 8% of pile caps were found to have "Minor" damage. A color-coded plan of the pile cap damage assessment can be found in **Appendix A**. **Concrete Encased H-Pile Damage Ratings**
The steel H-piles that support Pier 5 were encased in reinforced concrete for the upper intertidal and dry portion of the piles. At present, the reinforced concrete encasement is severely deteriorated exposing the reinforcing rebar and flanges of the H-piles themselves on all but a few piles. On many piles the reinforcing rebar has corroded to the point of being completely missing. At several locations splice plates were observed, and the weld material was observed to have 100% deterioration.

PILE CAP DAMAGE RATING FROM VISUAL INSPECTION

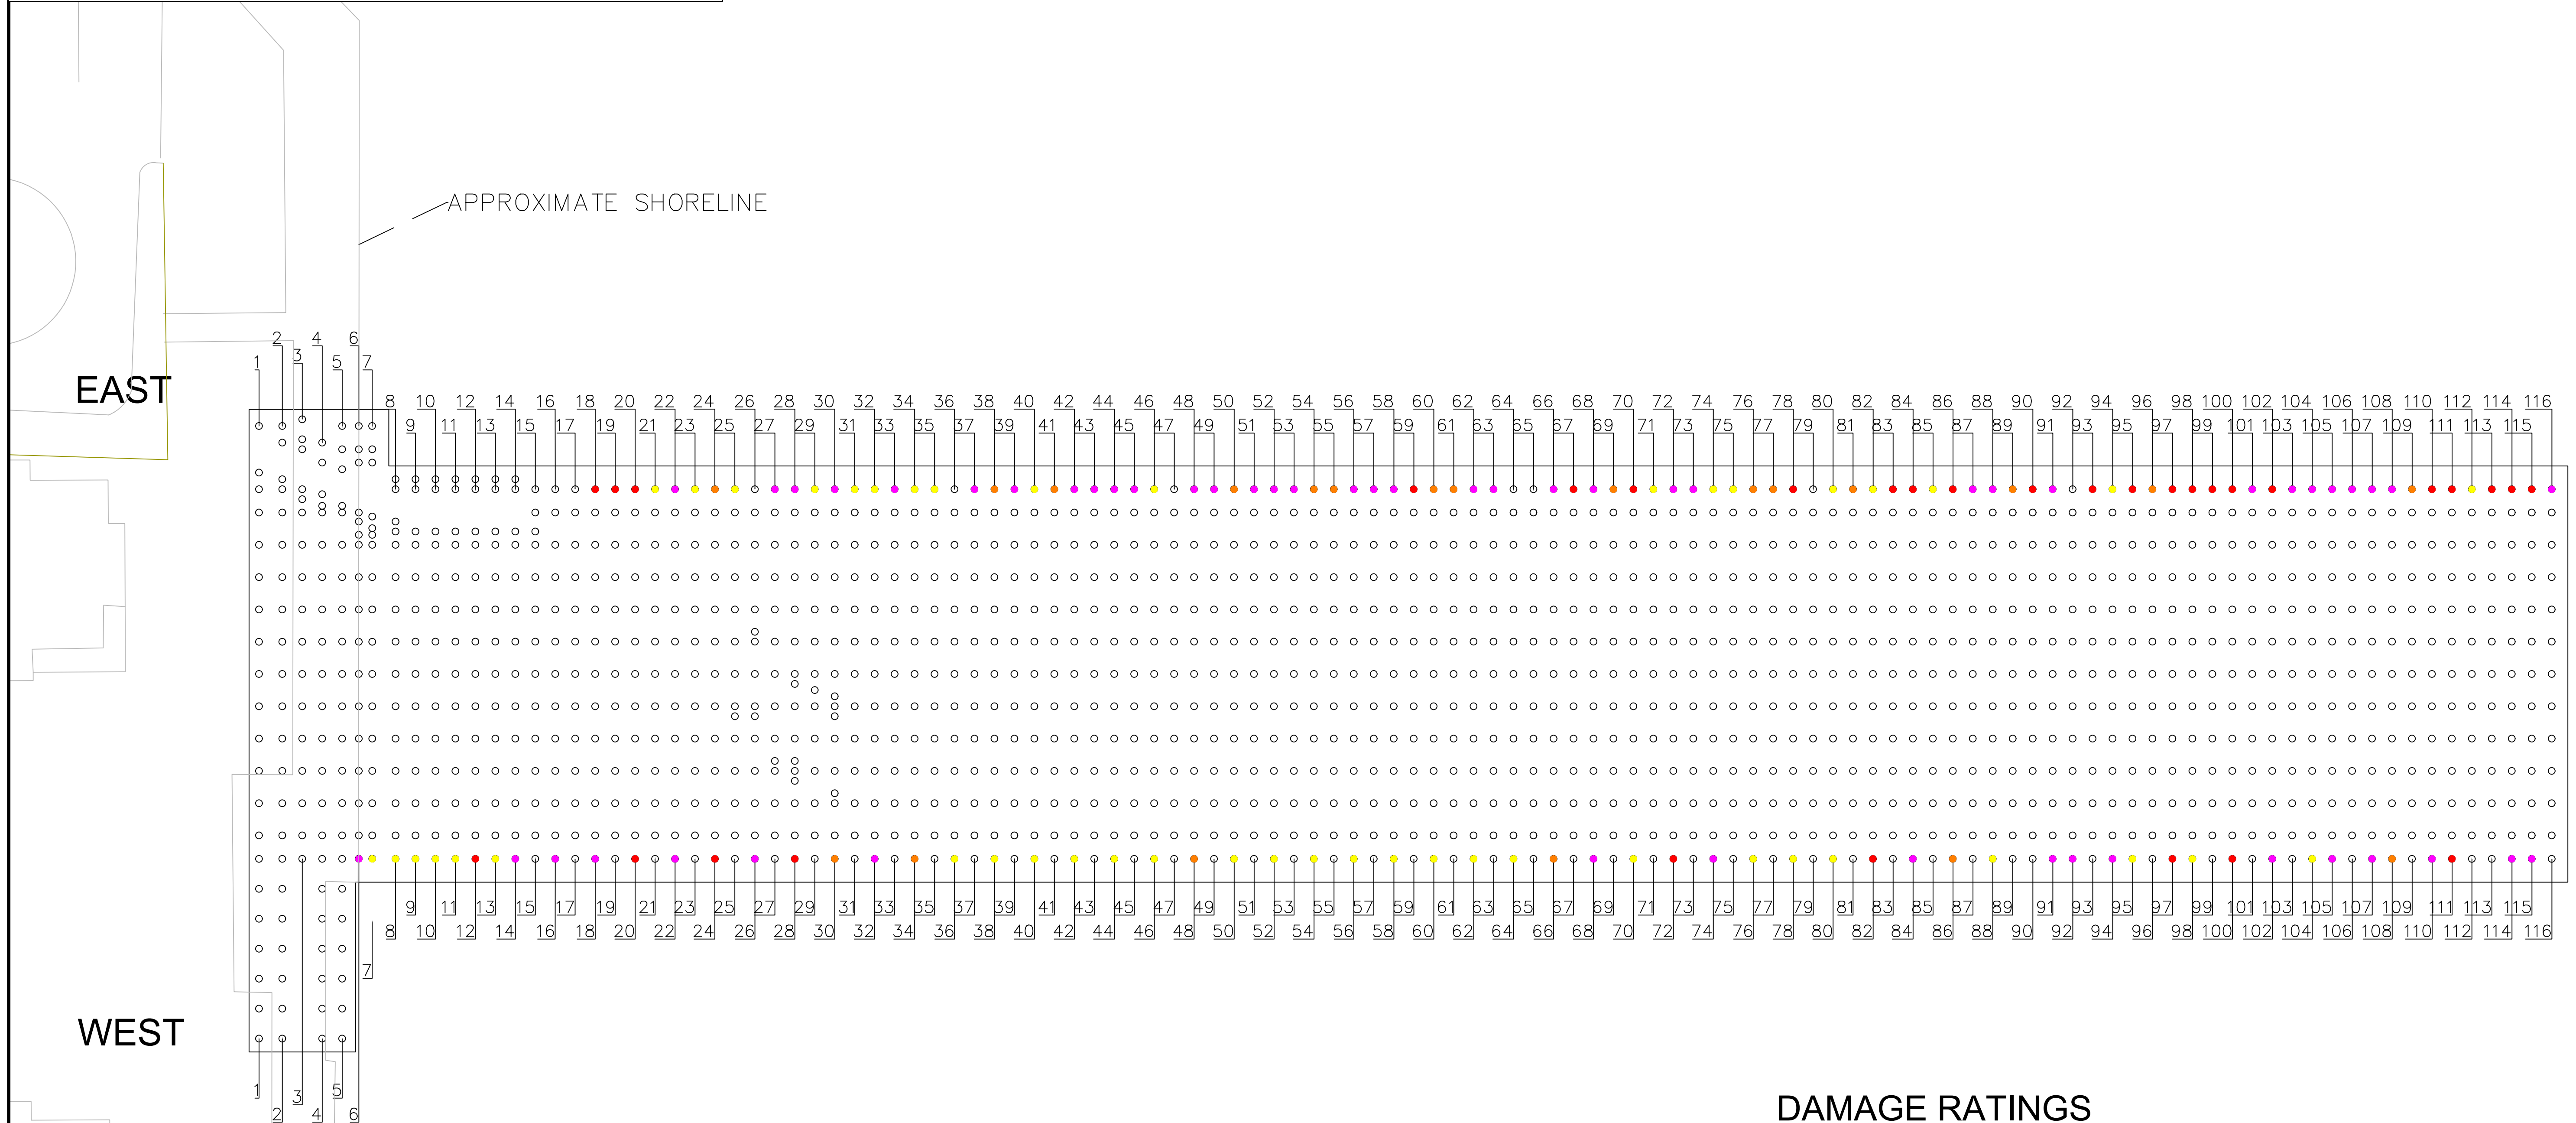
SHEET TITLE:
**BPDA PIER 5
 H PILE DAMAGE RATINGS**

Of the 154 H-piles measured for remaining steel thickness around the perimeter of the pier, 30% were categorized as Minor, 14% as Moderate, 21% as Major, and 36% as Severe damage. Photographic representative examples of these damages are shown in Figure 6 through Figure 10. A summary of the quantitative steel H-pile damage ratings in plan view can be found in **Appendix B**. A table summarizing the damage ratings of both the pile caps and steel h-piles can be found in **Appendix C**.

STEEL H PILE DAMAGE RATINGS
 % LOSS FROM UT READINGS ASSUMES ORIGINAL H-PILES WERE HP 14X102
