**Article 85 Review – Boston Zoning Code
17-19 Warren Street “Ferdinand’s Blue Store Addition”,
Roxbury, Boston, MA**

Engineering Design for Environmental Remediation
and Site Clearance at Dudley Square
Boston Redevelopment Authority
Project No. 5076

Re: Article 85 Application for 17-19 Warren Street, Roxbury, MA
New City Municipal Building
Phase 1 - Engineering Design for Environmental Remediation and
Site Clearance at Dudley Square, Roxbury, MA

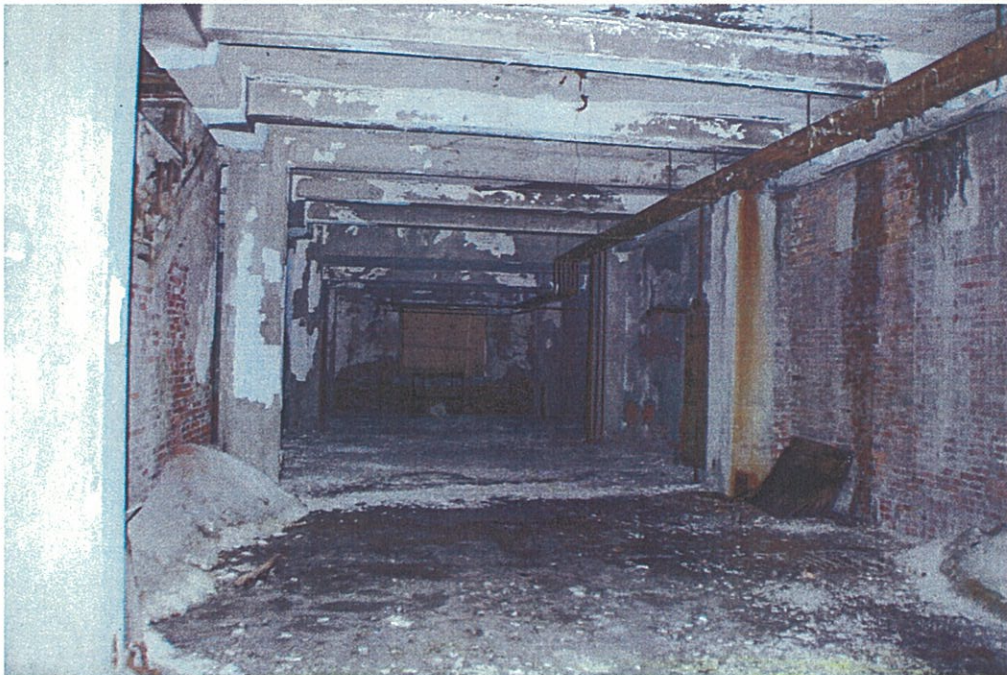
Photo G0.2 - Basement

General view of basement structural system.

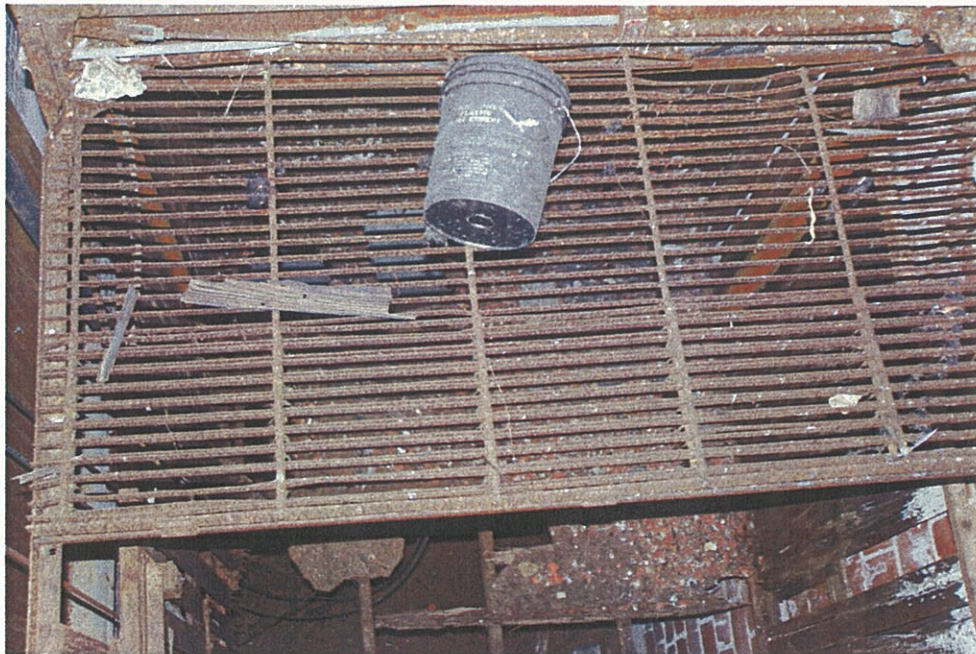
Photo G3.4 – 3rd Floor

Elevation of the abandoned elevator platform (looking down from 3rd floor).

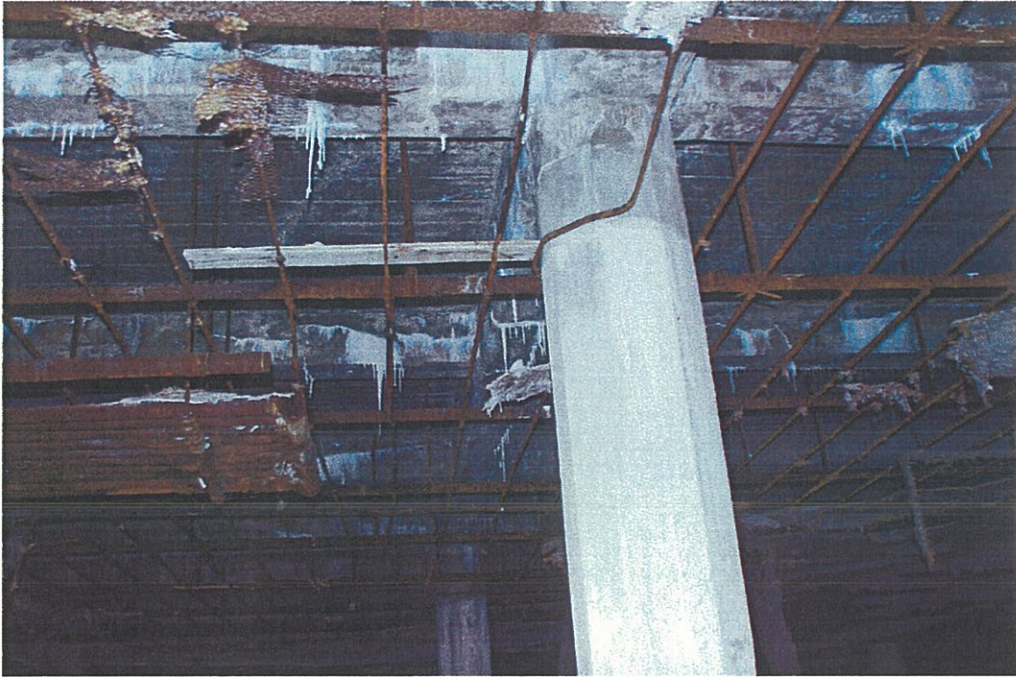
Photo G8.5 – 8th Floor
Ceiling framing suspended from structure above.

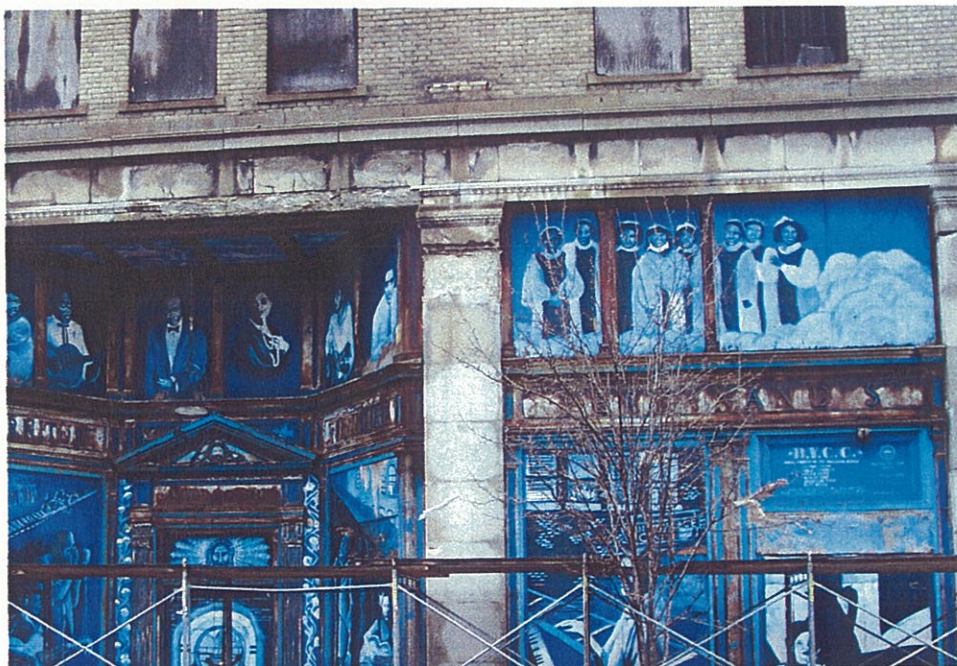
Photo GEX.8 – Front Entrance
Scaffolding placed along sidewalk to protect pedestrians from falling debris.

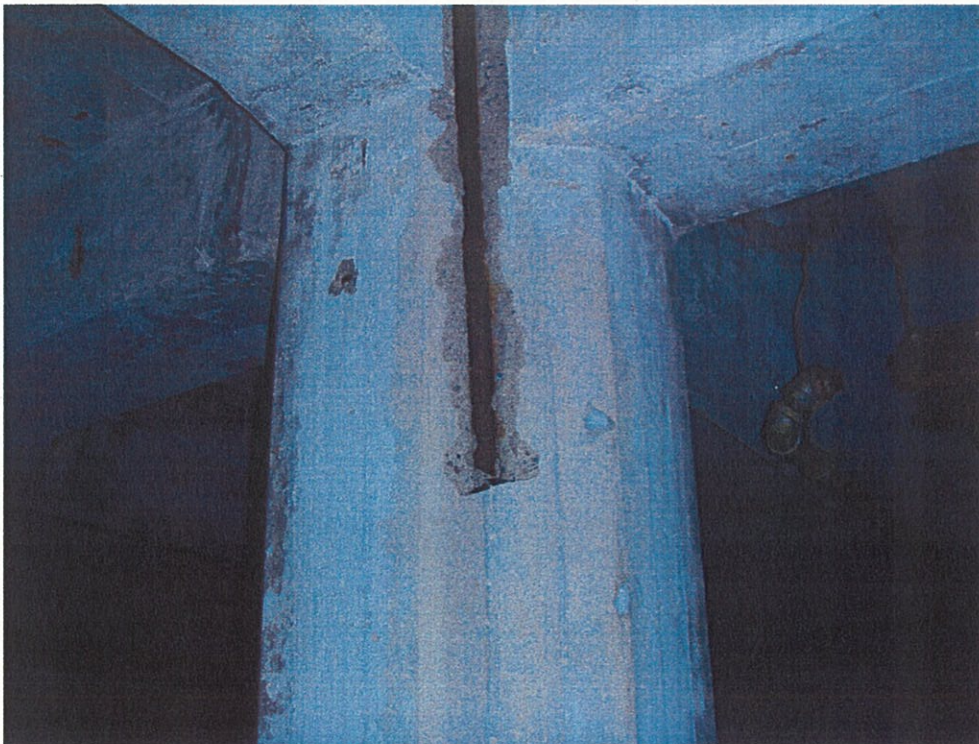
Photo CT0.4 – 4th Floor Column
Location of column where sample was taken.

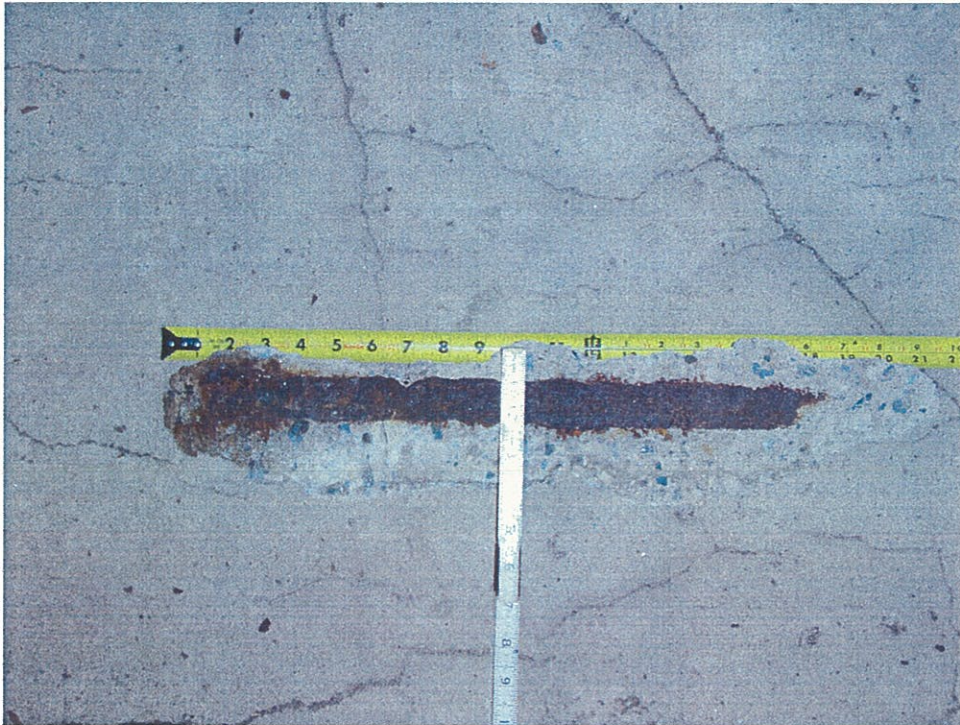
Photo CT0.5 – 5th Floor Column
Concrete sample removed by sledge hammer is 22” x 4”.

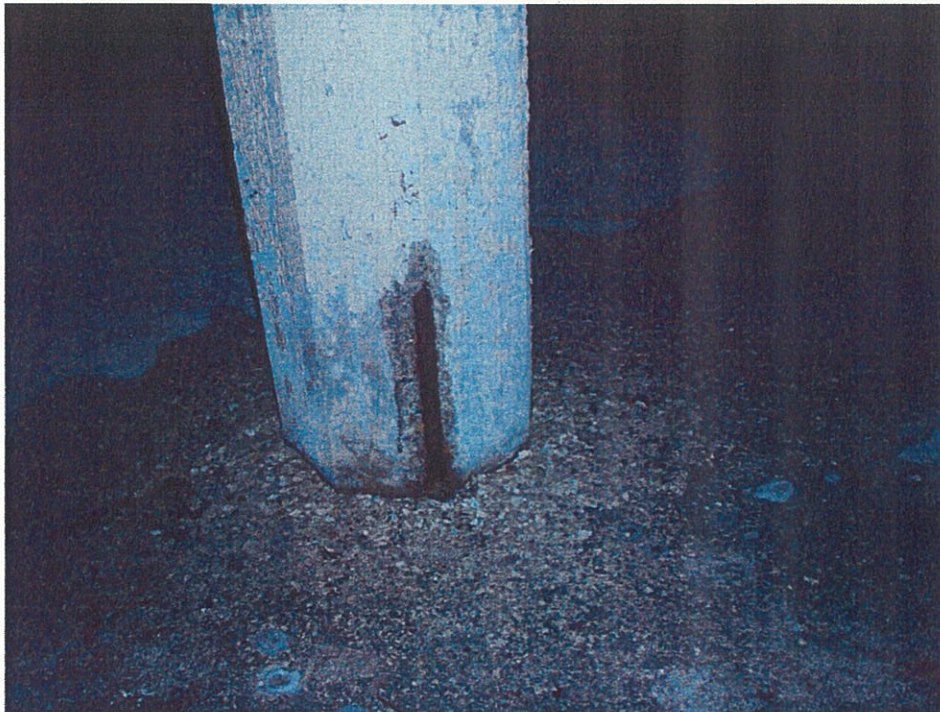
Photo CT0.6 – 5th Floor Column
Location of column where sample was taken.
