# Pier 5

Engineering Report & Visioning Session

# Pier 5 Waterfront Inspection and Assessment

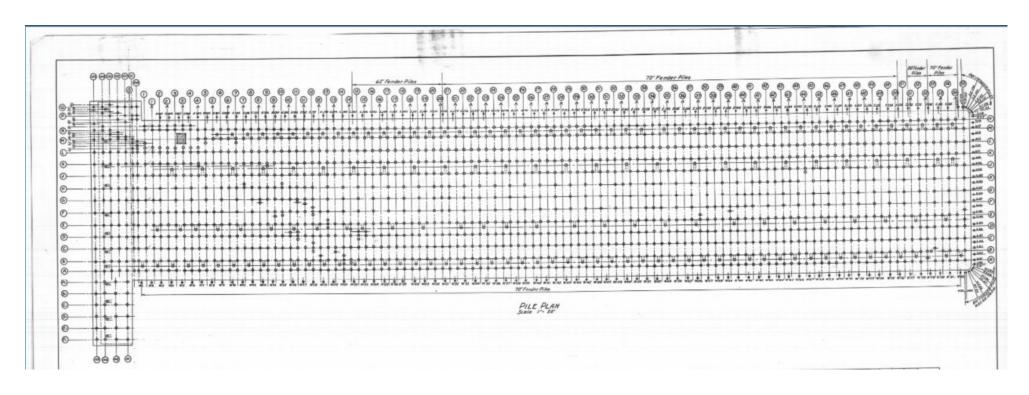
### Pier 5 Overview

- Built in 1943
- 665' long by 125' wide
- Approximately 1,650 spliced steel H-Piles, concrete encased In approximately 27' of water at low tide (MLW)

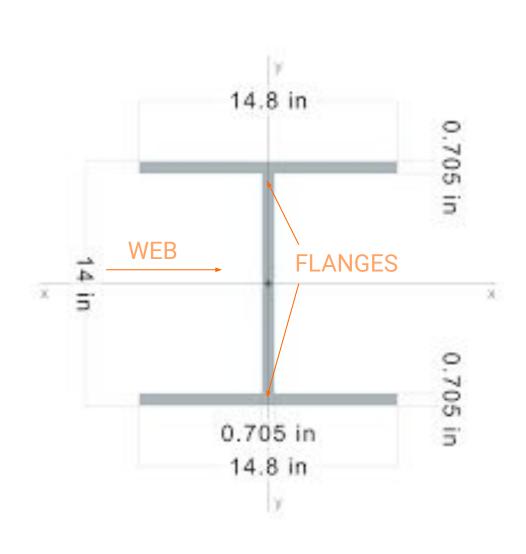
## **UT Measurements for Steel H-Pile Damage Rating**

- If concrete was included in assessment, all piles would have been Severe damage minimum since reinforcing rebar is all exposed
- Concrete aspect of the element was ignored, very conservative assessment. Steel H-Pile only
- Started with assumed HP-14x102 thicknesses
- Cleaned surface
- Measured current thickness
- % loss for each pile calculated
- Objective damage rating based on % loss assigned to each pile.

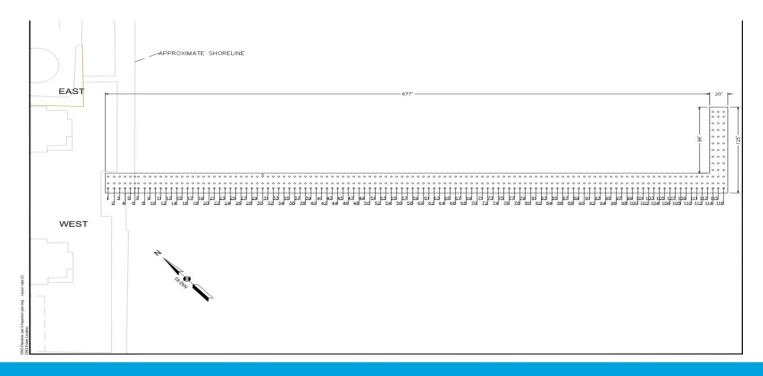
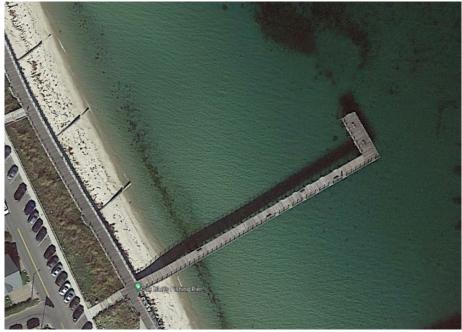
## **L-Shape Pier Options**

- Pedestrian Loading
- Full demolition with L-Shaped reconstruction \$10,800,000
- Partial demolition with L-Shaped non-traditional repair \$15,900,000
- Partial demolition with L-Shaped CarboShield repair \$14,600,000

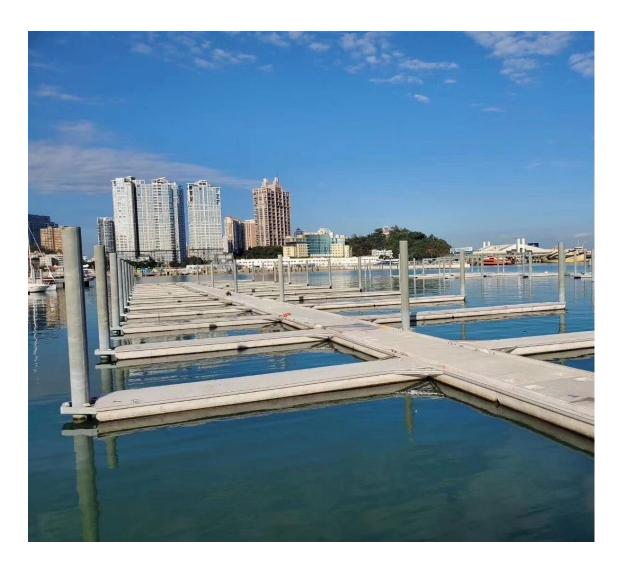
## Full Demolition with Floating Marina

- Main central floats approximately 550' long
- Assumes 20 finger floats, 10 on each side.
- \$11,200,000
