**Article 85 Review – Boston Zoning Code
17-19 Warren Street “Ferdinand’s Blue Store Addition”,
Roxbury, Boston, MA**

Engineering Design for Environmental Remediation
and Site Clearance at Dudley Square
Boston Redevelopment Authority
Project No. 5076

Re: Article 85 Application for 17-19 Warren Street, Roxbury, MA
New City Municipal Building
Phase 1 - Engineering Design for Environmental Remediation and
Site Clearance at Dudley Square, Roxbury, MA

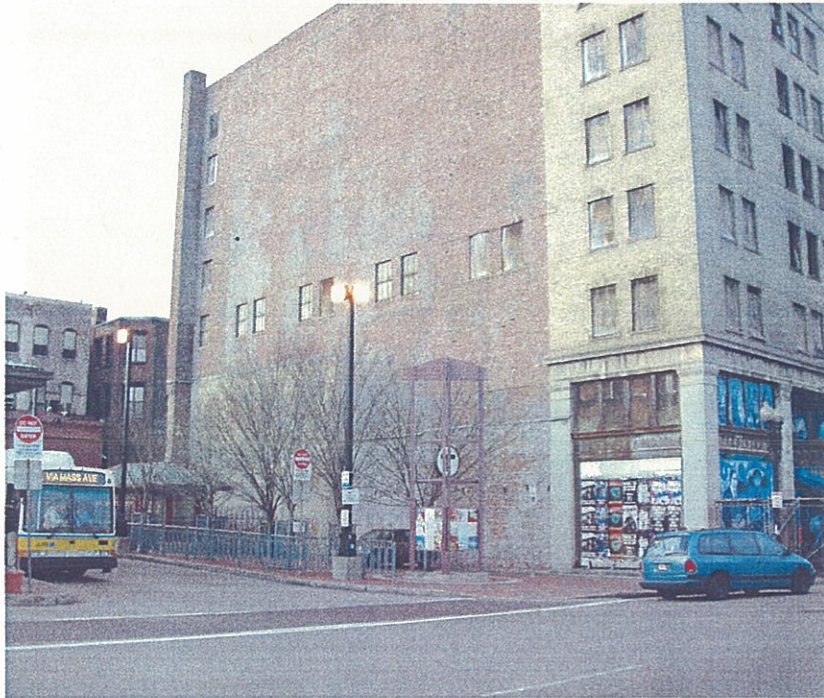
Photo GEX.5 - Elevation

Picture taken from Warren Street opposite MBTA Dudley Square Bus Station.

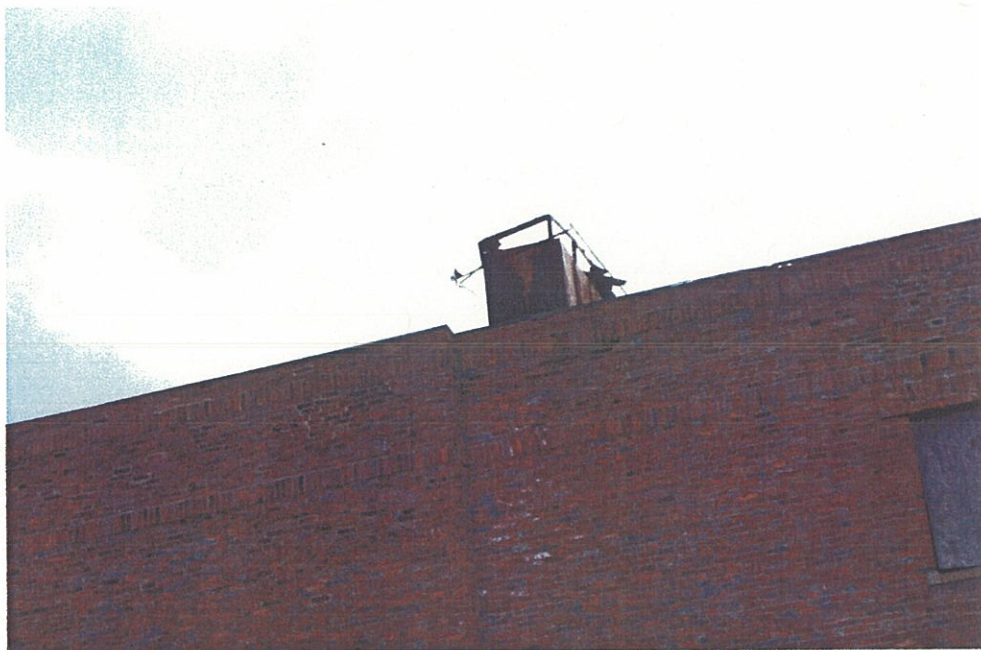
Photo GEX.7 – Partial Elevation
Some rooftop equipment seen, not inspected.

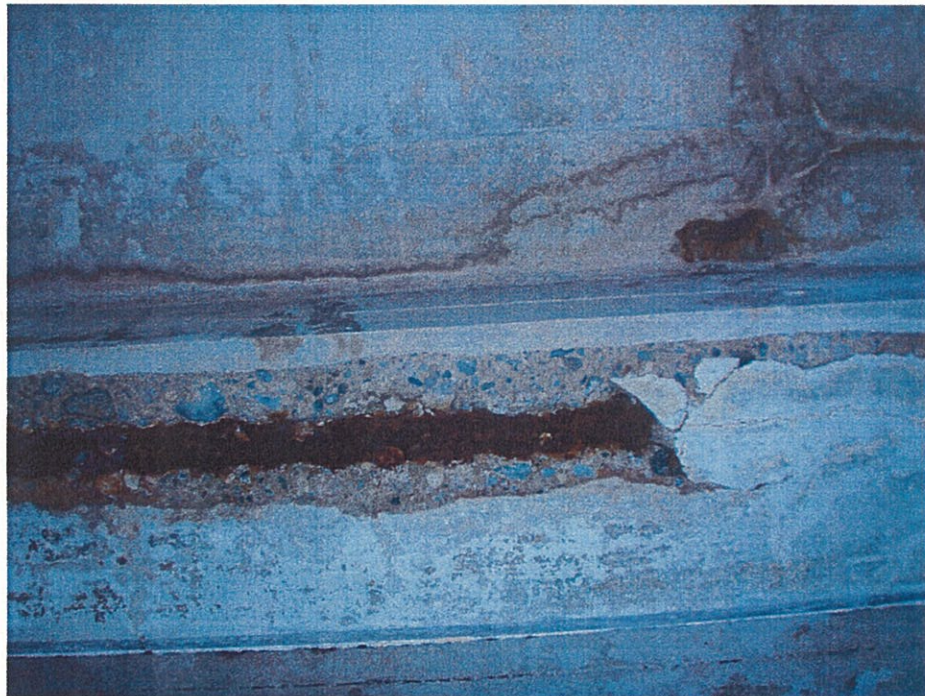
Photo CT0.2 - 3rd Floor Beam
Location of beam where sample was taken.
